Air Cleaner Assembly, Repair

M-256-001

All Mack GR, GU model trucks built between January 1, 2013, and April 30, 2023, utilizing an under hood, snow door air cleaner assembly.

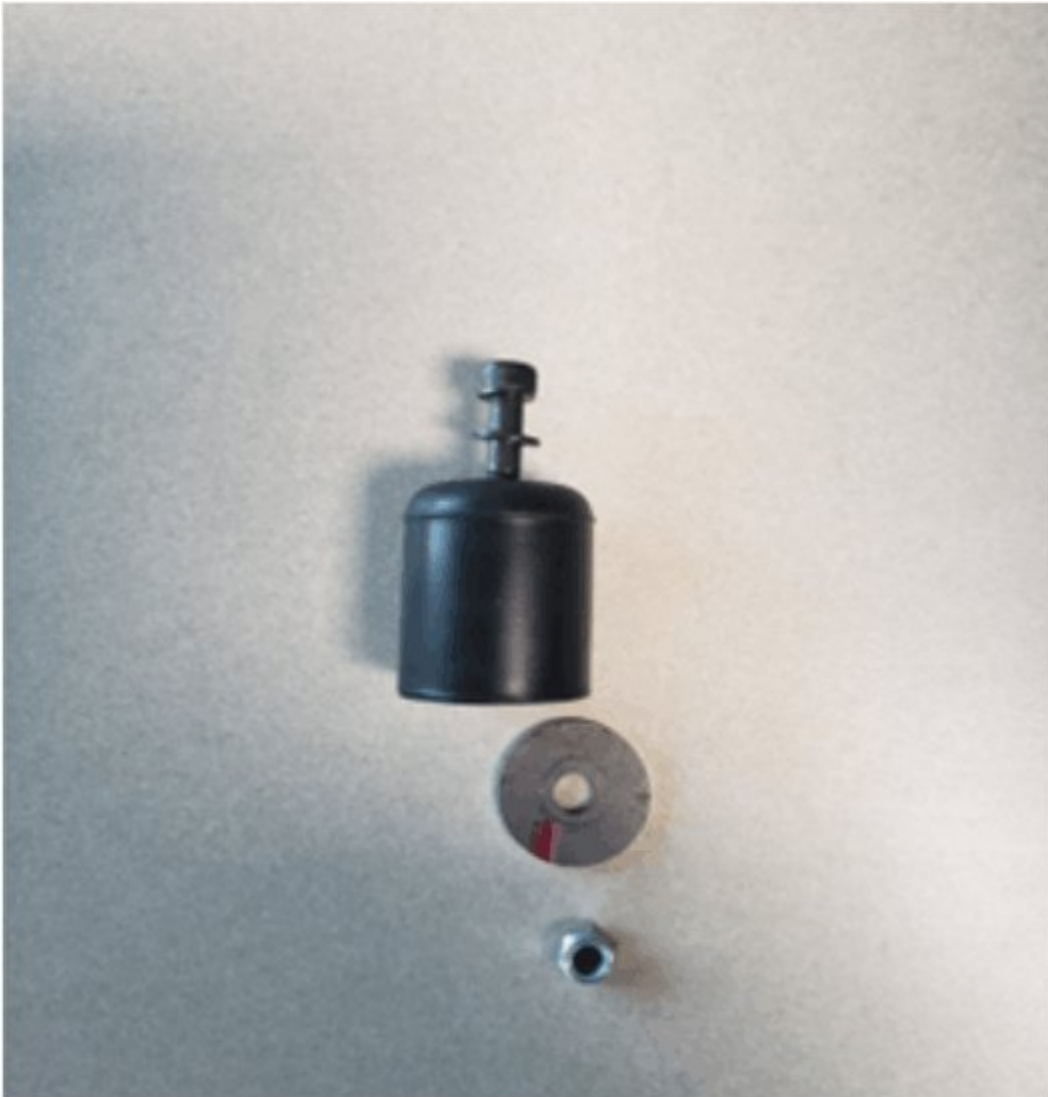
10. Install washer 60113296 onto the socket screw 60112804.
11. Insert socket screw and washer into the bumper 25108136.

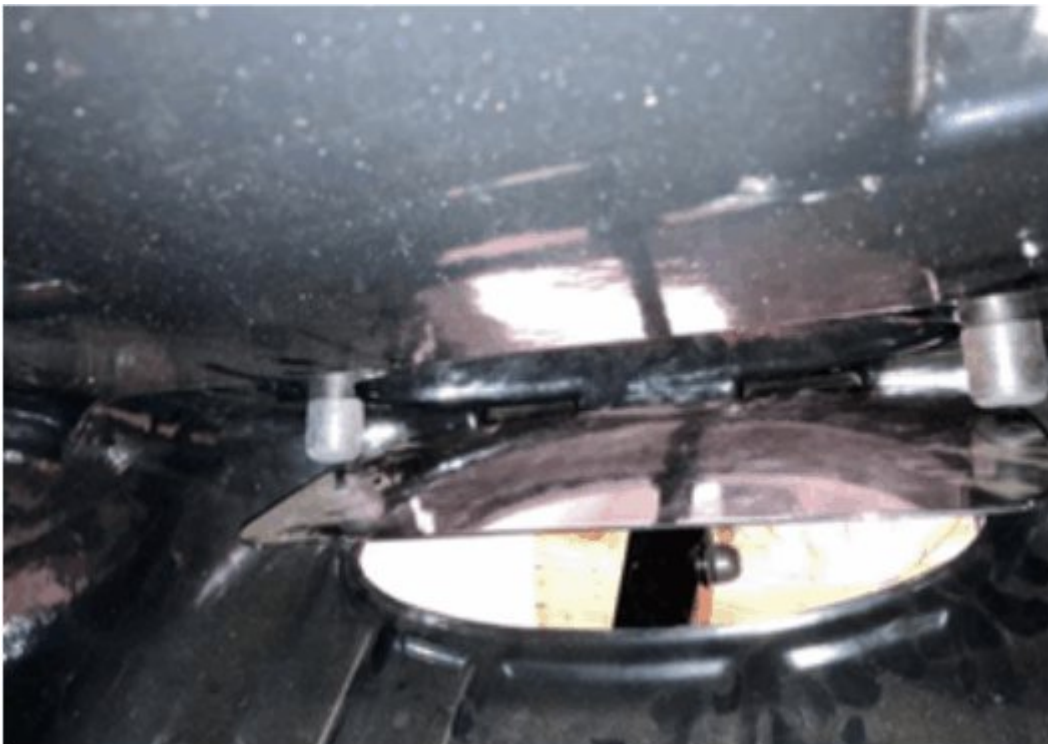
13. Using a 5/32 allen wrench and a 5/16 box end wrench, tighten the hardware.
14. Repeat steps 9–13 for the other bumper.
15. Manually move the snow door making sure it contacts both rubber bumpers.
