# Service Alert

<b>Subject:</b>  RATTLE FROM SUNROOF AREA	<b>Service Alert No.:</b> SA-014/23
	<b>Last Issued :</b> 03/10/2023

2023 CX-50 with VINS lower than 7MMVA\*\*\*\*\*140173 (produced before March 9, 2023)

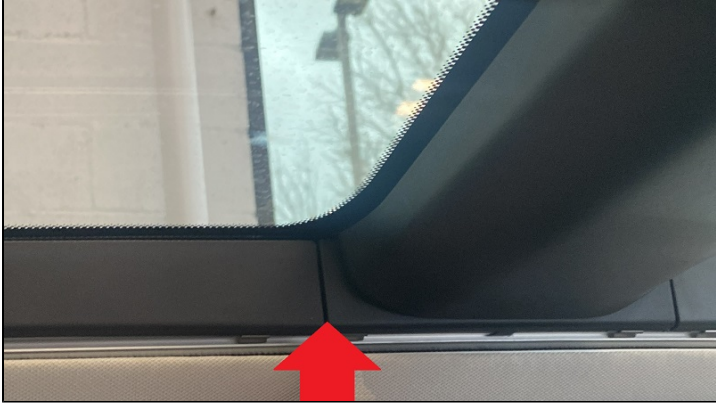
The noise comes from the side cover vibrating against the assembly at the location marked by the arrow due to poor retention of the cover clips.

1. Test drive the vehicle and if you hear the noise, press the area at the red arrow on both sides of the vehicle.

2. Remove the side covers from the sides of the sunroof assembly.
3. Bend the mount clips as shown below. If needed, remove them from the covers.

**CAUTION:** DO NOT bend the clips too far or they will break.
