69 Front seat belt is twisted

69 23 87 2058455/6 March 29, 2023. Supersedes Technical Service Bulletin Group 69 number 21-71 dated October 12, 2021, for reasons listed below.

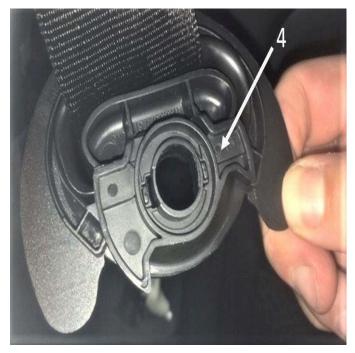
Figure 2. Backside of seat belt deflector. Deflector trim tabs engaged in the old belt guide.

3. Use your thumb to remove the old belt guide (plastic part) from the steel deflector. Start by detaching the guide from the bolt hole, then press out the lower section covering the metal tab (Figures 2 -3).

5. Install the modified belt guide 4K8 857 799 on the front driver side and 4K8 857 800 on the front passenger side (Figure 2, Pos. 4).

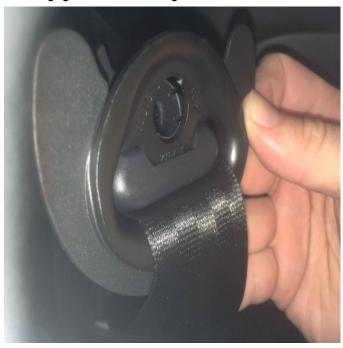
Figure 3. Removing old seat belt guide starting at the bolt hole.

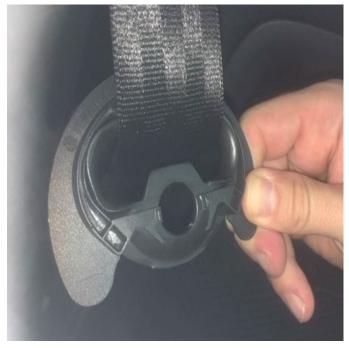
Figure 4. Old seat belt guide removed. The seat belt twist is corrected.

4. With the old belt guide removed, turn the seat belt webbing to remove the twist (Figure 4).

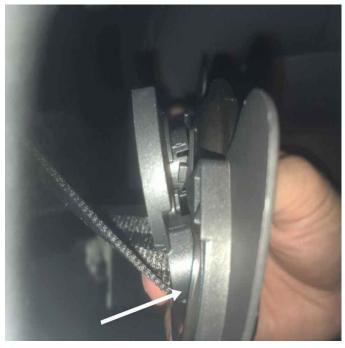
Figure 5. Installing modified seat belt guide starting with the metal tab on the bottom.

6. Start installing the modified seat belt guide at the deflector metal tab (Figure 5).

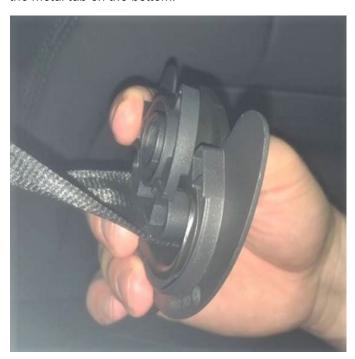
Figure 6. Seat belt deflector with the new guide installed.

7. Push the new guide into the bolt hole until you can hear the plastic retainers snap into place (Figure 6).

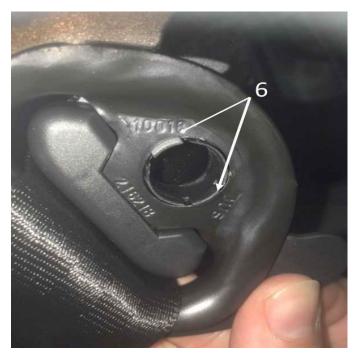
Figure 7. Belt guide locking tabs correctly secured at the bolt hole.

8. Inspect the front of the deflector for proper installation of the guide locking tabs at the bolt hole (Figure 7, Pos. 6).

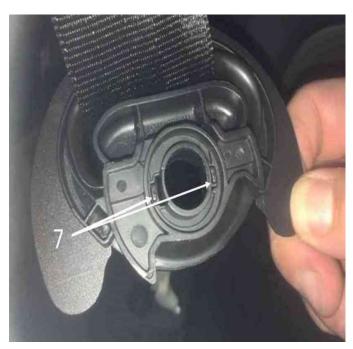
Figure 8. Seat belt deflector trim locking tabs properly secured to the seat belt guide.

9. Inspect the back of the deflector for proper installation of the deflector trim locking tabs to the seat belt guide (Figure 8, Pos. 7).
