# Special Bulletin

# SP22-314 CO 20

## CHANGE ORDER NO. 20 – 3-POINT ORANGE SEAT BELT INSTALLATION

Prevost vehicles

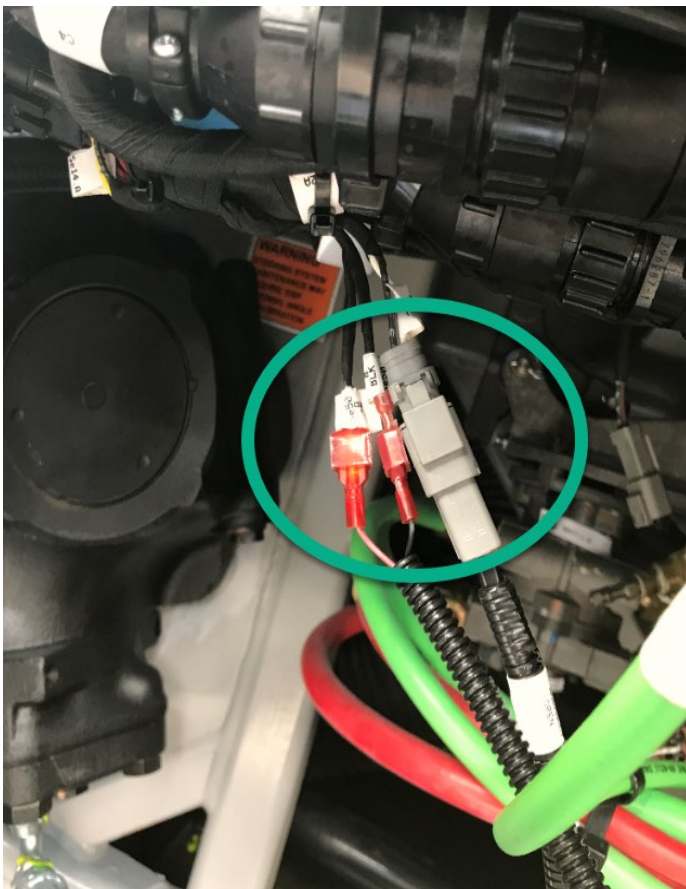
1. In the front service compartment, disconnect the driver seat harness.

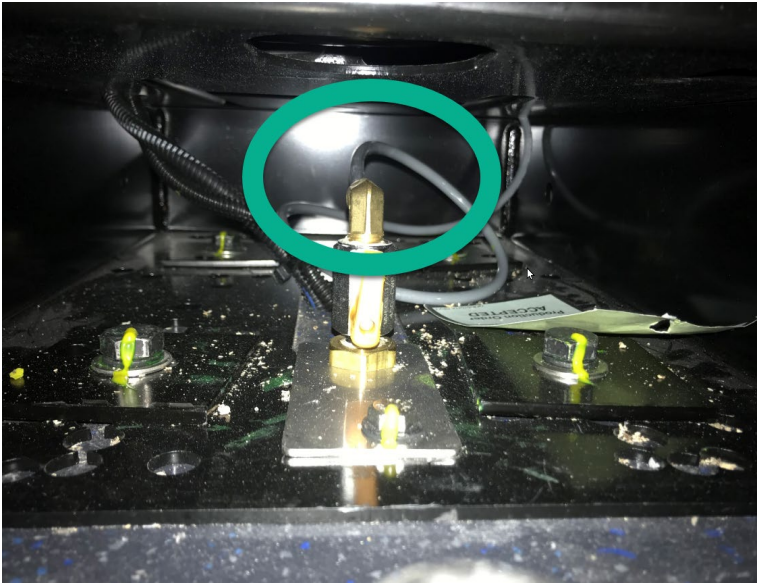
2. Under the driver seat, disconnect the air supply line.

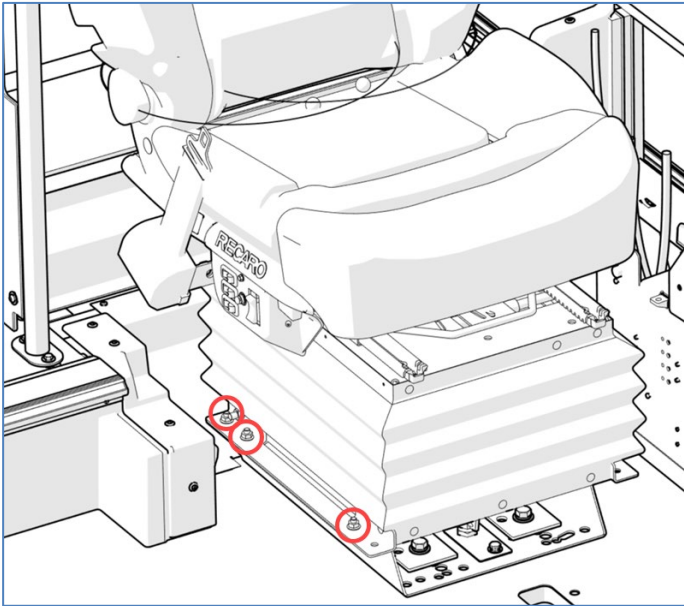
3. Unscrew and remove 6 screws attaching the seat to the riser (3 screws per side). Note if torque seal marks are present.

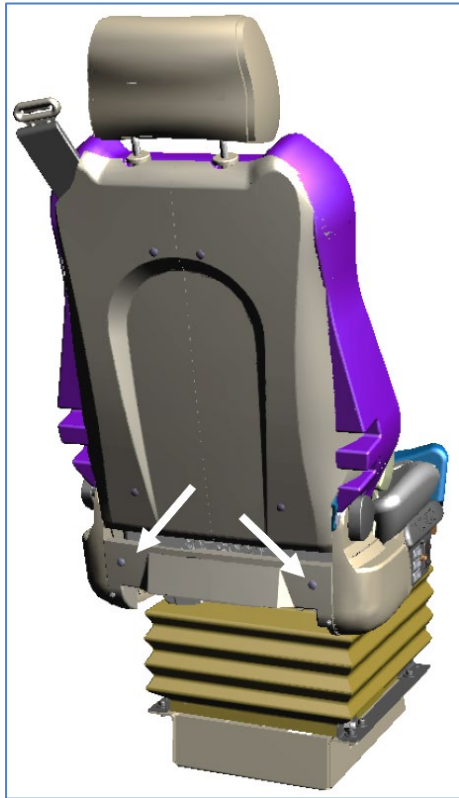
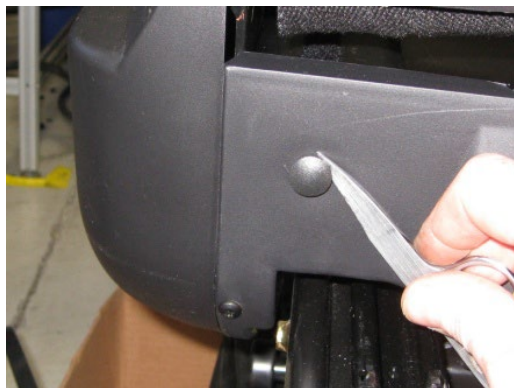
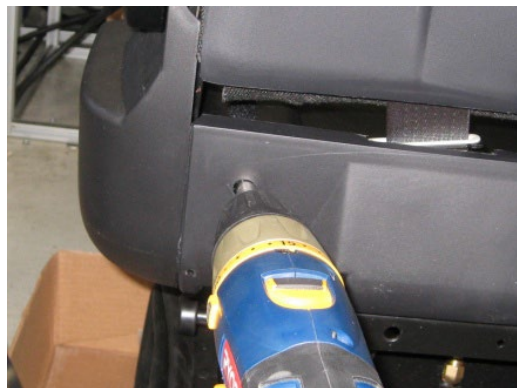
1. Remove hole plugs from lower rear trim panel using small pick. Save for re-use. Remove rear lower trim panel using Phillips #2 screwdriver. Set aside caps, screws, and panel.

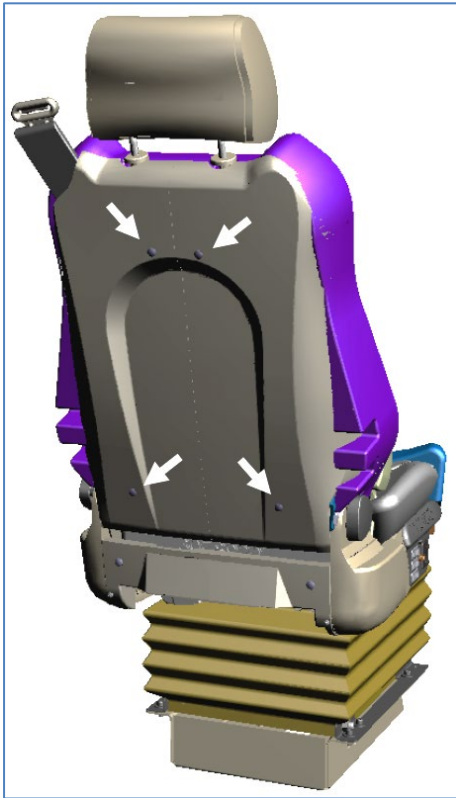
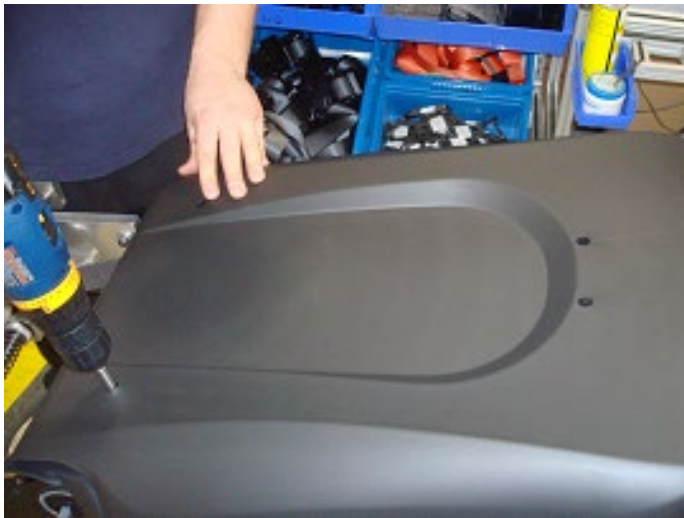
2. Remove 4 small caps with small pick from plastic back protector to allow access to 4 mounting screws. Remove 4 screws with Phillips #2 screwdriver. Set aside caps & screws. Remove plastic back protector.

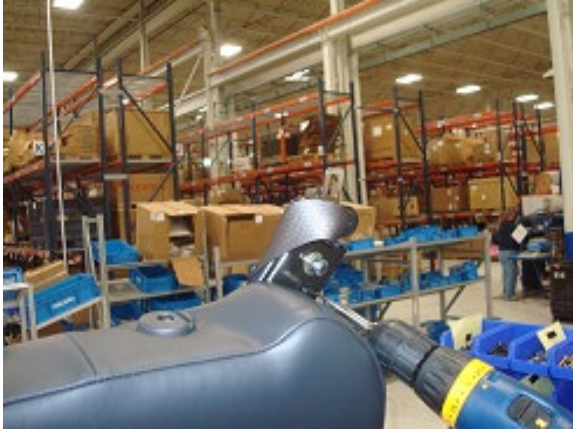
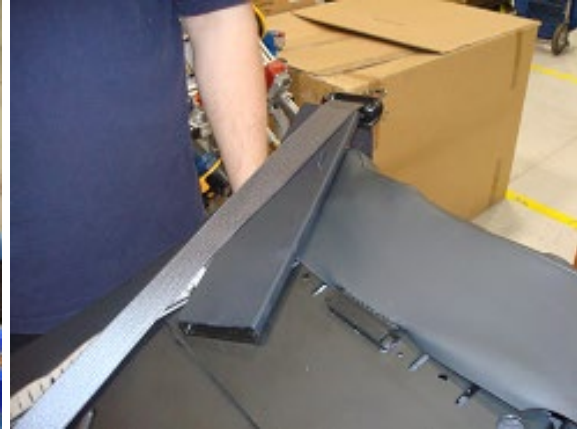
3. Using a Phillips screwdriver, remove the turning loop bracket trim cover from the turning loop bracket and discard cover and screws.

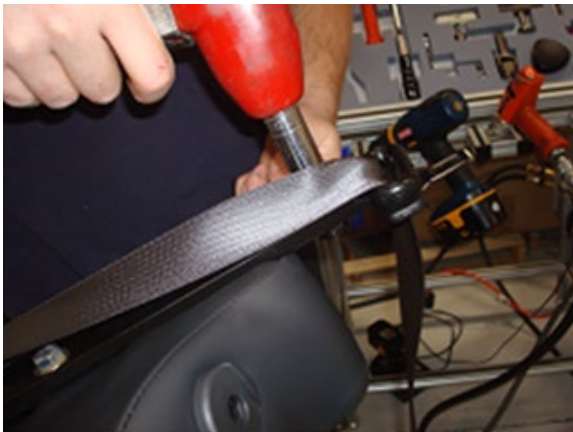
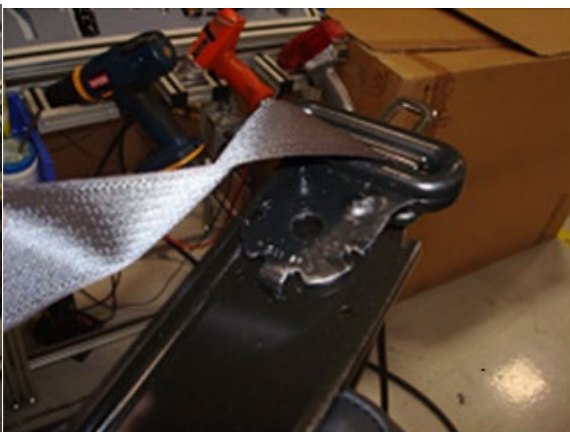
4. Remove 5/8" nut cap. Disassemble the turning loop from the bracket with a 5/8" socket/ratchet and 5/8" wrench.

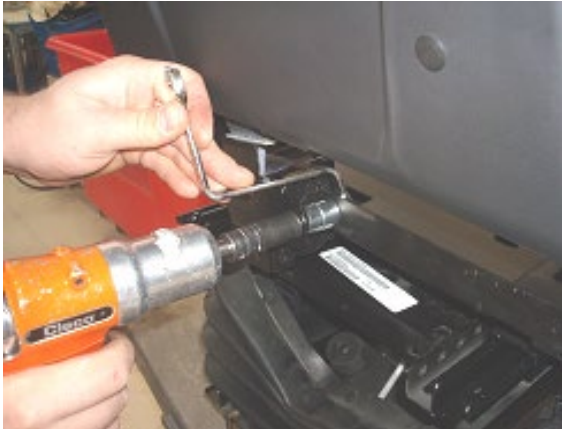
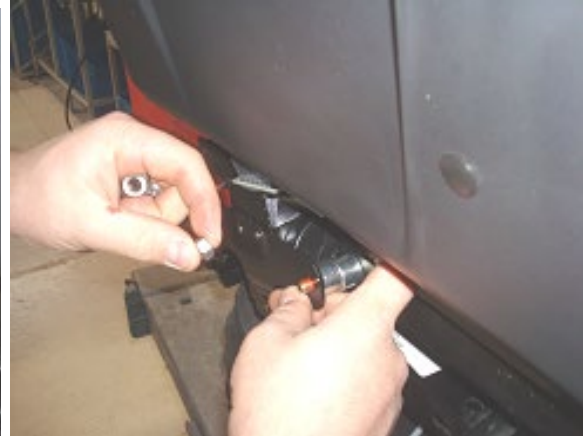
5. Remove retractor assembly from cushion frame with 13 mm hex wrench for the nuts, a 13 mm hex wrench for one bolt (shown), and a 6 mm Allen wrench for the other bolt.

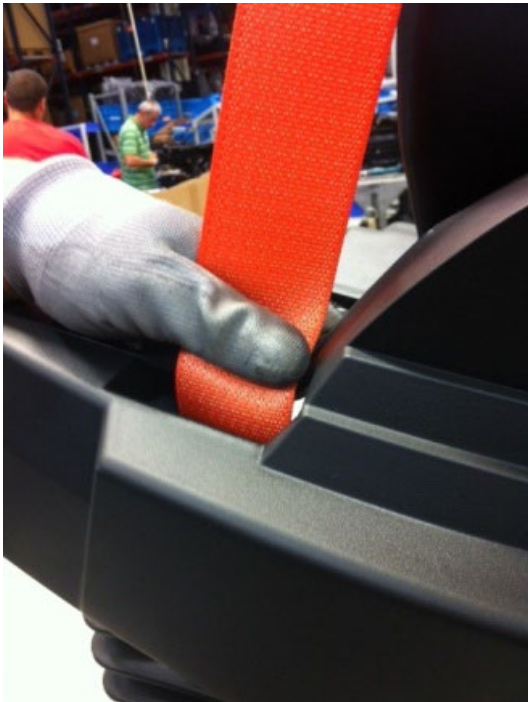
6. Lift back of cushion foam to remove from the Velcro pieces securing to the cushion frame. Flip cushion foam forward over thigh extension to access the side trim panel.
7. Remove left rear trim panel by removing the screw securing to the cushion frame with a Phillips #2 screwdriver. Slide panel upward along seat belt webbing to access the lap anchor bolt mounting location.

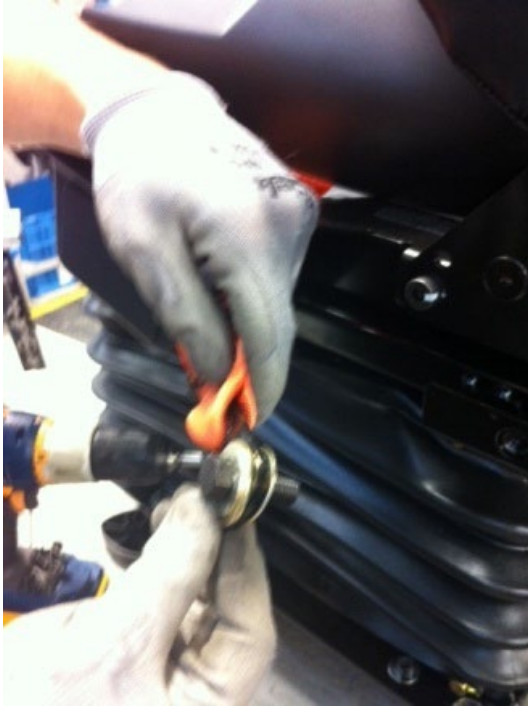
8. Remove lap anchor bolt from the cushion frame using a 5/8" hex wrench. Set aside washers and bolt. If the seat also has a 2-point lap belt retractor, set aside.

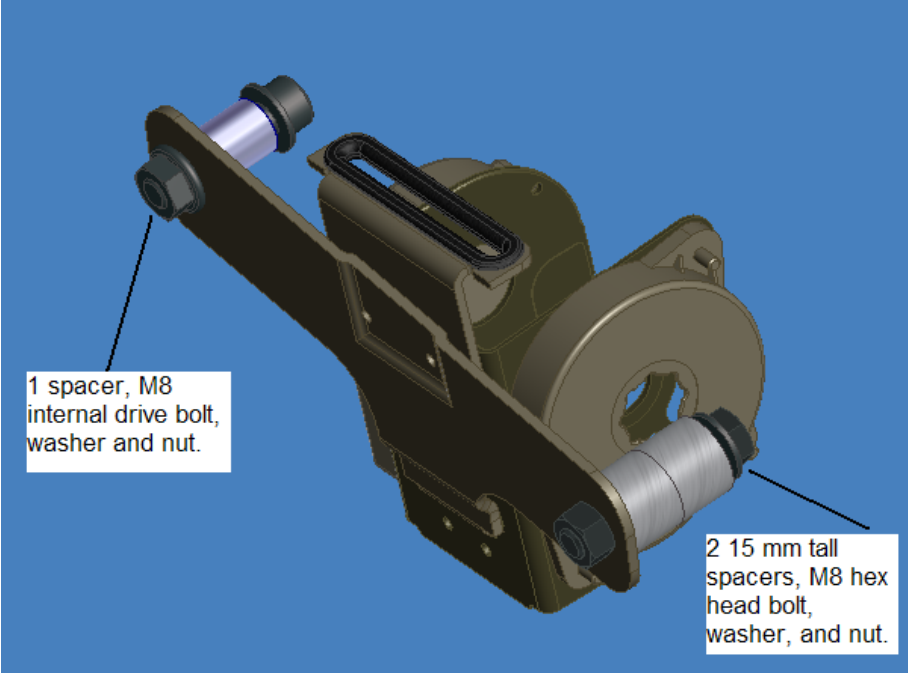
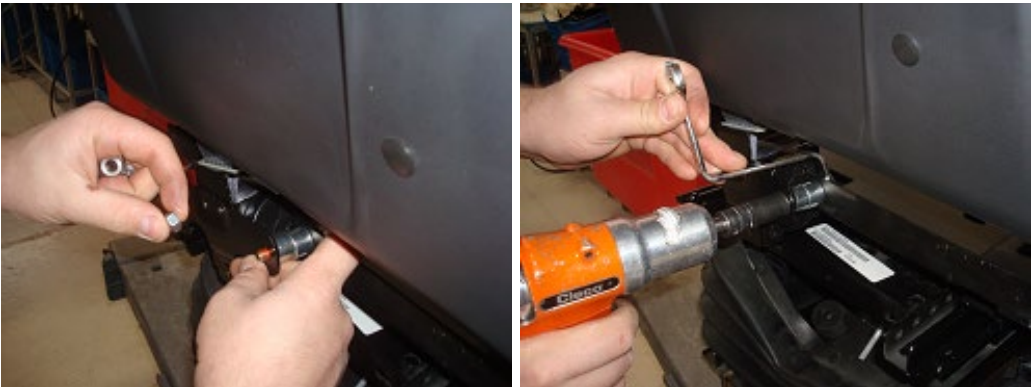
10. Install new seat belt assembly 777979 at the retractor attachment first. Align the retractor with the 2 holes on the back of the cushion frame. Shown is a graphic for the correct arrangement of bolts and spacers used to install the retractor. Secure bolts to 22 Nm.

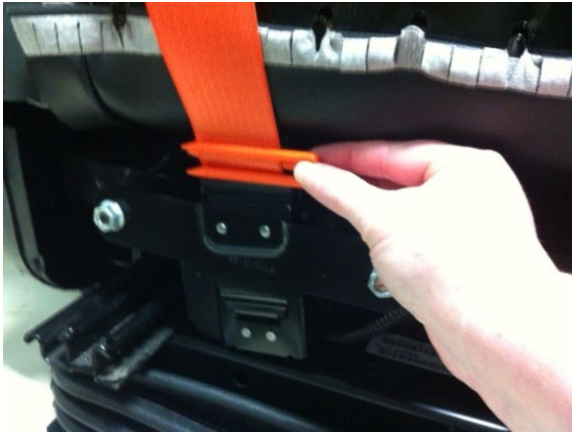
11. After securing retractor, remove the plastic shipping clip from the webbing.

**NOTE: It is important to wait until the retractor is installed before removing the shipping clip. If removed prior to installation, too much webbing may feed into the retractor spool, preventing the retractor from working properly.**

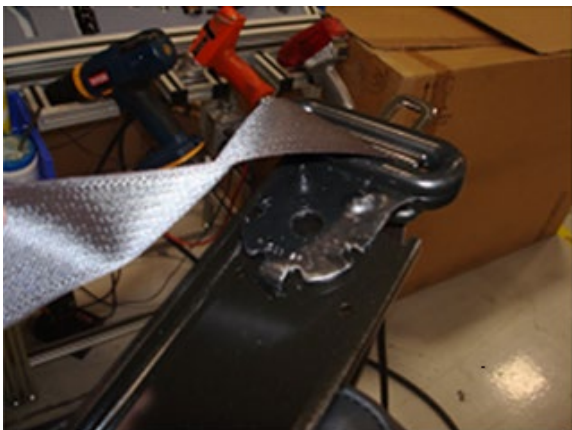
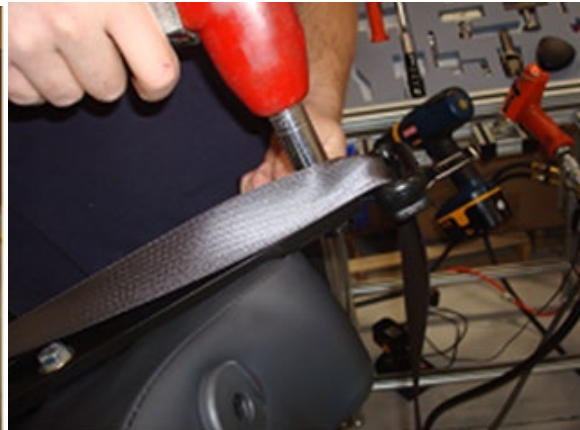
12. Route turning loop up to the mounting location, ensuring that there are no twists in the webbing. Install turning loop to mounting bracket on the top of the seat back with 1 bolt, 2 washers and 1 locking nut, using a 5/8" wrench or socket. Torque to 50 Nm. Install new 5/8" cap over turning loop bolt.

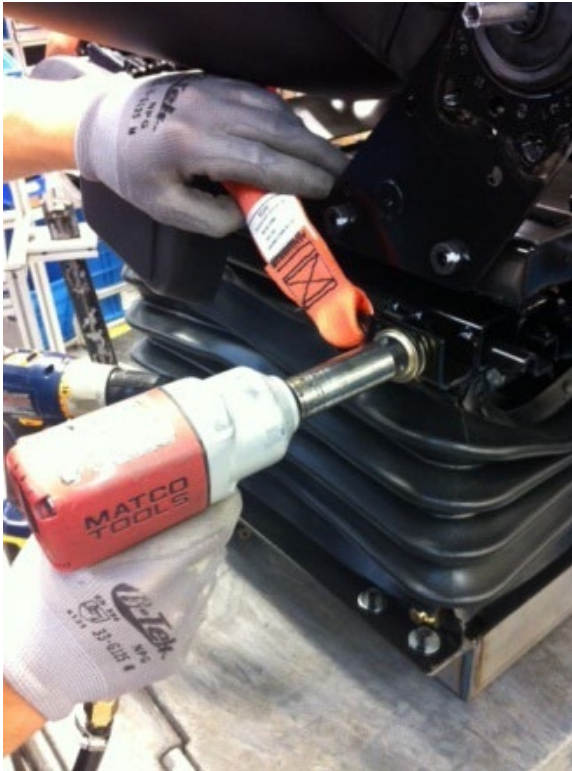
13. Route the lap anchor through the opening in the left side trim panel, ensuring there are no twists in the webbing.
14. Place the 3/8" washer and 7/16" washer on the 7/16" bolt for the lap anchor, with the smaller washer closer to the head of the bolt.

Place the additional 7/16" washer on the other side of the anchor. Install the bolt into the attachment location on the seat. Torque to 50 Nm.

If the seat has a 2-point lap belt retractor, place the 3/8" and 7/16" washer on the bolt, then the retractor, and finally, the lap anchor. Install onto the seat and torque to 50 Nm.

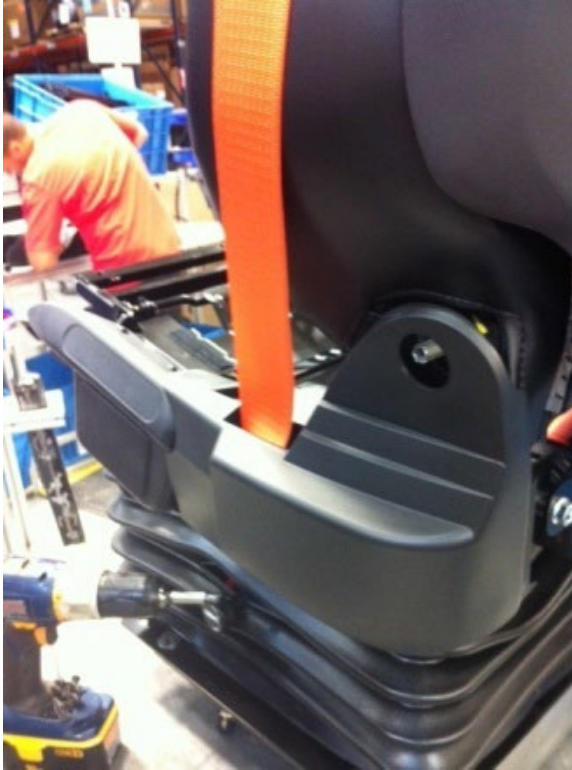
15. Slide the side trim panel down the webbing and align over the mounting location on the cushion frame. Secure the screw with a Phillips #2 screwdriver.

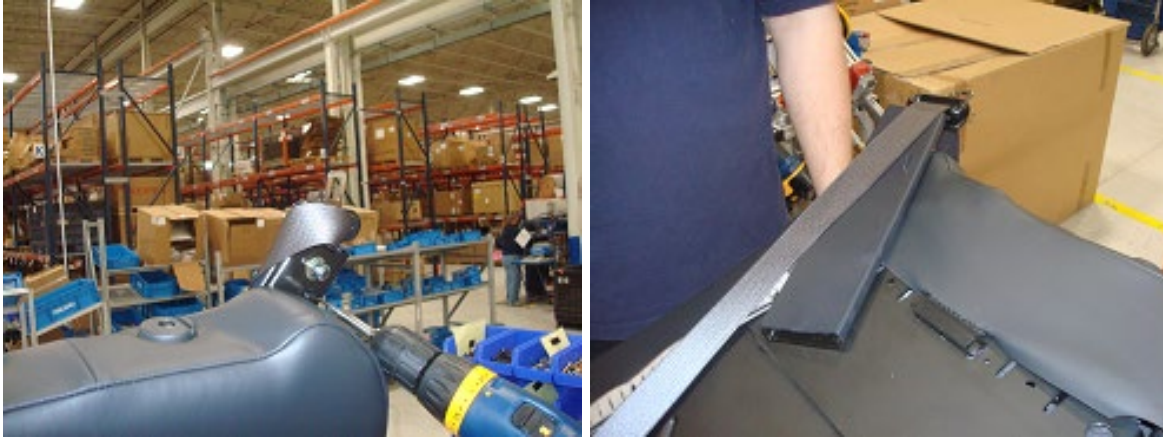
16. Reinstall cover over turning loop using a Phillips #2 screwdriver.

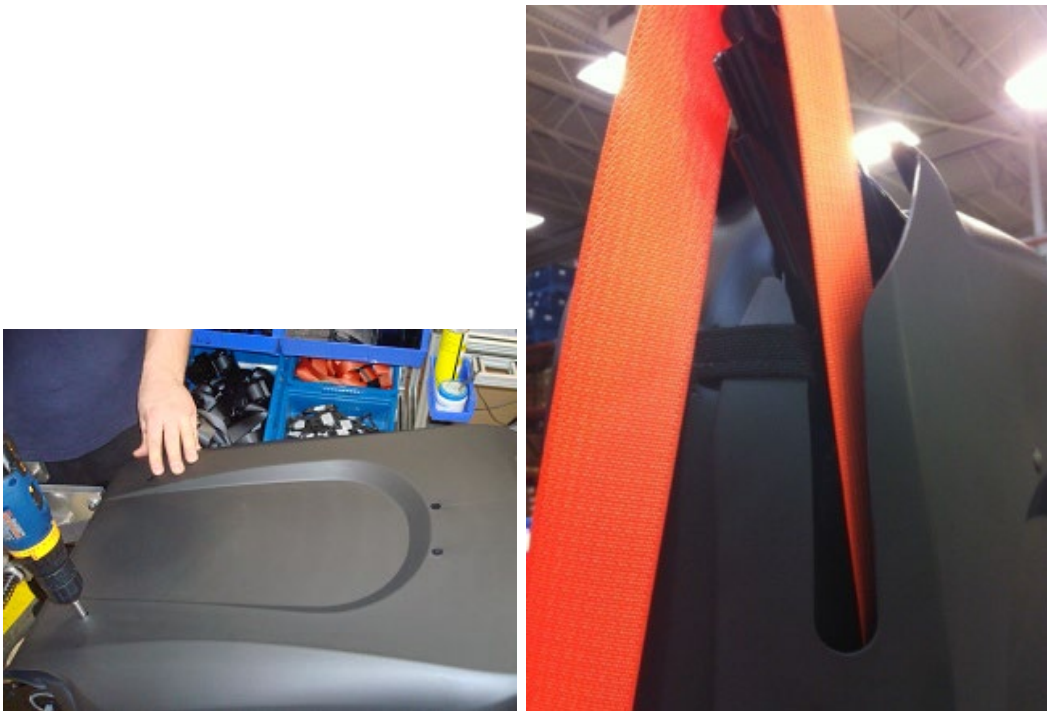
17. Reinstall plastic back protector using a Phillips #2 screwdriver. Reinsert 4 hole plugs, using a small rubber mallet if necessary. Ensure that the top of the plastic back protector near the seat belt turning loop is routed through the loop of fabric sewn into the trim cover.

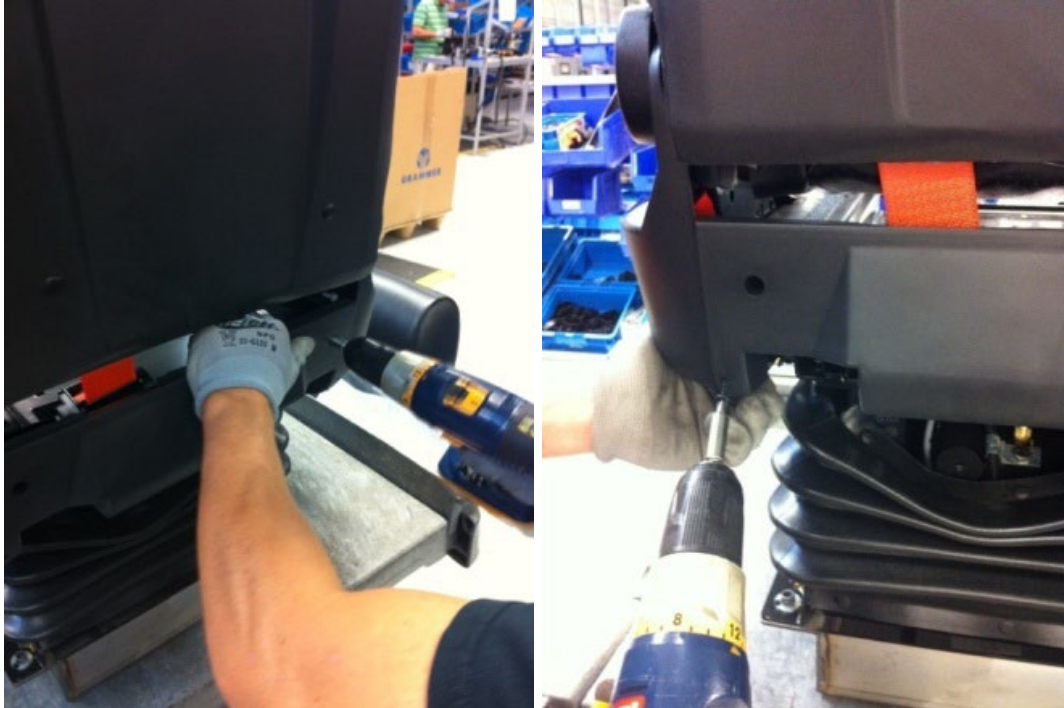
18. Reinstall rear trim panel over the seat belt retractor on the back of the cushion frame with 2 screws using a Phillips #2 screwdriver. Install 2 pan head screws to the lower corners of the rear trim panel to the left and right-side trim panels. Insert hole plugs into the 2 holes in the rear trim panel.

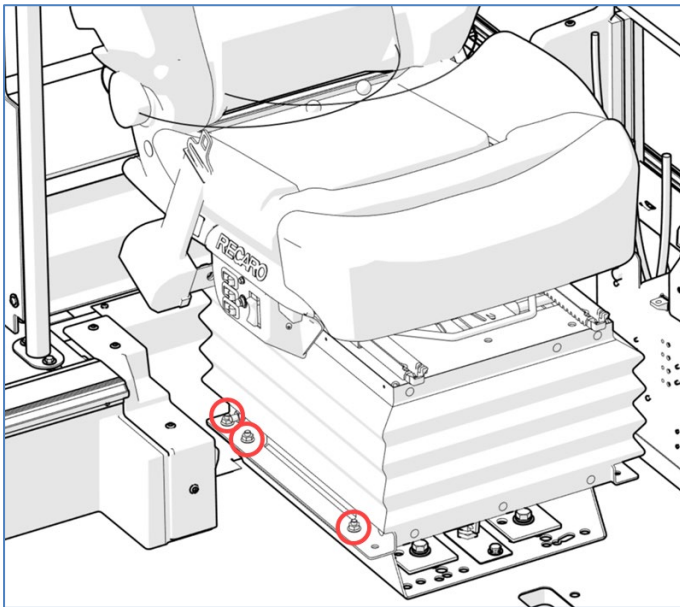
1. Install the new seat with the 6 screws previously removed. For aesthetic consideration, apply torque seal marks only if torque seal marks were present on the previous installation.

***Torque to 16.5 lb-ft***

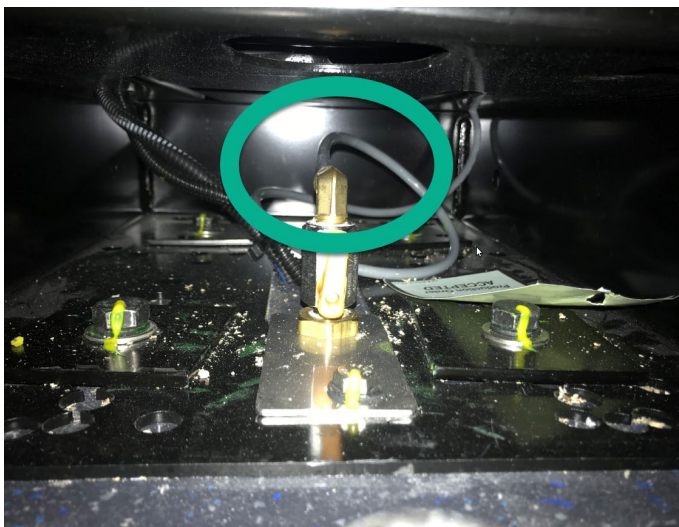
2. Under the seat, connect the seat air supply line from the push-in fitting.

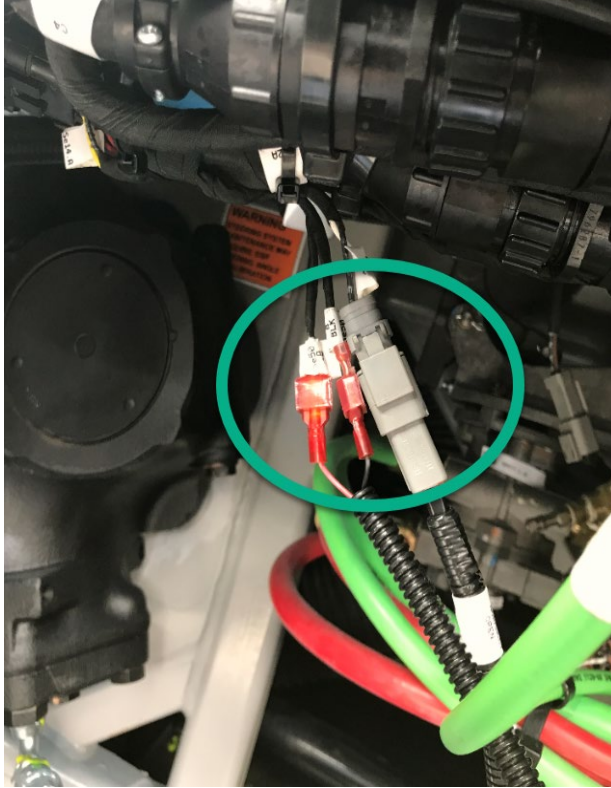
3. In the front service compartment, connect the driver seat harness, red, black and Open.
