Technical Service Bulletin

Subject: SEAT WARMER DOES NOT OPERATE WHEN TURNING IGNITION ON WHILE CABIN TEMPERATURE AND/OR SEAT IS WARM	Bulletin No.: 09-012/23
	Last Issued : 03/22/2023

APPLICABLE MODEL(S)/VINS:

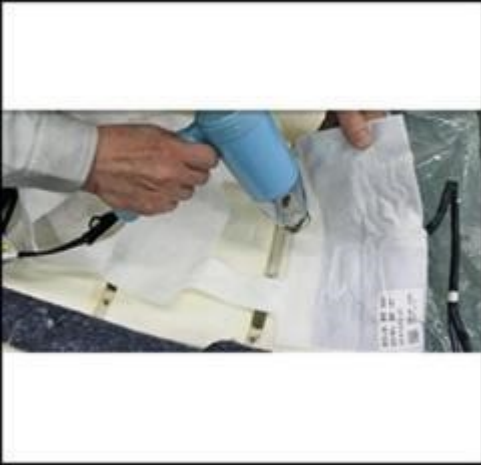
3. Replace the seat warmer unit of the seat cushion side according to the following steps.
 - a. Remove the heater mat gently while using a hair dryer or an iron to warm up the adhesive parts (1).

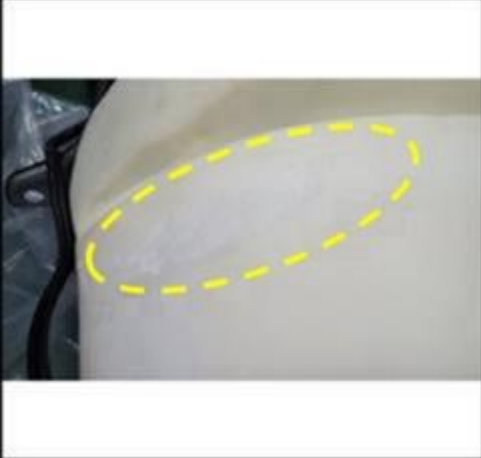
NOTE: If the adhesive surface is not warmed up sufficiently, the urethane pad may be damaged (example image below).

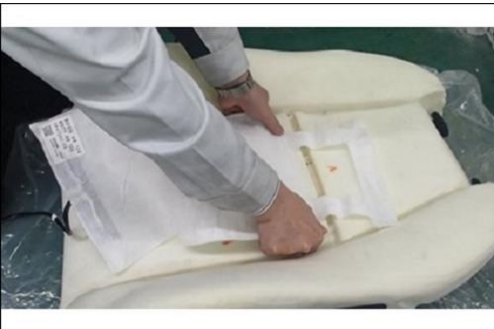
NOTE: Location of the markings of the urethane pad

c. Remove the three release papers on the seat warmer unit, and then apply it to the the urethane pad according to the markings on the pad (Refer to the procedure below).

NOTE: Align with the seat warmer and the markings on the urethane pad.

Marking A: DO NOT cover the marking with the adhesive tape on the seat warmer unit.

Marking B: Apply the edge the adhesive tape of the set warmer unit on the marking.
