**Title:** LT Truck Headlight Harness Inspection and Repair

**Applies To:** All LTs built until 4/11/2022

Certain International® LT® Series trucks may have headlight issues due to headlight harness damage.

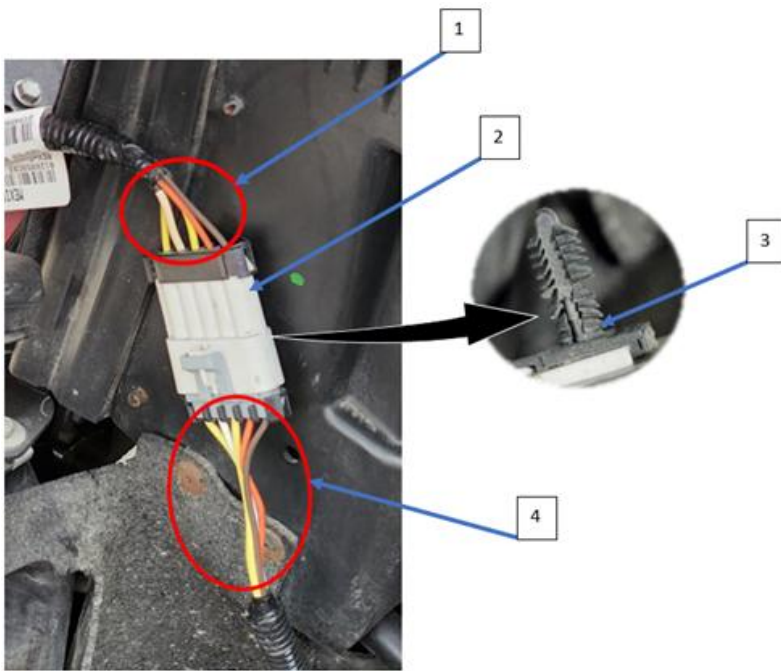
**Figure 1. Driver-Side Headlight Assembly Harness**

1. Headlight assembly harness
2. Connector 8001F
3. Fir tree
4. Forward chassis Harness

7. Carefully remove fir tree (Figure 1, Item 3) with connector 8001F (Figure 1, Item 2) from radiator shield.

8. Inspect headlight assembly harness (Figure 1, Item 1) and forward chassis harness (Figure 1, Item 4) for any damage to the wires.

- a. Repair any damaged wire(s) using butt splice, solder and heat shrink.

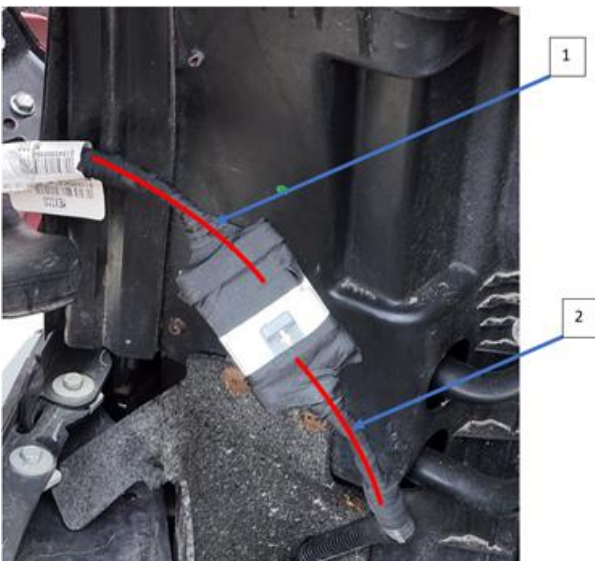
**Figure 2. Wiring Harness Taped**

1. Headlight assembly harness
2. Chassis forward harness

**Use approximately 5 feet of electric harness tape for driver-side headlight assembly harness**

9. Add electric harness tape to the 5-pin connector and headlight assembly harness (Figure 2, Item 1).
10. Add electric harness tape to the 5-pin connector and chassis forward harness (Figure 2, Item 2).

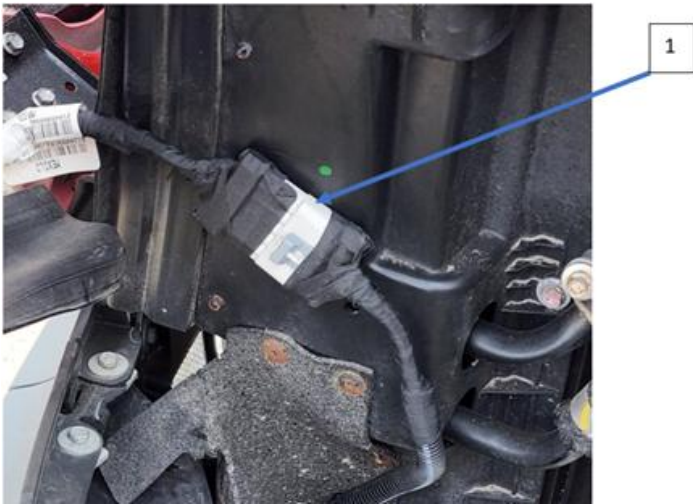
**Figure 3. Driver-Side Headlight Assembly Harness**

1. 5-pin connector

11. Install and position the 5-pin connector (Figure 3, Item 1) as close to horizontal position as possible.

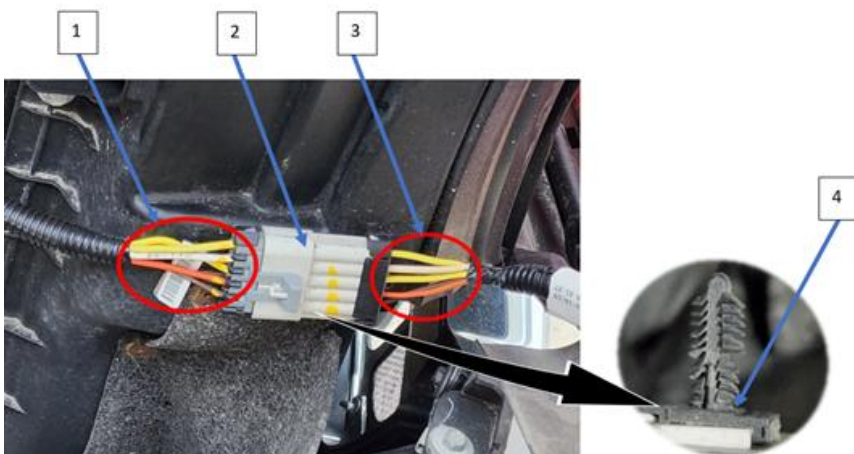
**Figure 4. Passenger-Side Headlight Assembly Harness**

1. Chassis forward harness
2. Connector 8000F
3. Headlight assembly harness
4. Fir tree

12. Carefully remove fir tree (Figure 4, Item 4) with connector 8000F (Figure 4, Item 2) from radiator shield.

13. Inspect headlight assembly harness (Figure 4, Item 3) and chassis forward harness (Figure 4, Item 1) for any damage to the wires.

a. Repair any damaged wire (s) using butt splice, solder and heat shrink.

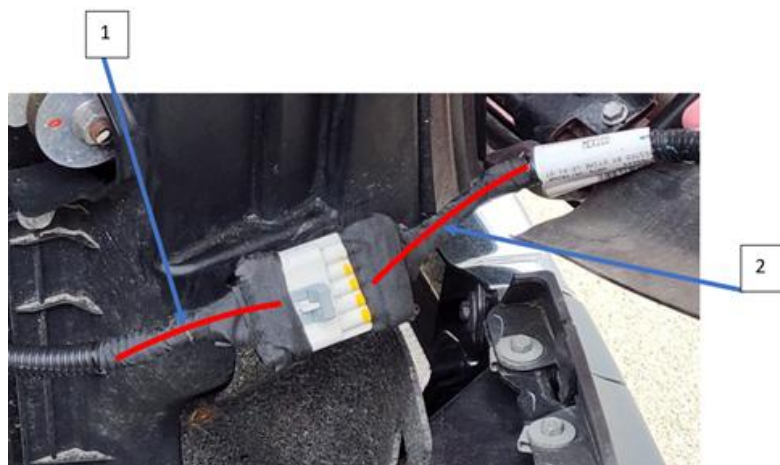
**Figure 5. Wiring Harness Taped**

1. Chassis forward harness

2. Headlight assembly harness

**Use approximately 5 feet of electric harness tape for passenger-side headlight assembly harness**

14. Add electric harness tape to the 5-pin connector and headlight assembly harness (Figure 5, Item 2).

15. Add electric harness tape to the 5-pin connector and chassis forward harness (Figure 5, Item 1).
