QUALITY ACTION

CAMPAIGN BULLETIN

HVAC Pipe Inspection

Reference: PC963

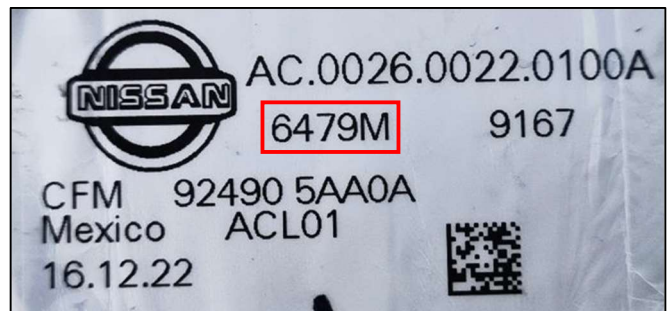
3. Write down the 5 digit lot code on the A/C pipe shown in Figure 2 and Figure 3.
- If the lot code **IS** 6479M, continue to Step 4 for High pressure A/C line.
 - If the lot code is **NOT** 6479M, no further action is needed, close the hood and continue to claims information on last page.

4. Replace the high-pressure flexible hose.

- Refer to the ESM section: *VENTILATION, HEATER & AIR CONDITIONER - HEATER & AIR CONDITIONING SYSTEM - REMOVAL AND INSTALLATION - COOLER PIPE AND HOSE - HIGH-PRESSURE FLEXIBLE HOSE - Removal and Installation - Removal and Installation*
