SHOWER PAN REPLACEMENT

Bulletin Type:	SRP	Publication Date:	April 2023
Bulletin #(s):	23-097	Make(s):	Jayco & Entegra
Job Code(s):	<i>If affected unit has warranty remaining, submit your claim following the normal process</i>	Model(s):	Swift 20T & Swift LI 20TL Ethos 20T & Ethos LI 20TL
Flat Rate(s):		Model Year(s):	2021-2022

Incident:	Crack develops in wet bath shower pan system.
Affected Units:	2021-2022 Jayco Swift and Swift LI; 2021-2022 Entegra Coach Ethos and Ethos LI
Parts List:	SEALANT,CLKG QUAD WHT LOW VOC 10.2 OZ. (Purchase locally) SEALANT,CAULK NUFLEX 302 TRANLUCENT WHT 10.1 OZ (Purchase locally) CAP,HNG SNAP WHITE F/#8 SCR (Jayco Part#2014712) (Contact Jayco Parts if part is needed) Shower Pan (Contact Jayco Parts if part is needed) BRACKET,SH SPRT 8.78X9.85 14 GA STL BLK (Jayco Part#2044820)
Misc. Tools & Supplies:	N/A

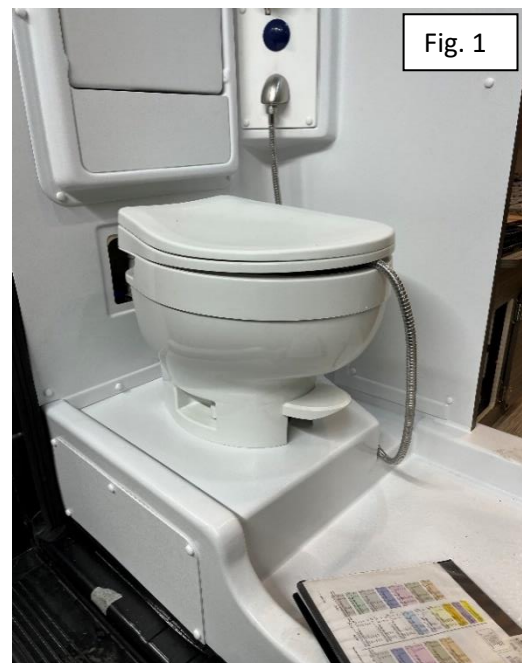
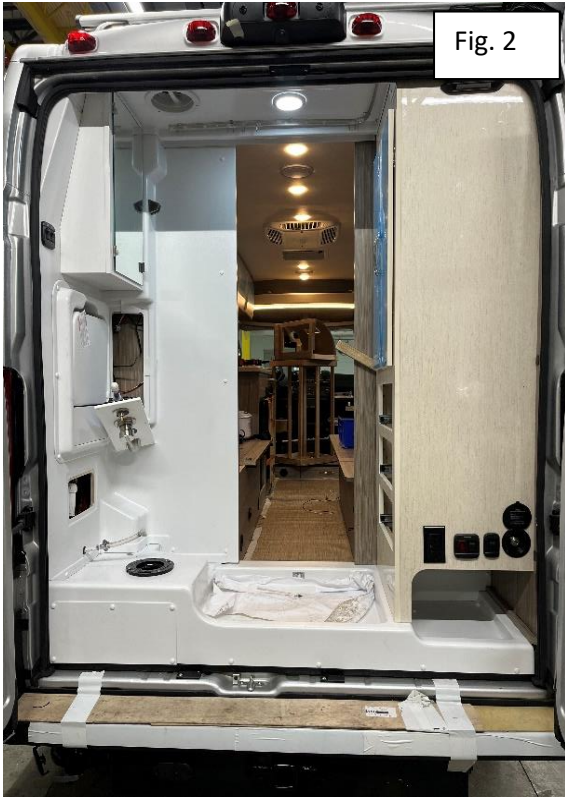
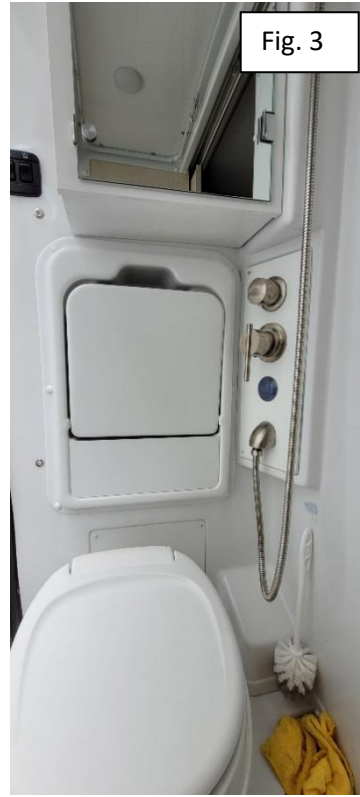
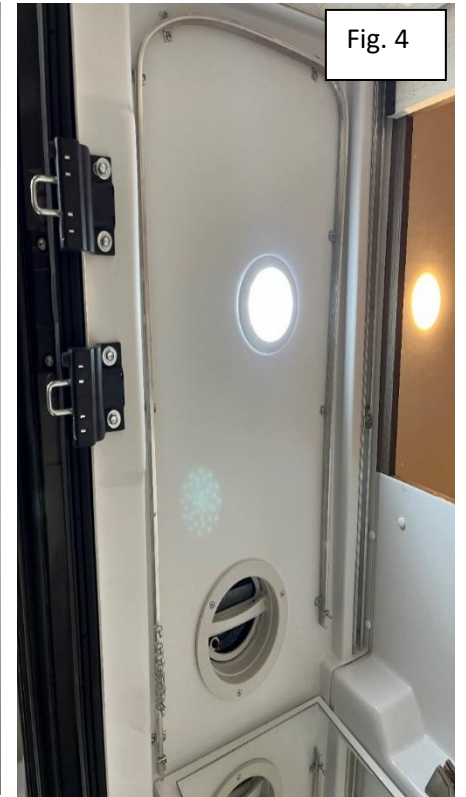
- Check and inspect shower pan floor around cracked area for flex or problems that caused cracking, support may need to be added when pan is removed.
 - All components attached and setting on top of the shower pan will need to be removed to allow removal and installation of any backer support and new pan.
1. Starting at the toilet, disconnect and remove all surface mounted components on the driver side, toilet, faucets & fixtures, panels, medicine cabinet, shower track, and pocket door/track.
 2. Disconnecting plumbing and wiring to fixtures.
 3. Taking photos may help during replacing and re-connecting process).
 4. Figures 1-4 shows this process.

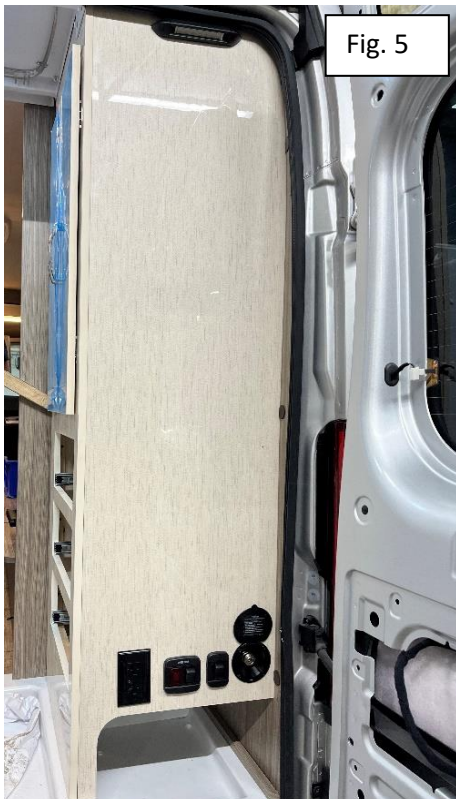
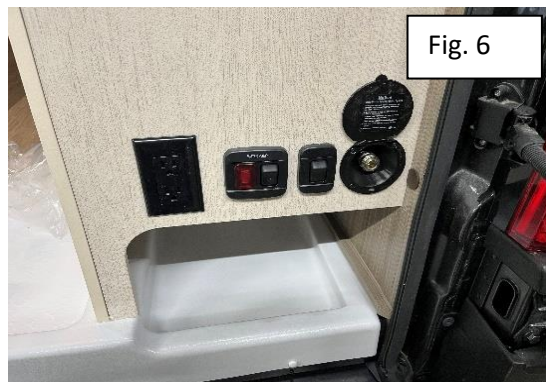
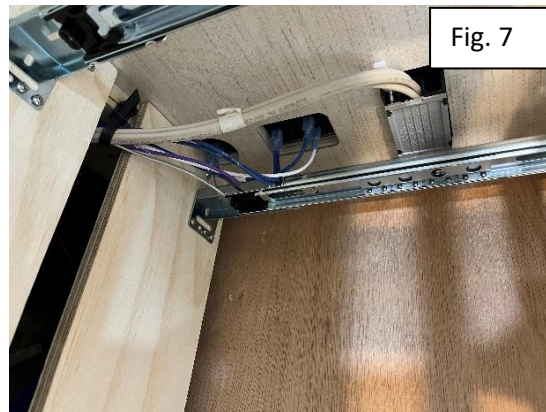
- 5. After wet bath ceiling has been removed, the main cabinet on the PS can be removed. (Figure 5)
 - a. Any electrical or plumbing lines will need to be disconnected from the inside of the cabinet. (Figures 6-7)

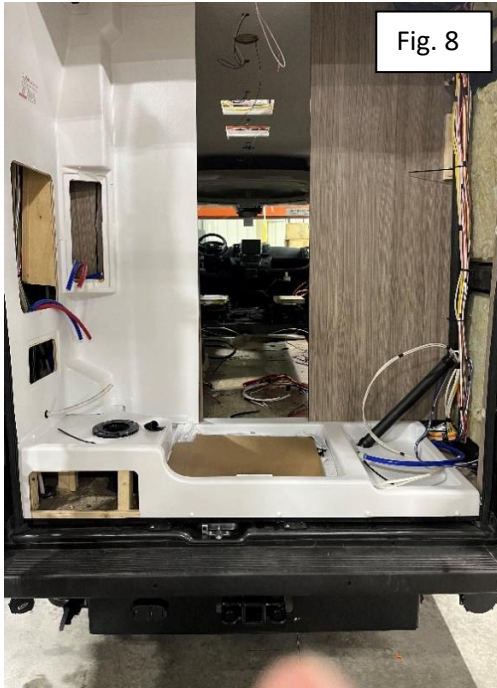
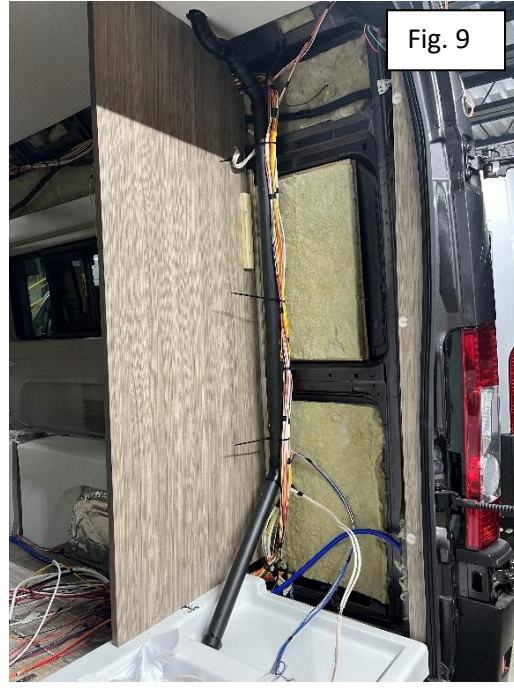
6. With the plastic panels on the DS, ceiling, and PS side cabinet removed the wood partitions between the wet bath and the end of the beds can be removed.
 - a. The vent pipe through the PS will need to be cut to remove the pan then spliced together after the new pan is installed. (Figures 8-9)

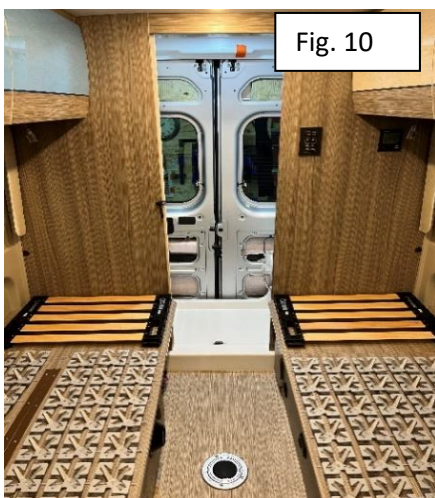
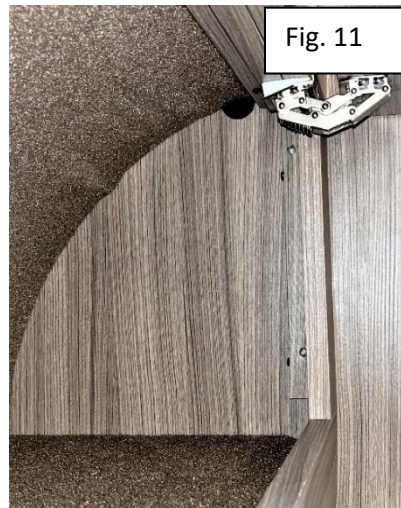
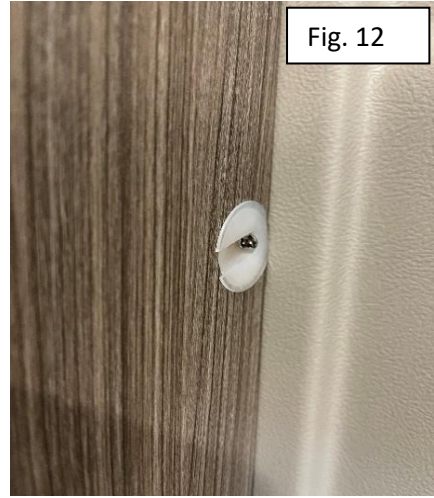
7. There will be plastic fasteners with a screw angled and embeded into the side wall of the vehicle holding the partian along with screws securing the foot of the bed into the end walls will need to be removed to release the partian. Some fastners are located in the ends of the cabinets over the beds. (Figures 10-12)

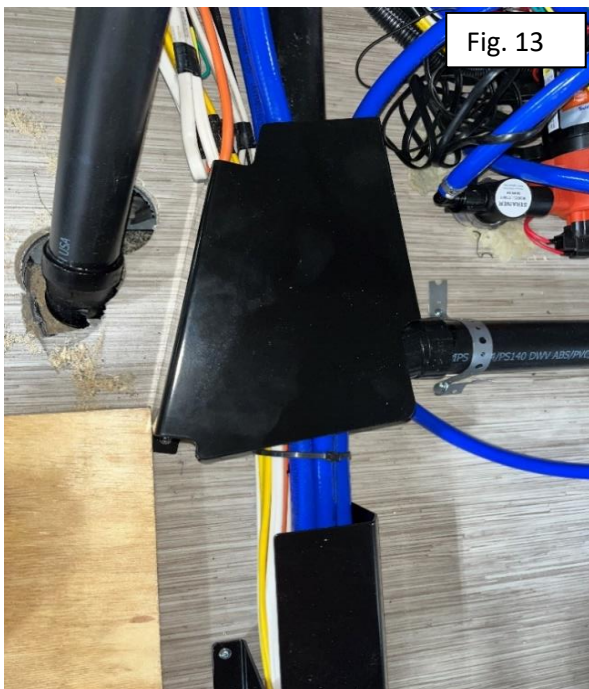
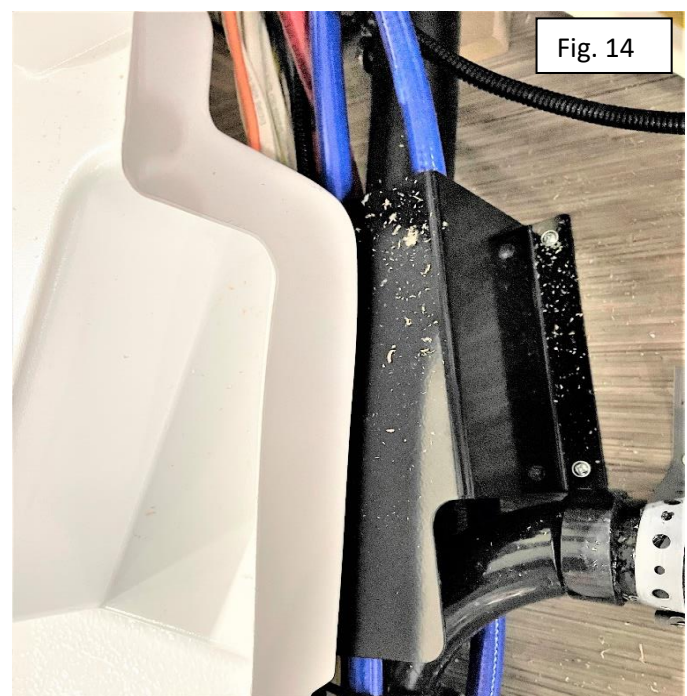
8. When the shower pan is free and removed, correction can be made to resolve the cause of the cracking.
9. Add BRACKET, SHOWER SUPPORT; 2044820 to the floor under the shower pan at the step front of the toilet. (Figures 13-14)
10. Check the length of the shower drain pipe to the connection point under the pan, insure it is not too long creating pressure around the drain.
11. Install the new shower pan with proper support where cracking occurred under cabinet, shower standing, and toilet areas. Test floor and standing areas for flex for location support may need to be added.
12. When shower pan is supported and in place install components in reverse order of removal.
