Service Bulletin

Bulletin No.: 23-NA-061

Subject: Diagnostic Tip for Checking Exhaust System for Leaks for the L5P Engines, Malfunction Indicator Lamp (MIL) Illuminated - DTC P11D5, P14D9, P20EE, P2C7A, P0421 and/or P0402 Set

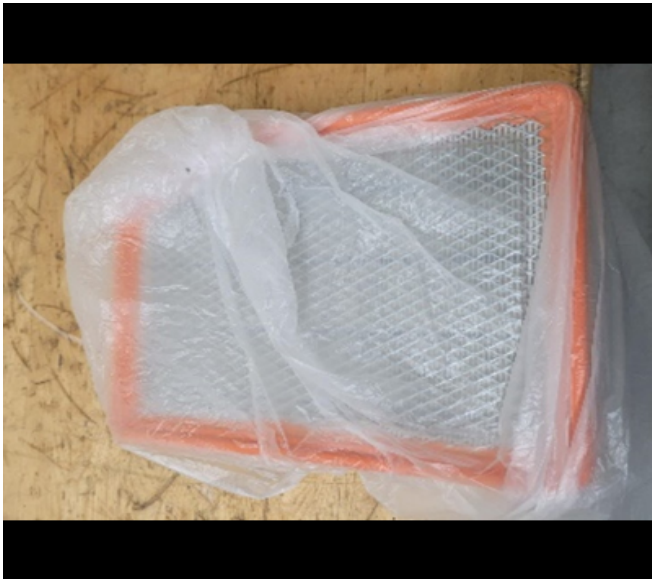
6140930

2. Put the air filter in a plastic bag.
3. Re-install the air filter into the air filter housing.
4. Raise the vehicle.

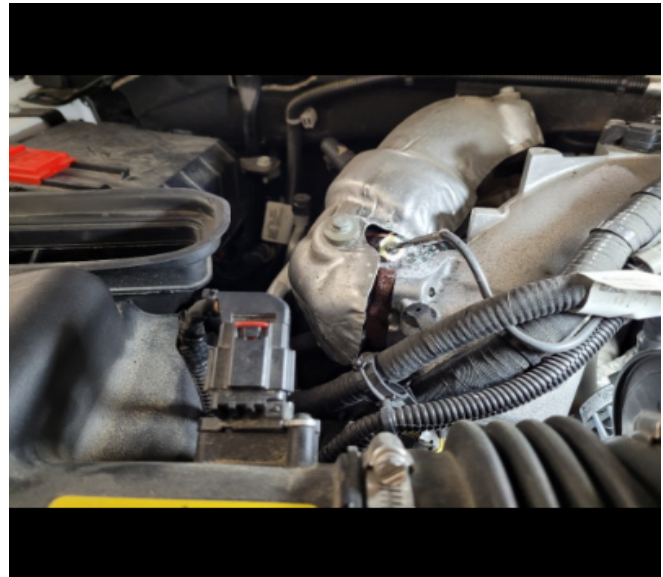
6306794

Exhaust temp sensor

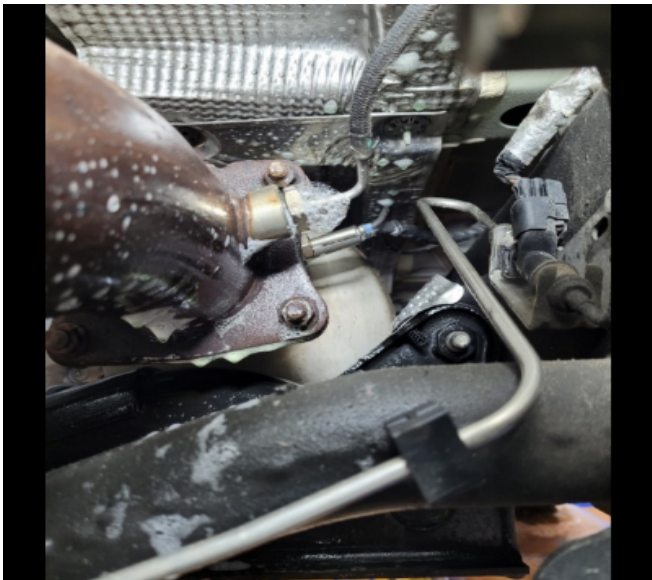
6306796

DEF Injector

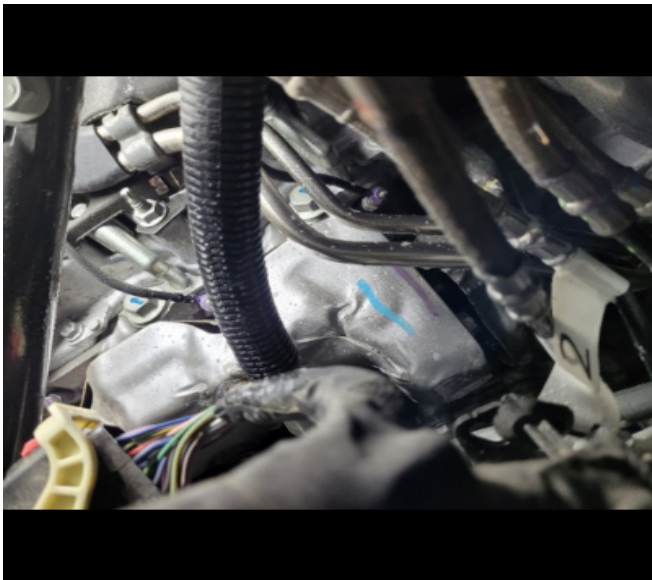
6306801

Left side exhaust manifold
