Subject <b>Rear Bumper Gap Difference - Measurement Tip</b>		Market <b>USA</b>
Service Category <b>Vehicle Exterior</b>	Section <b>Exterior Panels/Trim</b>	
Applicability <b>2022 - Present - Tundra &amp; Tundra Hybrid</b>

2022-2023	Tundra
-----------	--------

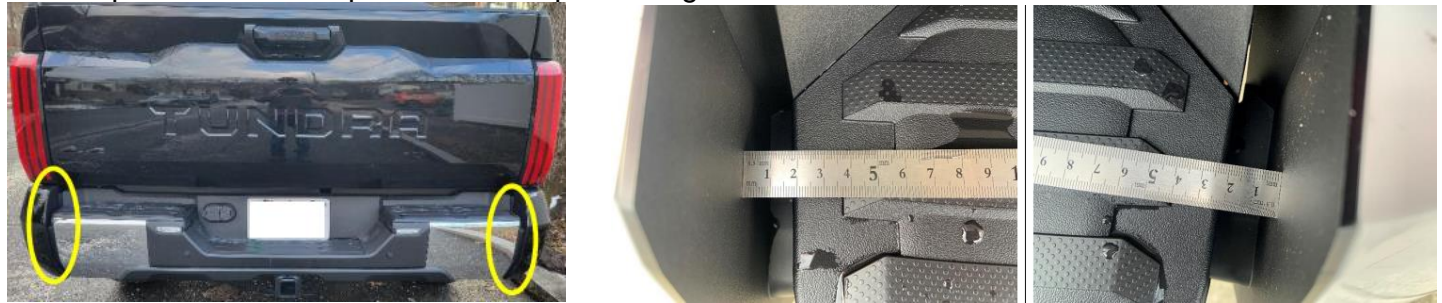
Fig. 1

Some customers may share a concern of the rear bumper ends/pillar garnish not being evenly aligned in comparison to center part of the bumper see figure 1 below for reference.

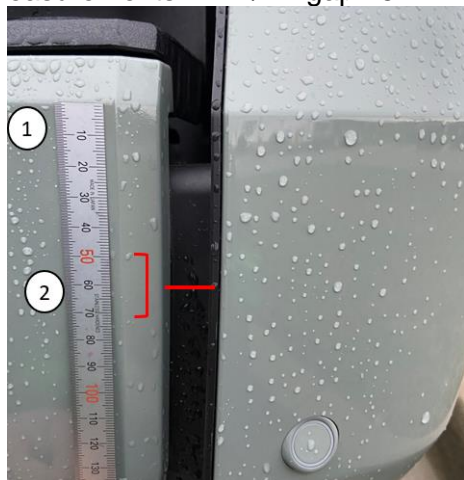
Figure 2

1. Use a millimeter (mm) scale to measure down from bumper styling line (see circle 1 below). Gap measurement should be taken at 50mm – 70mm below styling line. (See figure 2).
2. Submit a Dealership Product Report (DPR) with actual measurements prior to adjustments from both RH and LH side (see figure 3).
3. Recommended measurements = RH/LH gap 15mm +/- 5mm, Side to Side Difference: ≤ 7mm
