REFERENCE:	TSB: 23-020-23 REV. A GROUP 23 - Body	Date:	February 8, 2023	REVISION:	23-020-23
VEHICLES AFFECTED:	2018 - 2023 (JL) Jeep Wrangler 2020 - 2023 (JT) Jeep Gladiator	MARKET APPLICABILITY:			
		<input checked="" type="checkbox"/> NA		<input checked="" type="checkbox"/> MEA	
		<input checked="" type="checkbox"/> SA		<input checked="" type="checkbox"/> CH**	
		<input checked="" type="checkbox"/> **EE		<input checked="" type="checkbox"/> IAP	
CUSTOMER SYMPTOM:	Corrosion found on the door, hood and/or swing gate hinge(s).				
CAUSE:	Hinge composition

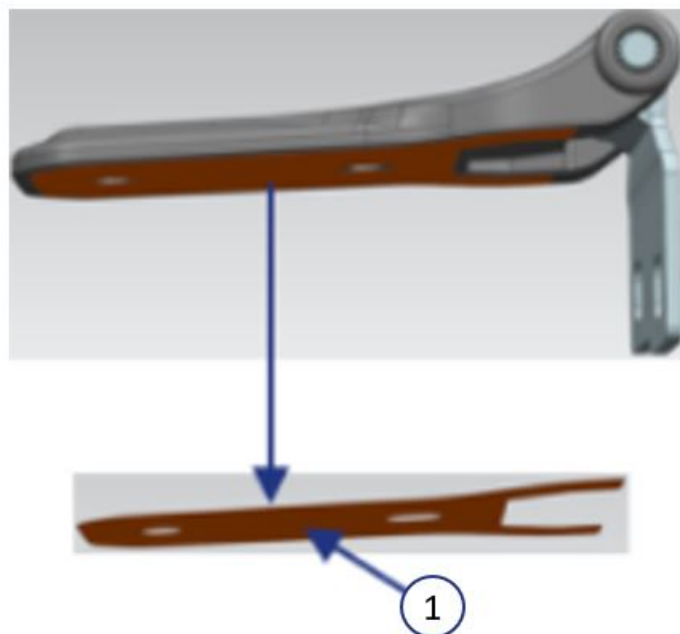
Fig. 1
Zinc Shim

This bulletin involves inspecting and replacing any hinge exhibiting corrosion. The replacement hinge is equipped with a Zinc shim (Fig. 1) .

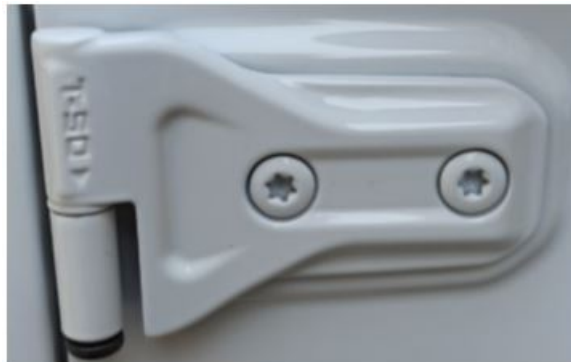
Fig. 2
Old Style Hinge

NOTE: There is only a slight difference between the old and new style hinges. There will be a small gap between the body and hinge (**Fig. 2**) and (**Fig. 3**) .

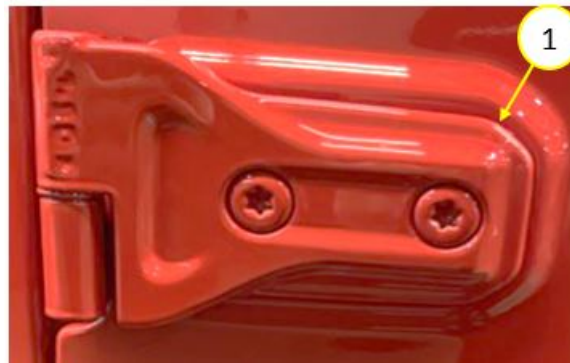
Fig. 3
New Style Hinge With Zinc Shim

1 - Slight Gap Between Body and Hinge

Shim

1. Paint the hinges that need to be replaced.
2. Prepare the paint in the ideal proportions according to the manufacturer. Test first in an appropriate place to check the color tone of the paint.

3. Replace the front door hinges. Refer to the detailed service procedures available in DealerCONNECT > Service Library under: 23 - Body / Doors - Front, Full / Hinges, Door / Removal and Installation.
4. Replace the rear door hinges. Refer to the detailed service procedures available in DealerCONNECT > Service Library under: 23 - Body / Doors - Rear / Hinges, Door / Removal and Installation.
5. Replace the hood hinges. Refer to the detailed service procedures available in DealerCONNECT > Service Library under: 23 - Body / Hood / Hinges, Hood / Removal and Installation.
6. Replace the swing gate hinges. Refer to the detailed service procedures available in DealerCONNECT > Service Library under: 23 - Body / Decklid/Hatch/Liftgate/Tailgate/Swing Gate / Hinges / Removal and Installation.
