# Technical Service Bulletin

## 85 Unpleasant odor is coming from the heating and ventilation system

85 23 25 2069903/1 April 5, 2023.

Model(s)	Year	VIN Range	Vehicle-Specific Equipment
A3, S3, and RS 3	2022 – 2023	All	Not Applicable

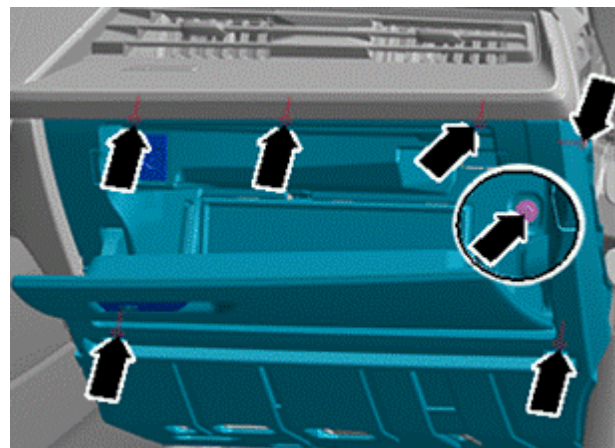
1. Remove and install the glove compartment.

*Figure 1. Glove compartment removal.*

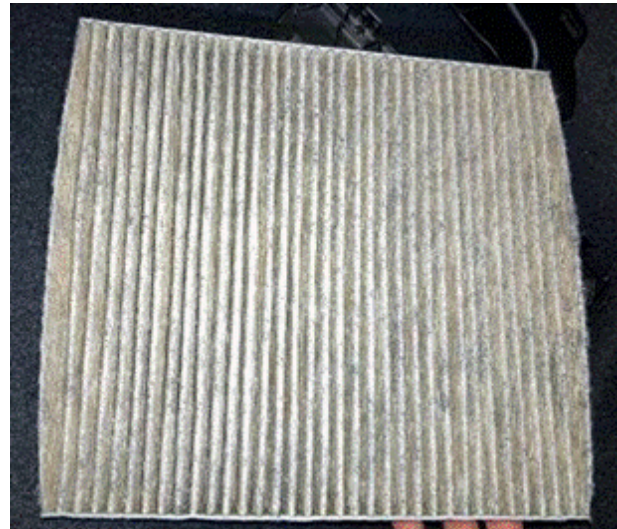
2. Remove the dust and pollen filter and inspect for water damage. Figure 2 shows a normal dust and pollen filter.

**Figure 2.** Dust and pollen filter with no water intrusion evidence.

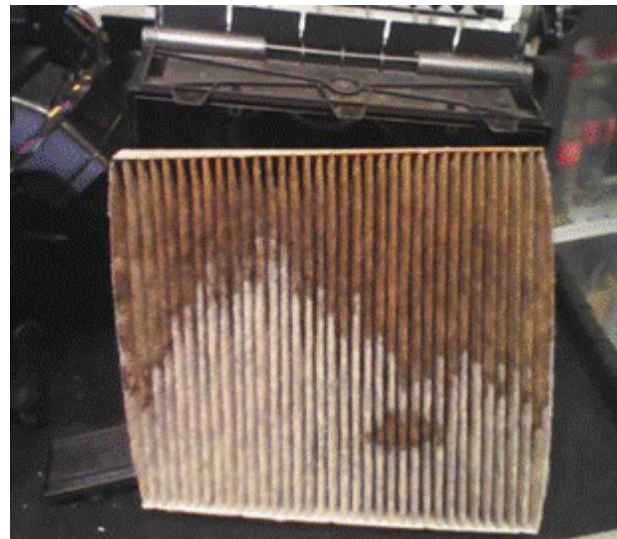
3. Figure 3 shows a dust and pollen filter with evidence of water intrusion.

**Figure 3.** Dust and pollen filter with water contamination.

7. Should evidence of water intrusion, undrained water staining or water contamination of the dust and pollen filter are discovered after these inspections have been completed replace the heater, air conditioning and air distribution housing assembly. The component parts include the air intake housing, evaporator housing, air distribution housing, dust and pollen filter and the fresh air blower V2.

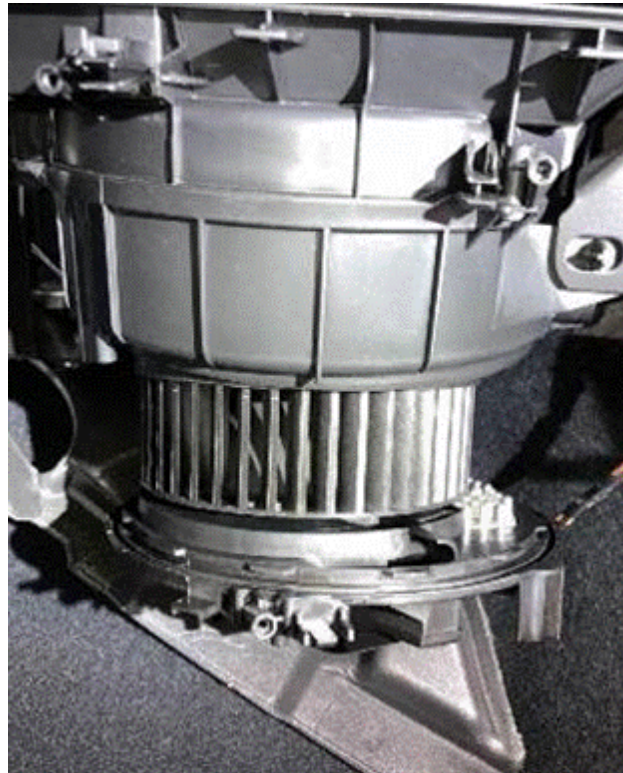
4. Remove the fresh air blower V2.

*Figure 4. Fresh air blower V2 removal.*

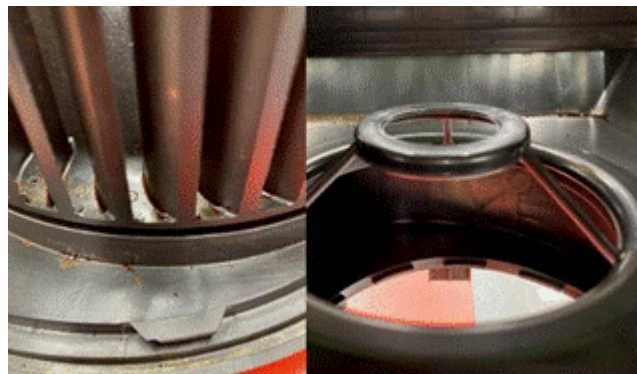
5. With the blower motor removed carefully inspect the inside of the fresh air blower housing for evidence of undrained water. Specifically, inspect the lowest point of the left section of the housing. The use of a Borescope may be necessary.

*Figure 5. Evidence of pooled and dried water on fresh air blower unit and blower housing.*

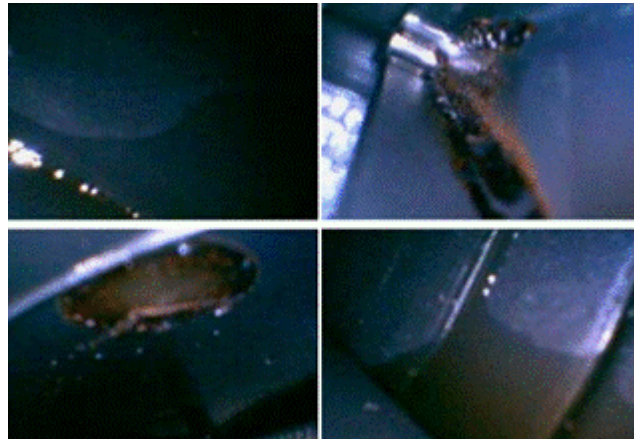
Due to a structural issue with the heater, air conditioning, and air distribution housing moisture accumulates in the housing. The drainage and evaporation efficiency is insufficient to prevent this odor from occurring.

6. Figure 6 shows a series of Borescope views inside the heater, air conditioning, and air distribution housing. Evidence of undrained water can be seen.

**Figure 6.** Borescope images showing evidence of water intrusion into the fresh air blower housing.

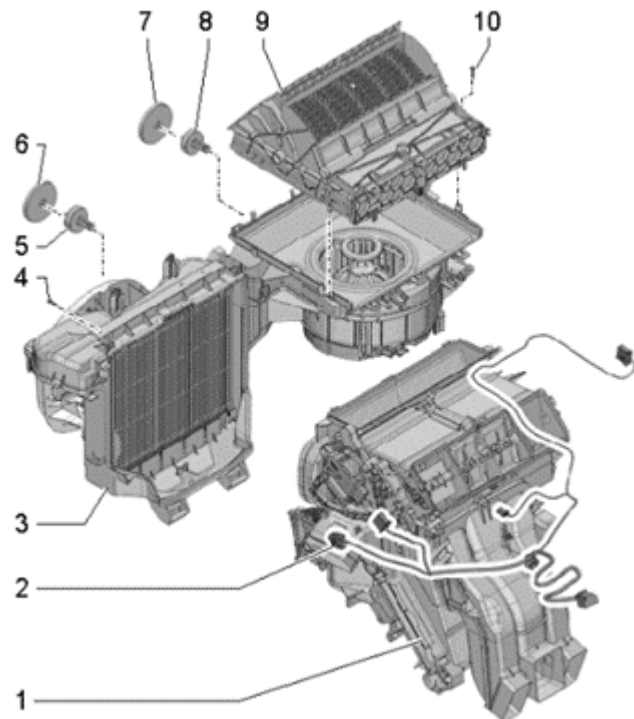
**Figure 7.** Heater, air conditioning, and air distribution housing assembly.
