**April 5, 2023**

**2016-2021 Civic A/C Compressor Shaft Seal Leak (1.5T, 2.0, 2.0T)****AFFECTED VEHICLES**

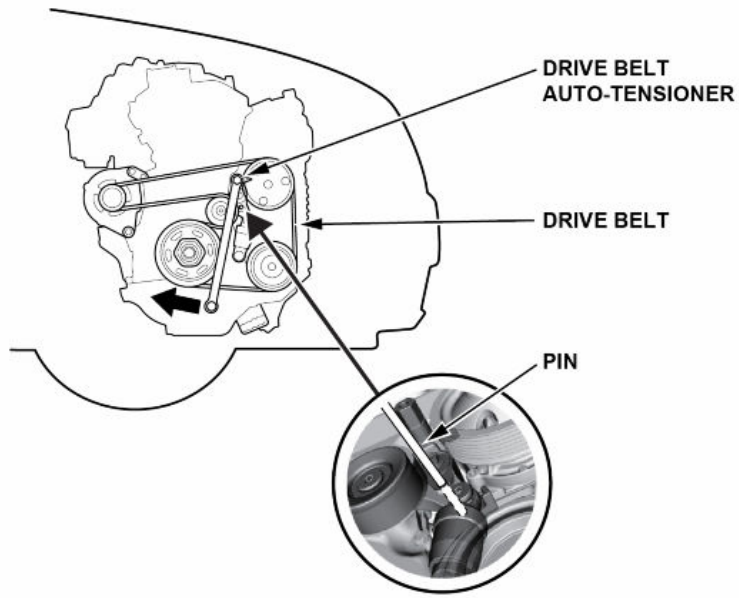
4. Inspect for oil on the clutch area of the compressor while in the on-car position.

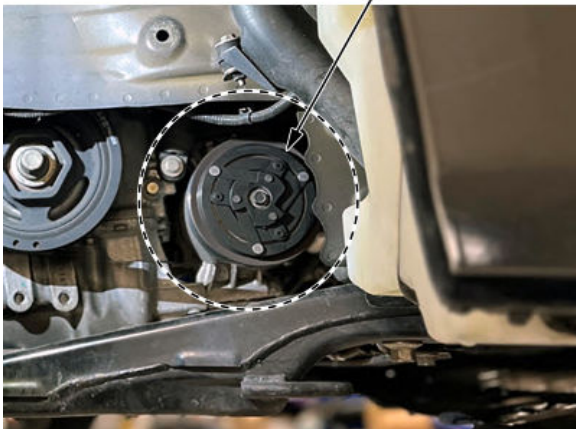
5. If no oil is noticed, leave the compressor on the vehicle. Remove the center hub bolt and hub/armature plate from the compressor. Then, inspect both for oil.

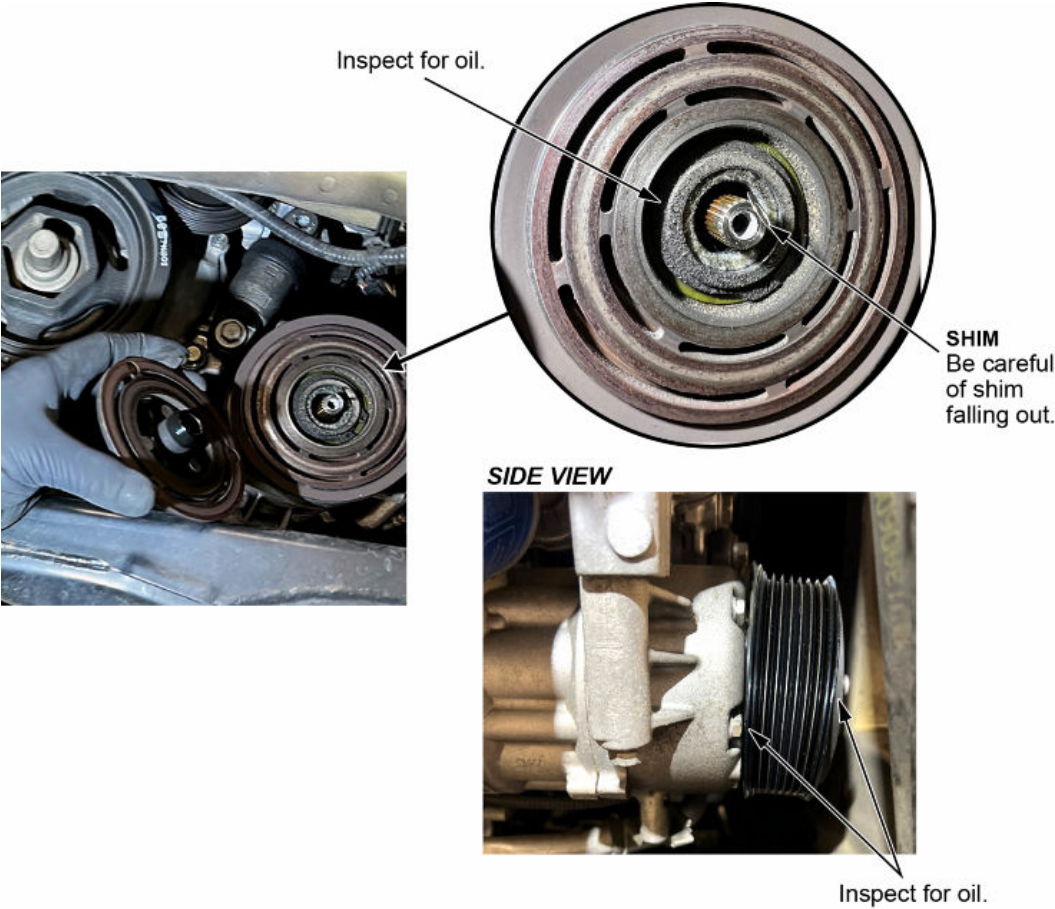
Examples of dry and oily clutch assemblies.

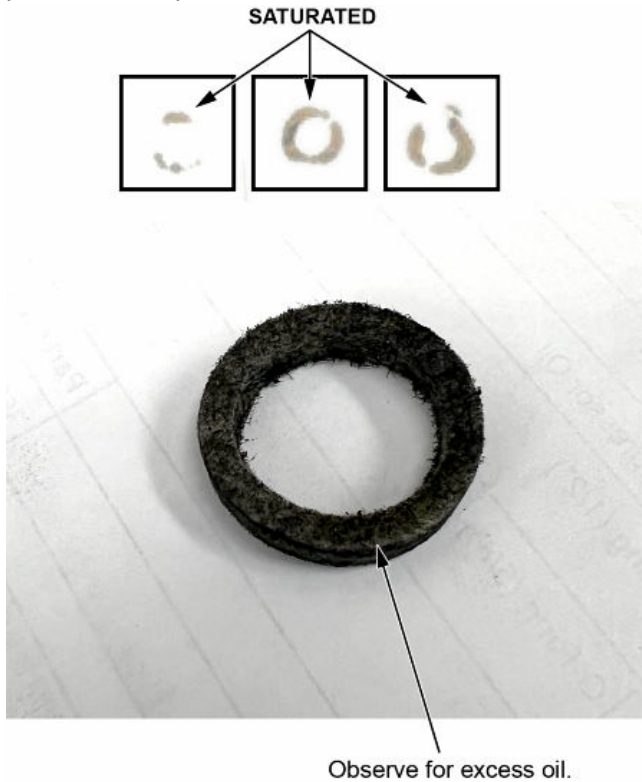
7. Using a calibrated sniffer, check for a leak.

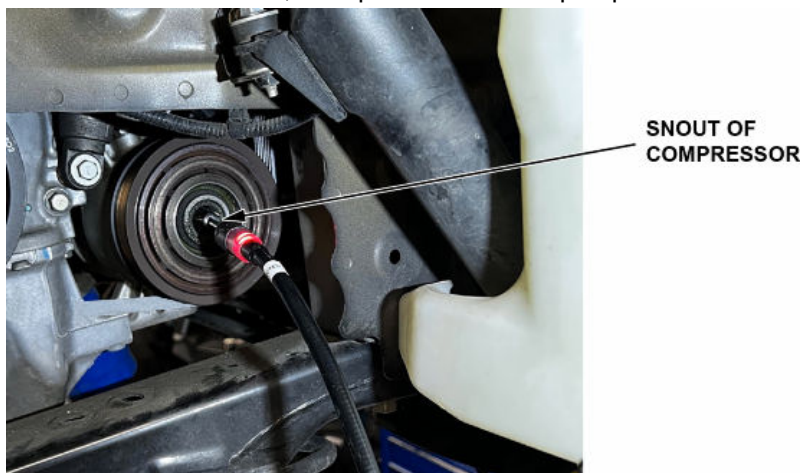
8. If no oil or leak is found, reassemble the hub/armature plate with the original bolt and torque to **(17 N·m or 13 lb-ft)**.

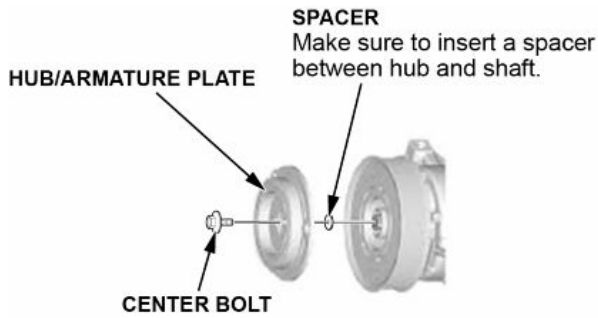
9. Reinstall the belt.
10. Run the vehicle for **ten minutes** and then do **step 7**, again.

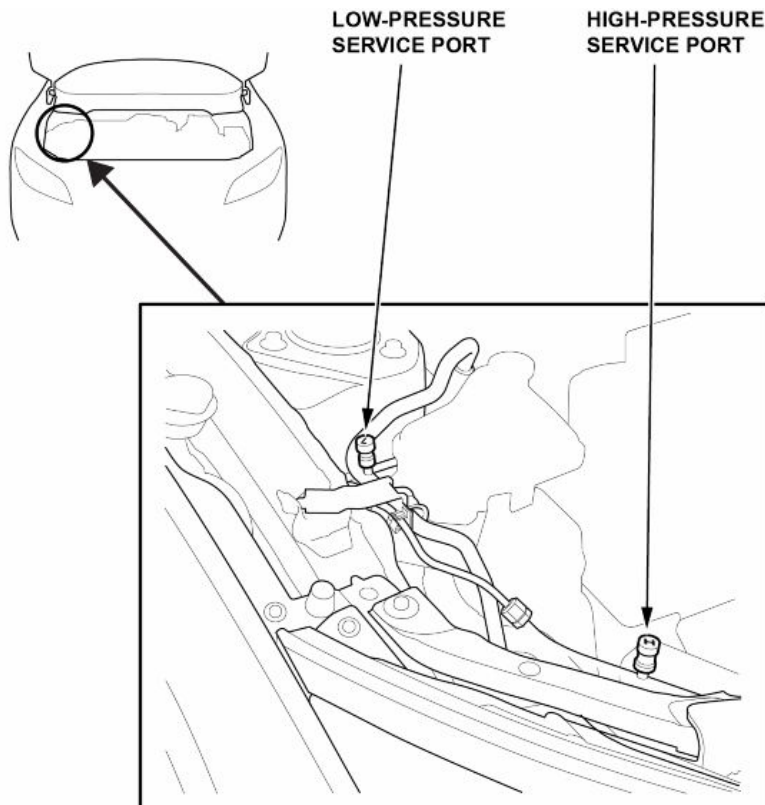
2. Recover the A/C refrigerant.

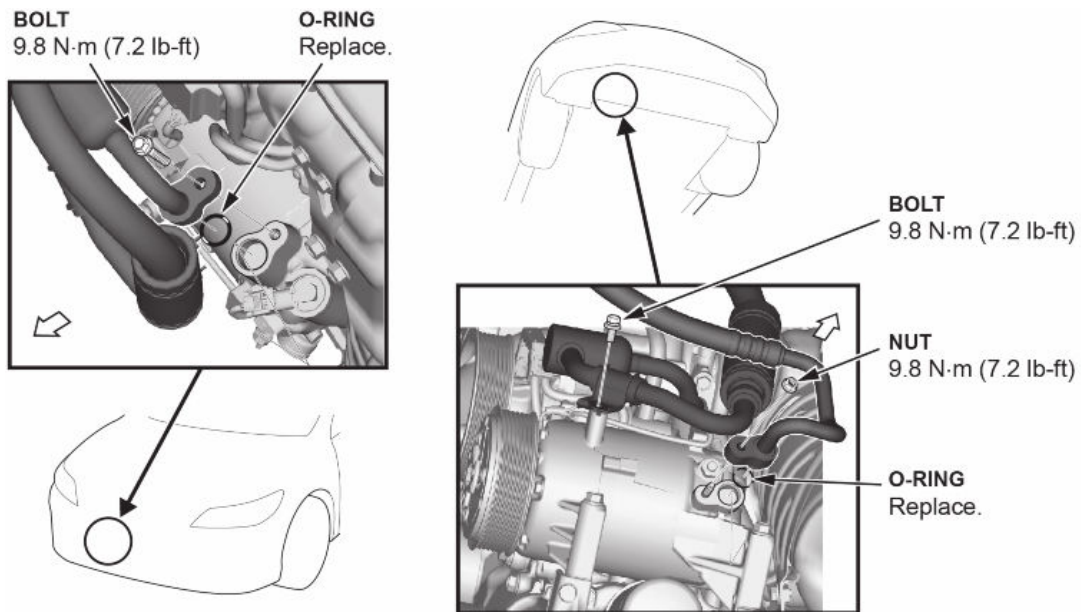
- Use the port plugs in the seal assembly kit to immediately seal the ports after disconnection. This avoids moisture and dust contamination from entering the air conditioning compressor. Installing an A/C compressor into a contaminated system can result in premature A/C compressor failure.
- For the Type R only, also remove the change air cooler inlet hose and A/C condenser fan shroud.

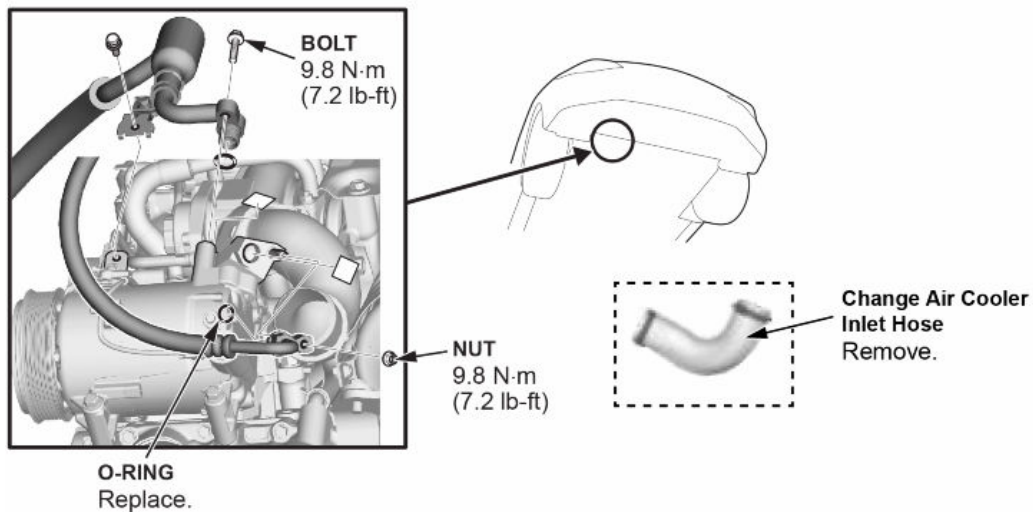
4. Remove the A/C compressor.

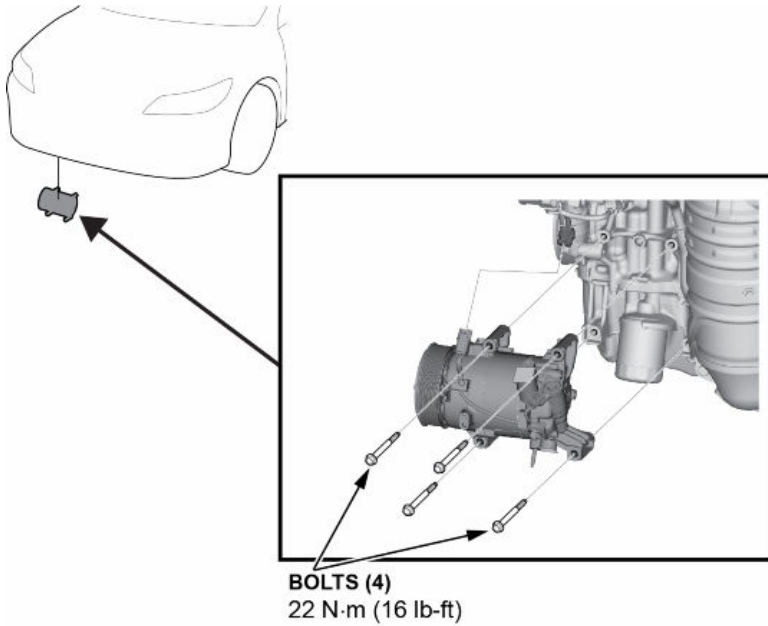
5. If not already removed, remove the clutch center flange bolt (**10 mm**), tightened at **17 N·m (13 lb-ft)**.

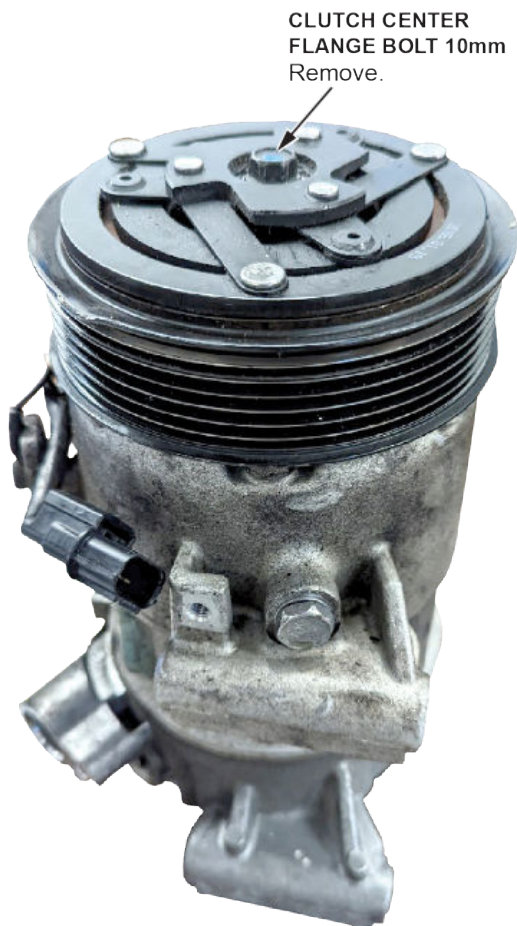
6. If not already removed, remove the clutch, carefully, to not drop/lose any shims (usually 1–2 shims).

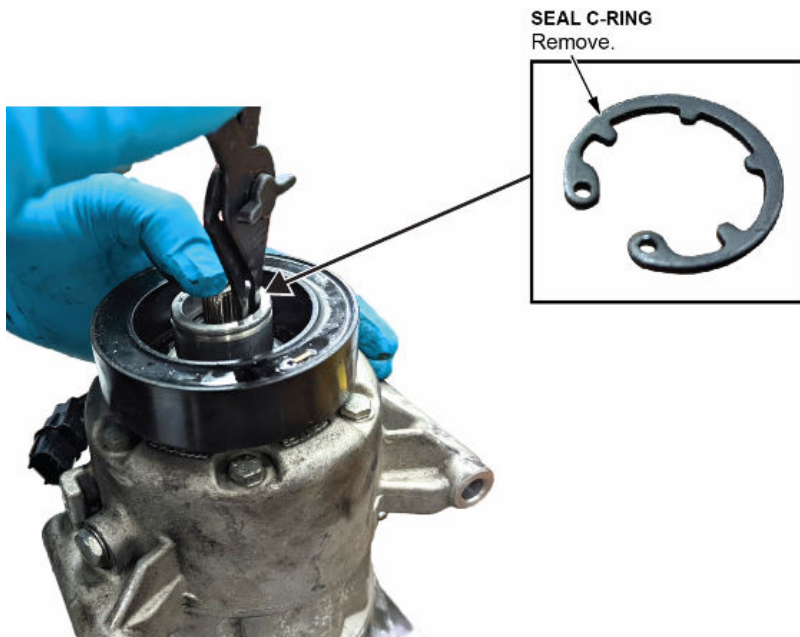
11. Thoroughly clean the bore and shaft with a lint free cloth.

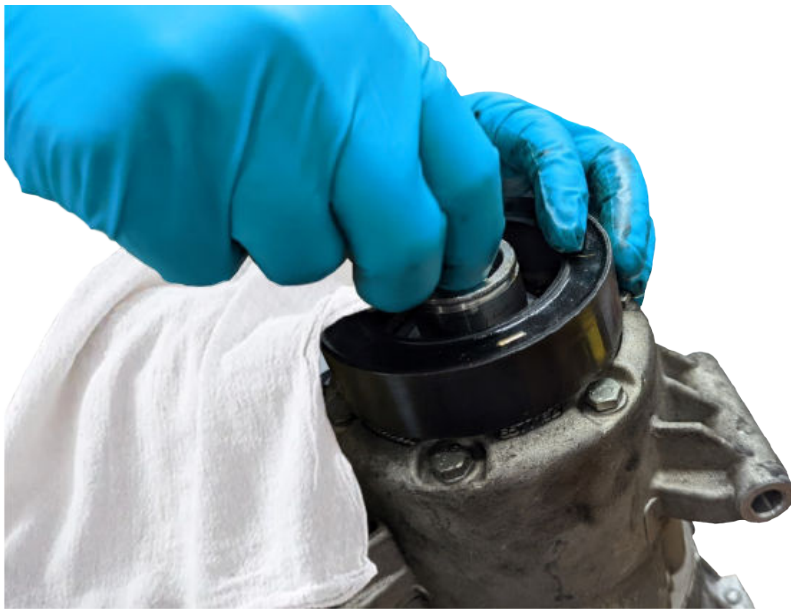
12. Remove the side bracket.

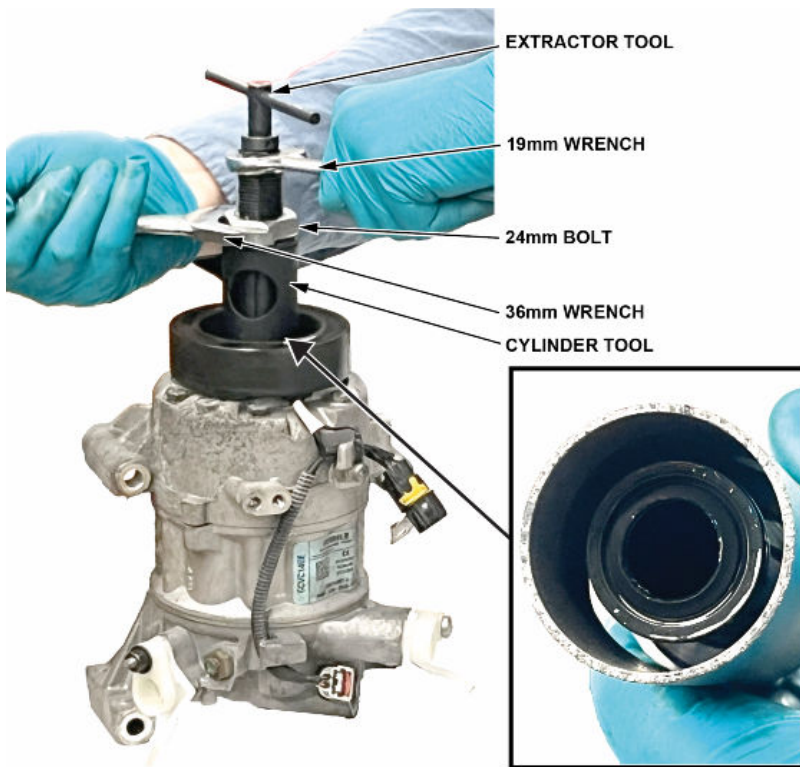
23. Thoroughly clean the bore and shaft with a lint free cloth.

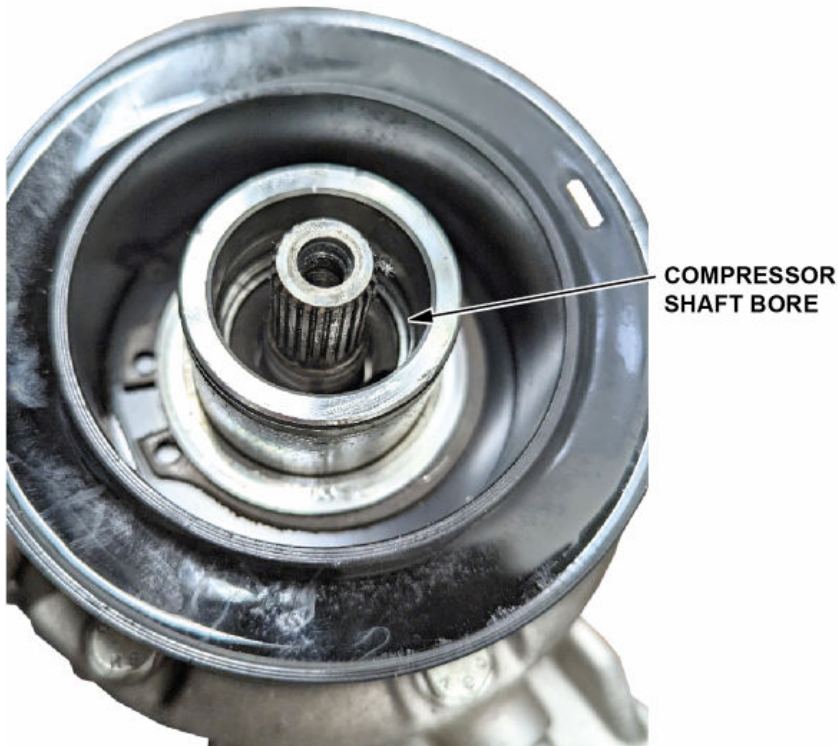
24. Inspect the compressor shaft bore for visible damage; Inspect the seal guide for contamination or damage.
