April 5, 2023

2017-21 CR-V: A/C Compressor Shaft Seal Leak**AFFECTED VEHICLES**

Year	Model	Trim	VIN Range
2017–21	CR-V	1.5T	ALL

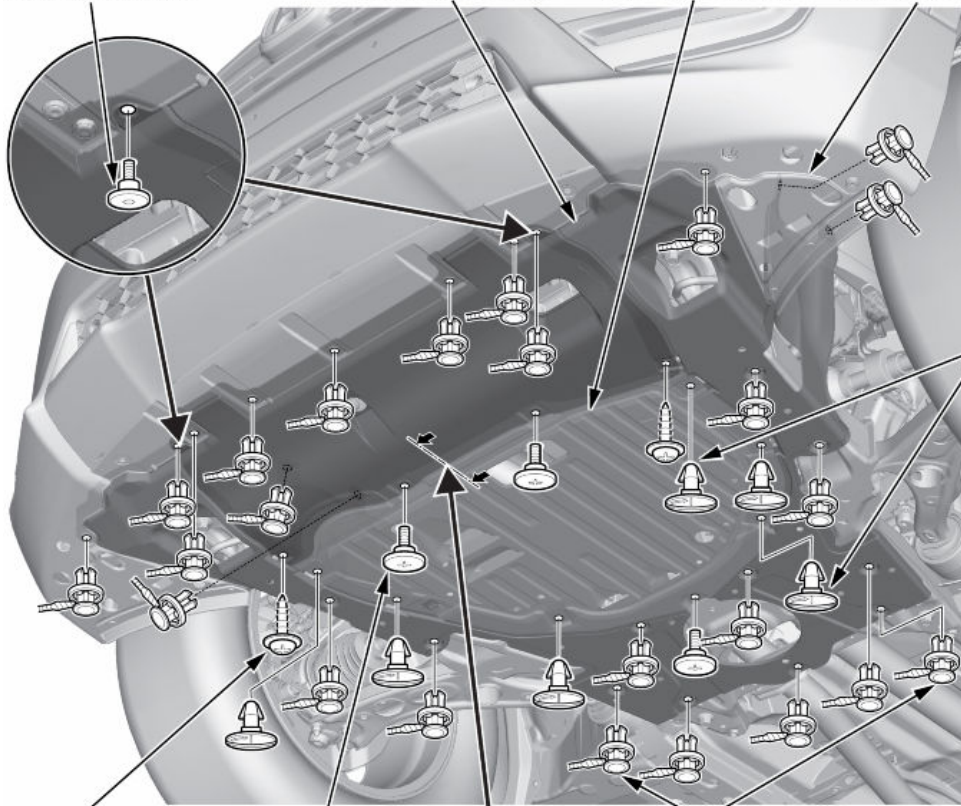
1. Remove the right front tire.
2. Remove the undercover assembly.

**PHILLIPS HEAD
SCREW FASTENERS (2)**
9.4 N·m (6.9 lb-ft)

**FRONT ENGINE
UNDERCOVER LID**

**ENGINE
UNDERCOVER LID**

**ENGINE
UNDERCOVER**

FASTENERS (6)
Remove.

SCREWS (2)
Remove.

**PHILLIPS HEAD
SCREW FASTENERS (3)**
Remove.

FASTENERS (24)
Remove with small screwdriver.

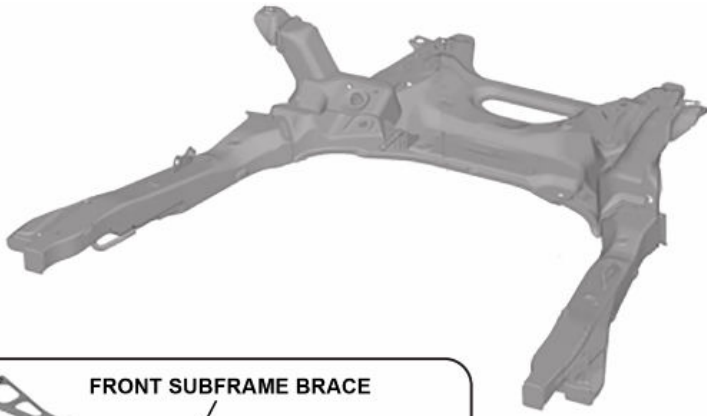
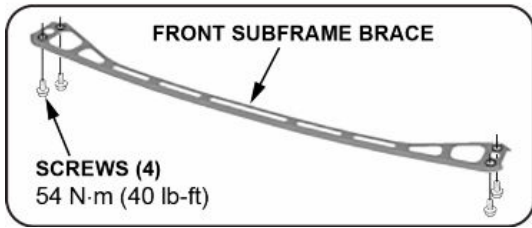
3. Remove the front subframe brace.

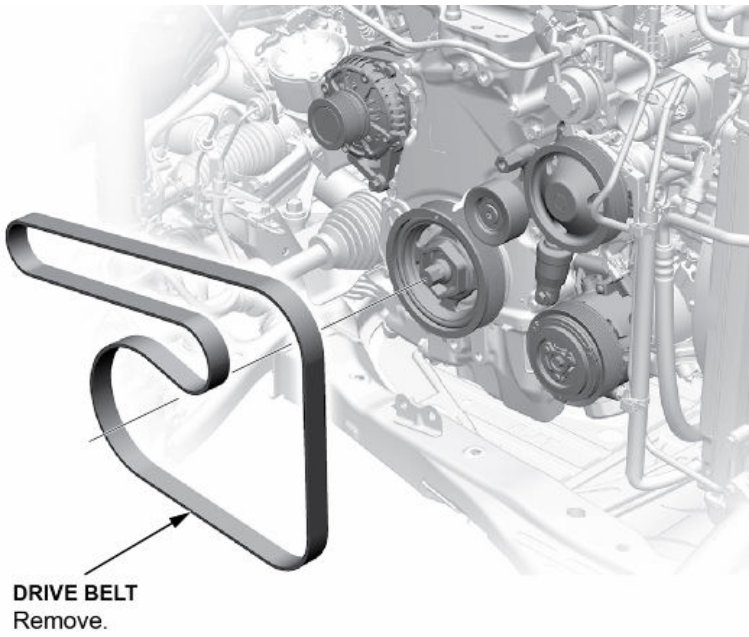
4. Remove the drive belt.

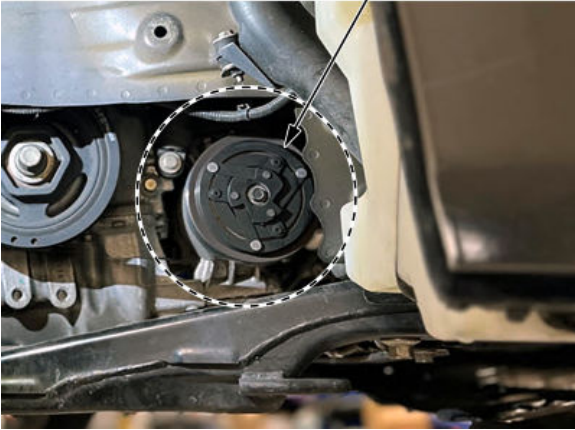
5. Inspect for oil on the clutch area of the compressor while in the on-car position.

NOTE: If oil is stuck to the clutch area of the compressor, then proceed to the repair procedure.

Inspect for oil.

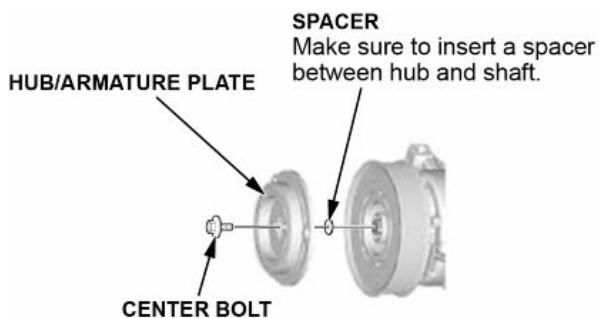
9. If no oil leak is found, reassemble the hub/armature plate with the original bolt and torque to **17 N.m (13 lb-ft)**.

If this is a second time and no leak is found, reassemble the hub/armature plate with a new bolt and torque to **17 N.m (13 lb-ft)**.

- Verify the clutch and pulley rotate smoothly and independently.
- Measure the clearance between the pulley and armature plate all the way around. If clearance is not within specified limits, remove the armature plate and add/or remove shims as needed.
- Clearance: **0.30–0.60mm (0.012–0.024in)**.
- Shims are available in three sizes: **0.3mm, 0.4mm, 0.5mm**.

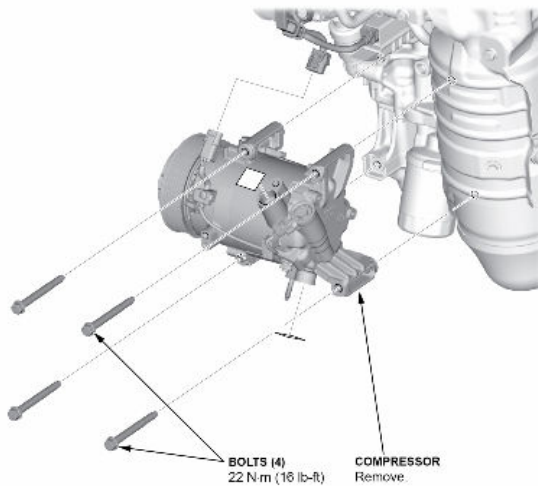
4. Remove the A/C compressor.

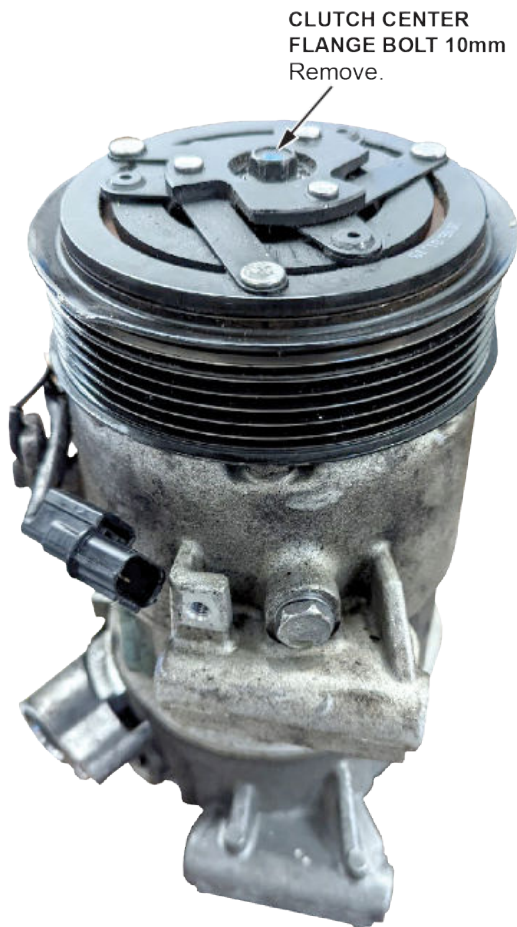
5. If the clutch has not been removed from a previous step, remove the clutch center flange bolt (17 N.m 13 lb-ft).

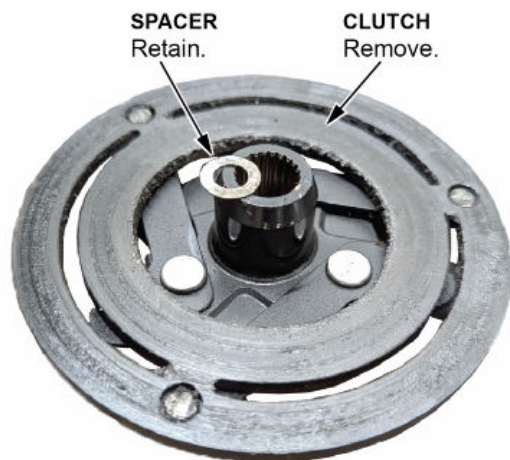
6. If the clutch has not been removed from a previous step, remove the clutch while being careful not to drop/lose any shims (usually 1-2).

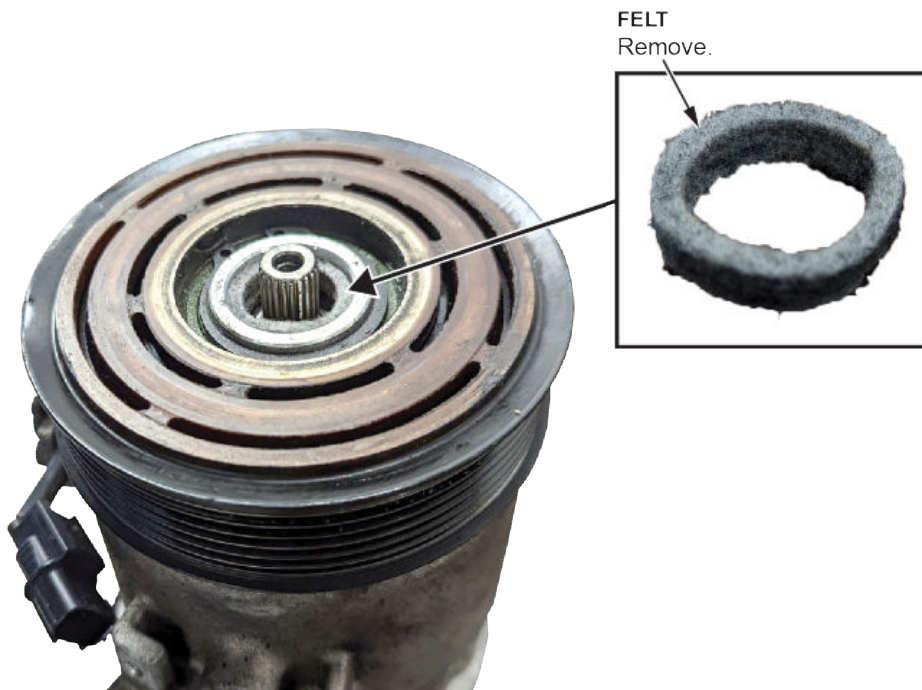
7. If the felt washer has not been removed from a previous step, use a pick to remove the felt washer.

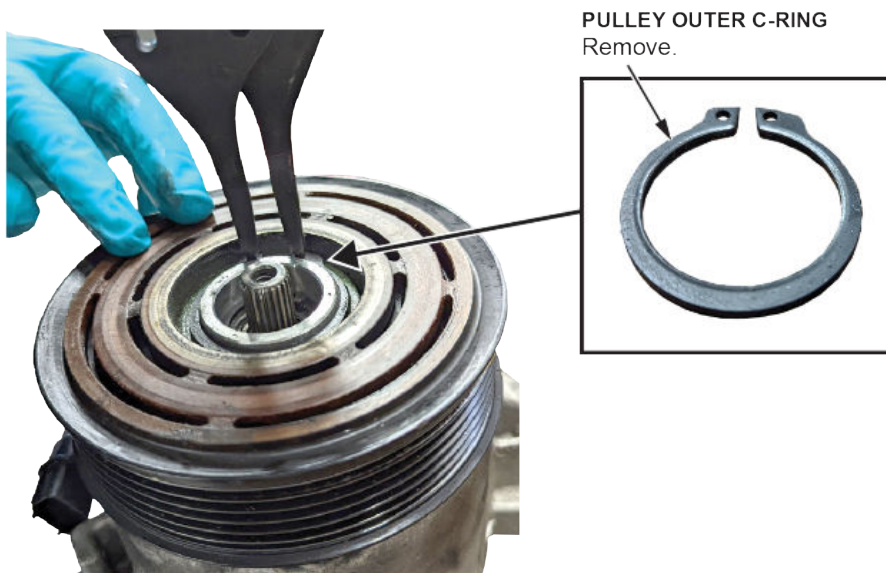
8. Remove the pulley C-ring.

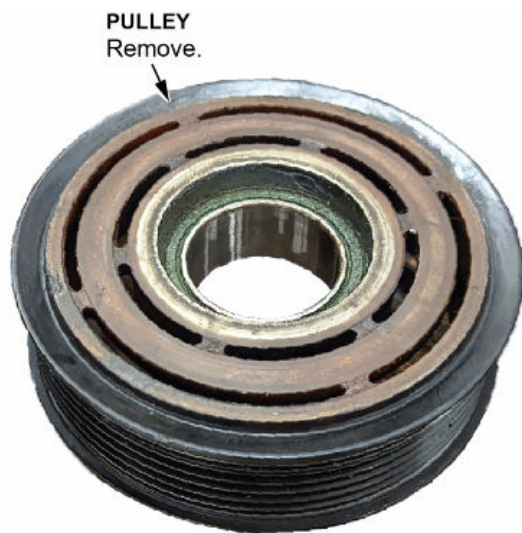
9. Remove the pulley.

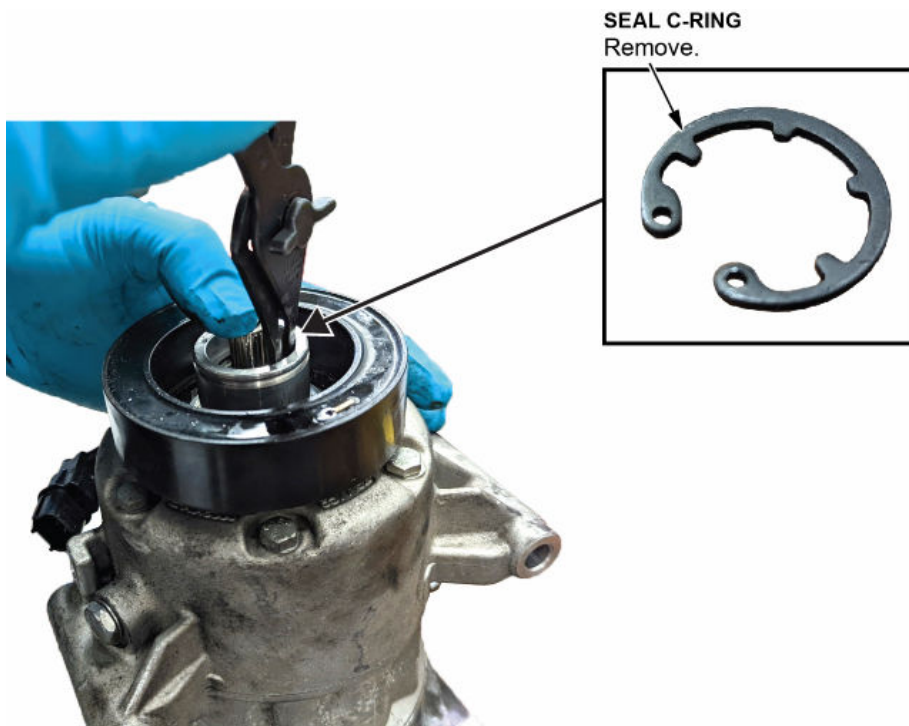
10. Remove the seal C-ring.

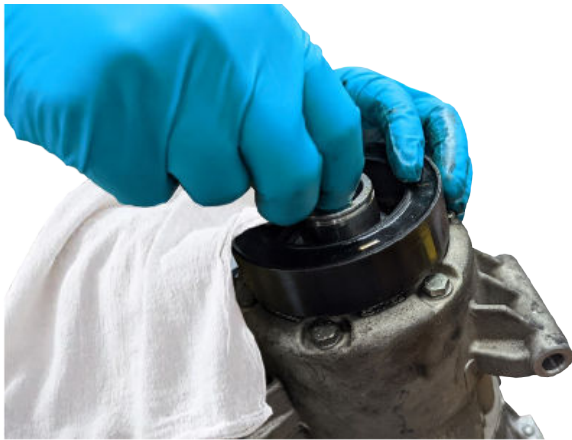
11. Thoroughly clean the bore and shaft with a lint free cloth.

NOTE: Do not use compressed air. The bore needs to be very clean as to prevent debris from entering the compressor once the seal is removed. Failure to remove all debris will result in future failure .

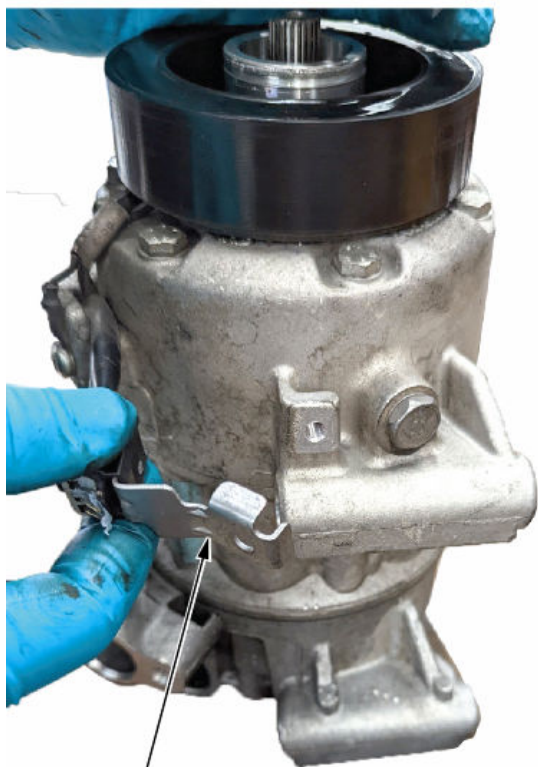
1.5L ONLY

12. Remove the side bracket (1.5L engine only).

SIDE BRACKET
Remove.

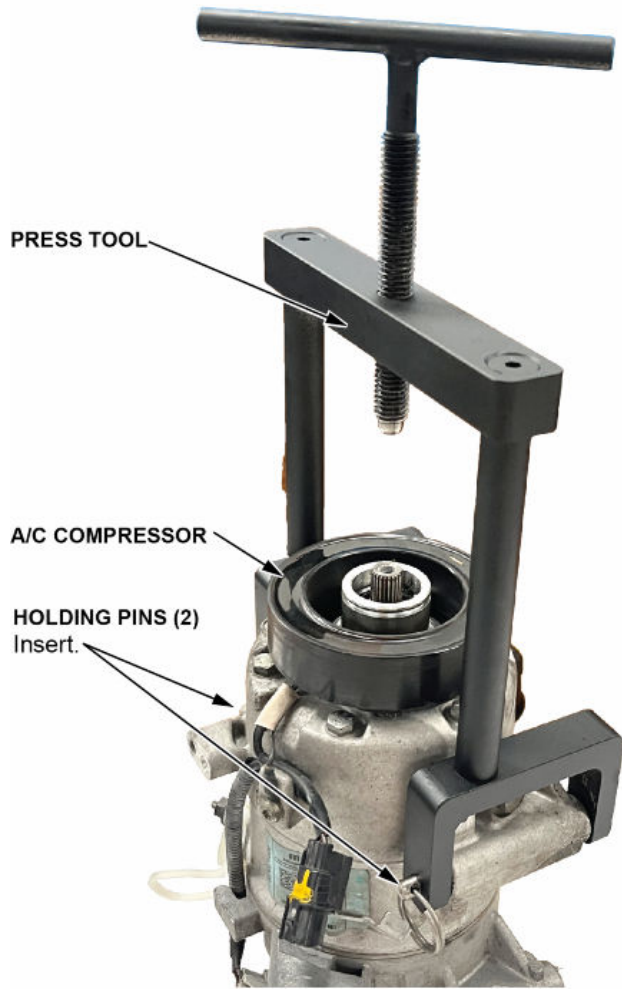
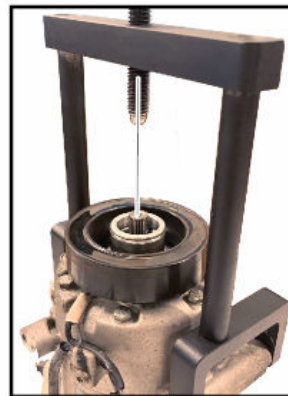
13. Place the press tool onto the A/C compressor and insert the holding pins (2). Make sure the press tool installs where the press shaft should align with compressor shaft. The press tool will only align correctly in one orientation. The pins must go all the way through.

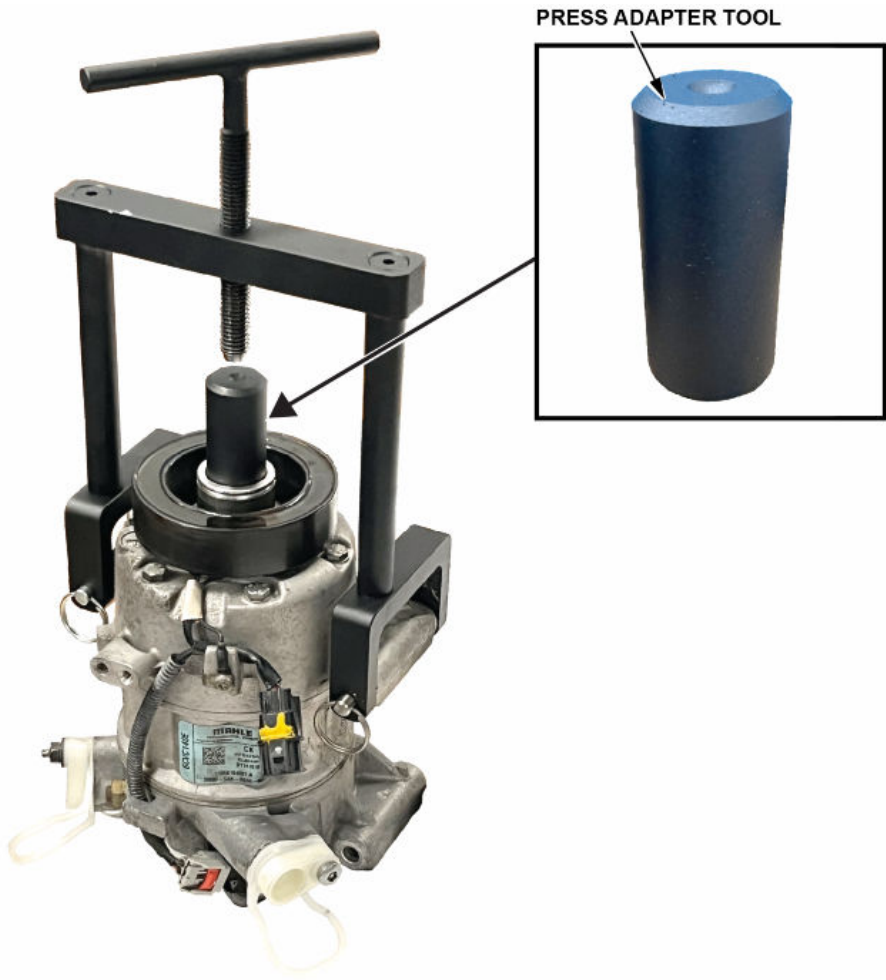
14. Add the press adapter tool.

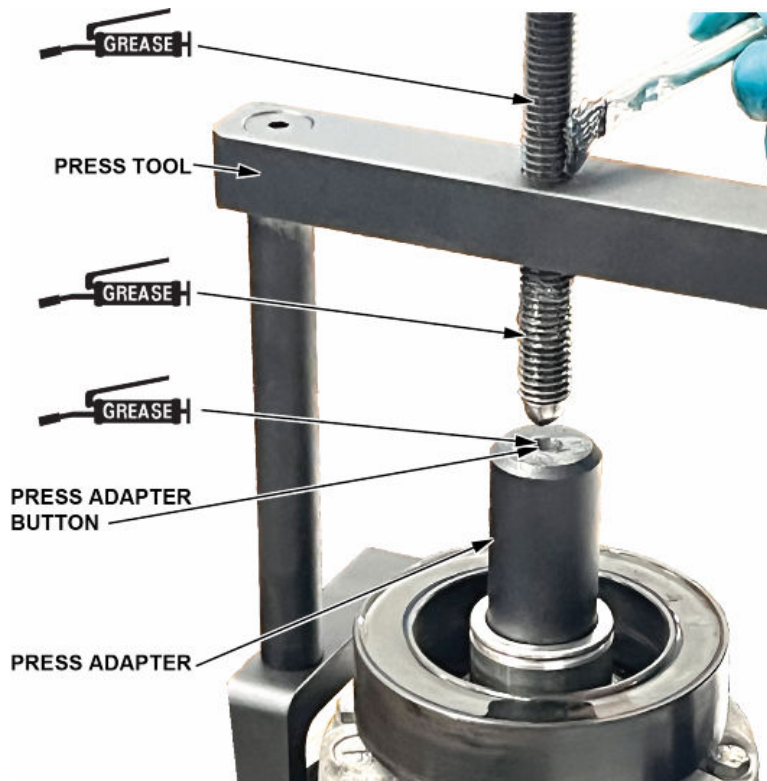
15. Add grease to the press adapter button and press threads.

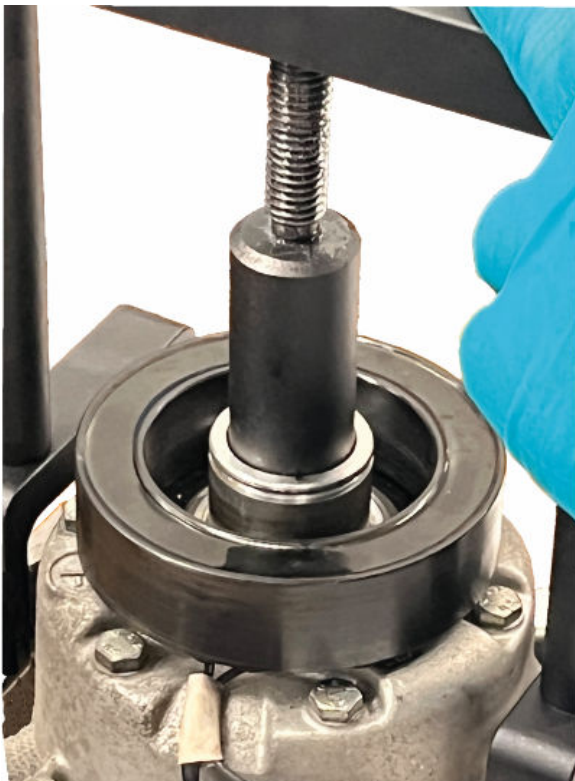
16. Tighten the press until there is no clearance, then **3/4 turn (270°)**.

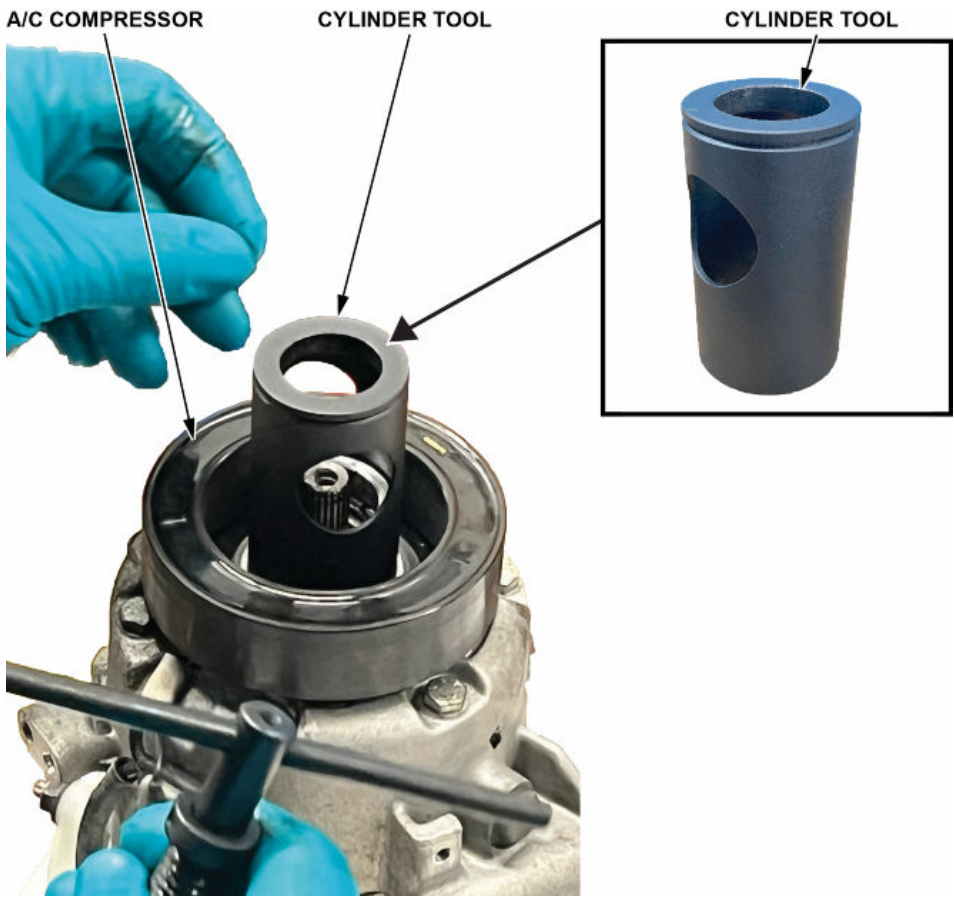
17. Release to remove the adapter and press.

18. Insert the cylinder tool onto the A/C compressor.

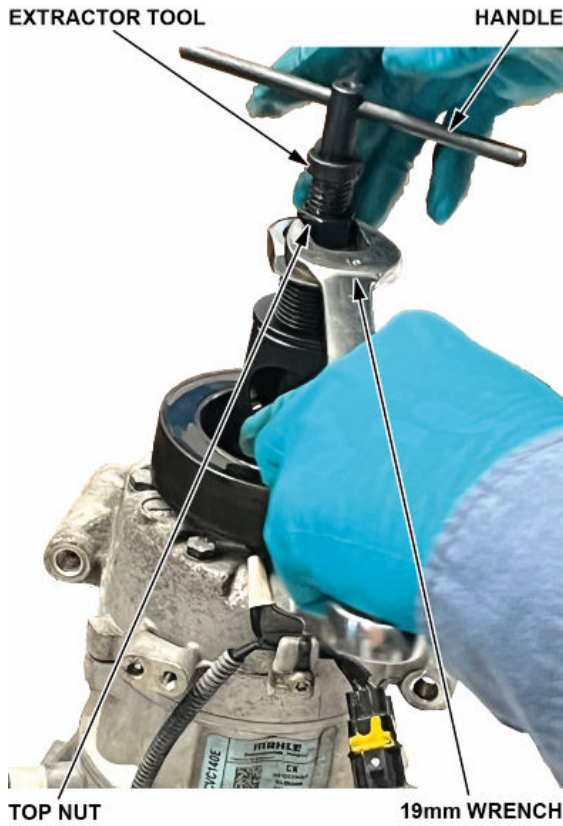
20. Stabilize the extractor tool using a **19 mm** wrench on the top. Then, turn the handle clockwise until the resistance is felt. Make sure that the space between the **19 mm** wrench and the bottom portion of the extractor tool is minimal.

NOTE: To confirm the extractor is engaged, hold the extractor tool and lift the compressor up.

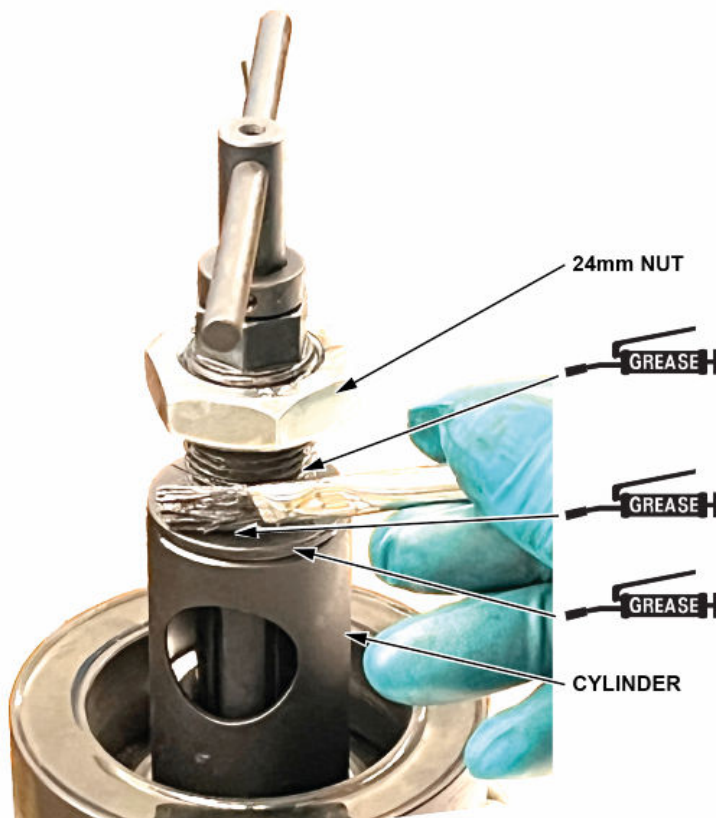
21. Apply grease between the **24 mm** nut and cylinder top.

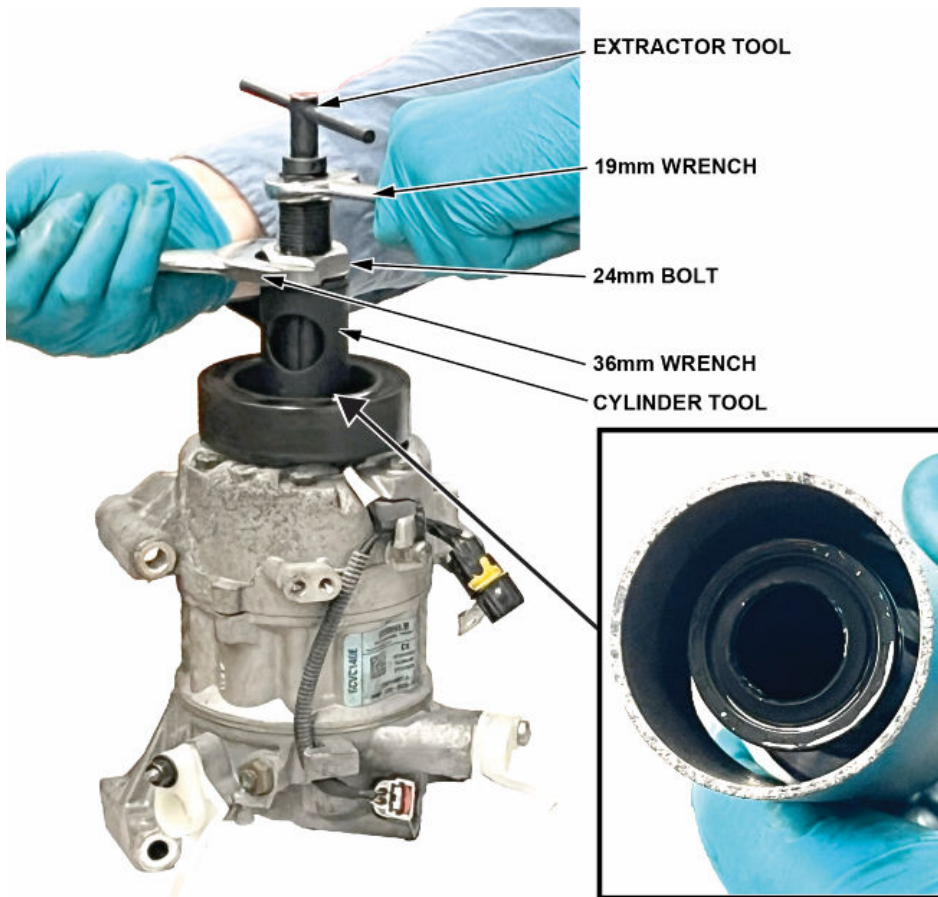
22. With the **19 mm** wrench in place, lower the **24 mm** nut down until it reaches the cylinder. Slowly and carefully adjust until the extractor tool comes out freely with the seal.

- Resistance will be felt while lowering **24 mm** nut and will cease once the seal is extracted.
- If the seal does not come out on the first step, repeat the process starting at step 13.

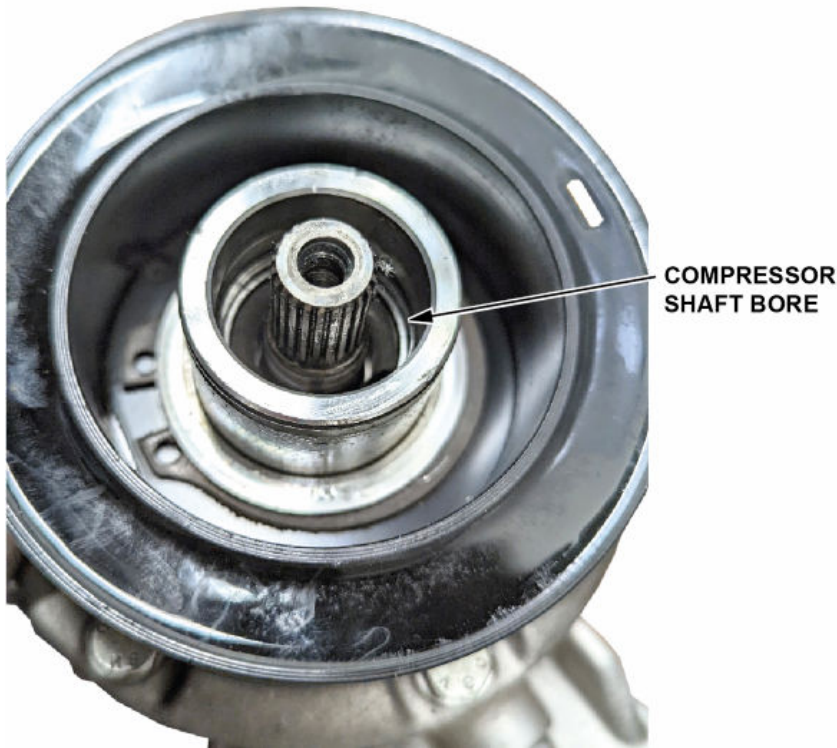
23. Thoroughly clean the bore and shaft with a lint free cloth.

NOTE: Do not use compressed air. The bore needs to be very clean as to prevent debris from entering the compressor once the seal is installed. Failure to remove all debris will result in future failure.

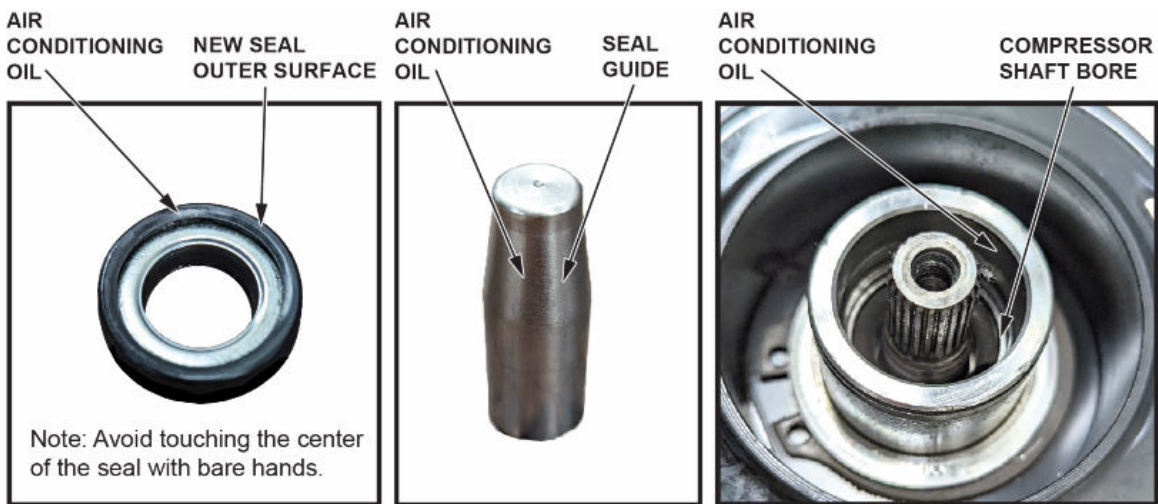
24. Inspect the compressor shaft bore for visible damage; Inspect the seal guide for contamination or damage.

25. Lubricate the new seal outer surface, seal guide, and bore with new POE air conditioning oil.

NOTE: Avoid touching the center of the seal with hands as to prevent cross-contamination of the A/C refrigerant system.

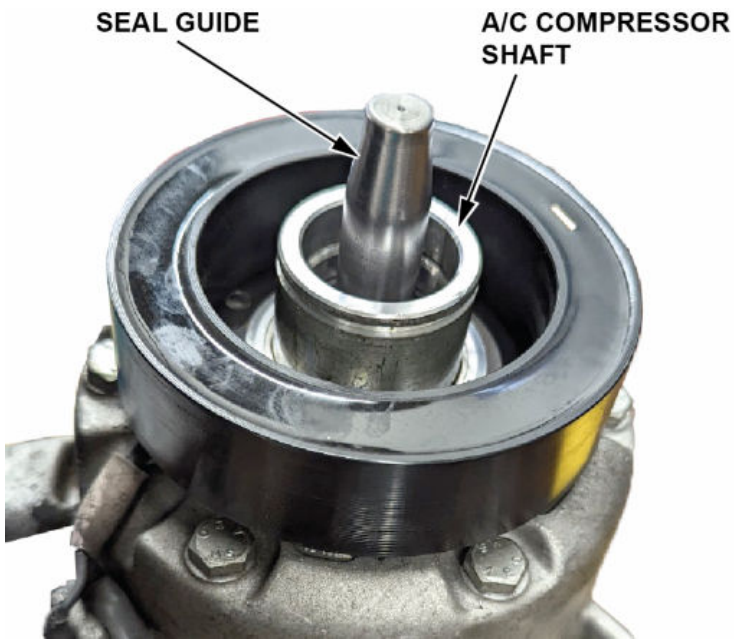
26. Insert the seal guide tool onto A/C compressor shaft.

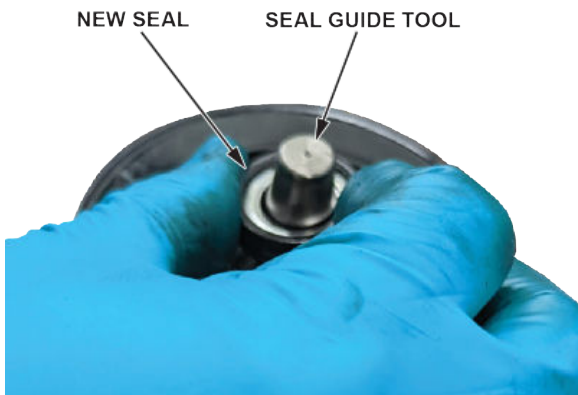
27. Insert the new seal onto the seal guide tool.

NOTE: The seal is directional and must be placed with the metal side upward.

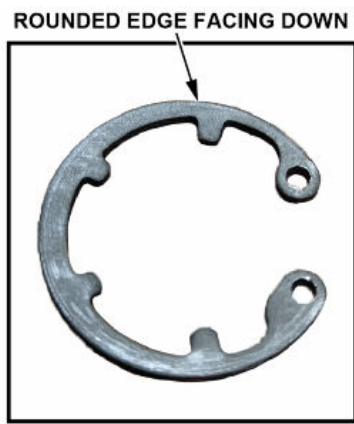
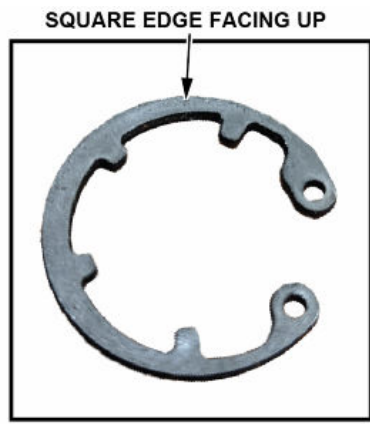
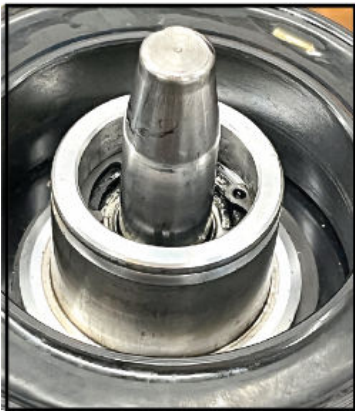
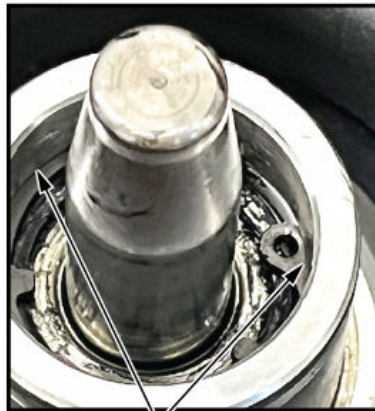
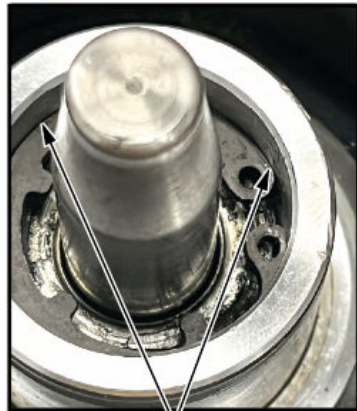
30. Insert the seal C-ring with the teeth's rounded side pointing down into the bore.

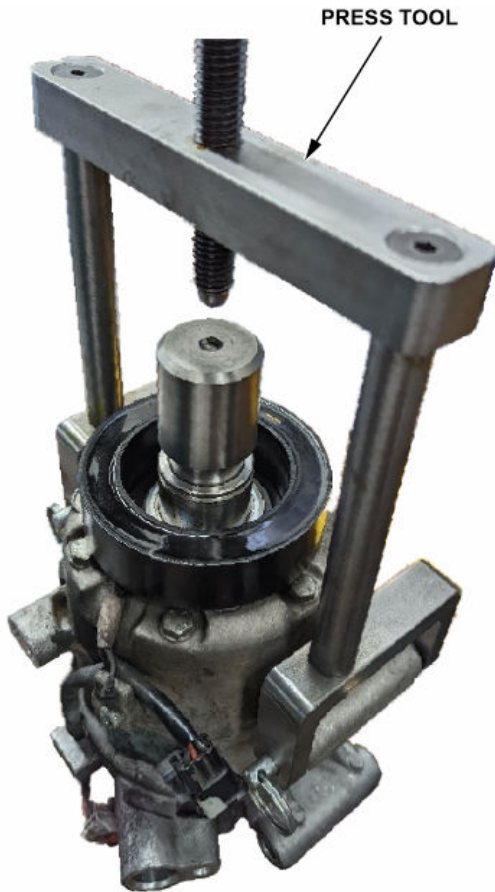
31. Install the press tool.
