Subject: Improvement on TS45 WC Water Filling Connector Connection

Bulletin type: **FIX AS FAIL**

Bulletin Nu: **TS45-FC-2303**

Vehicle Model: TS45 EPA 21 / EPA 17

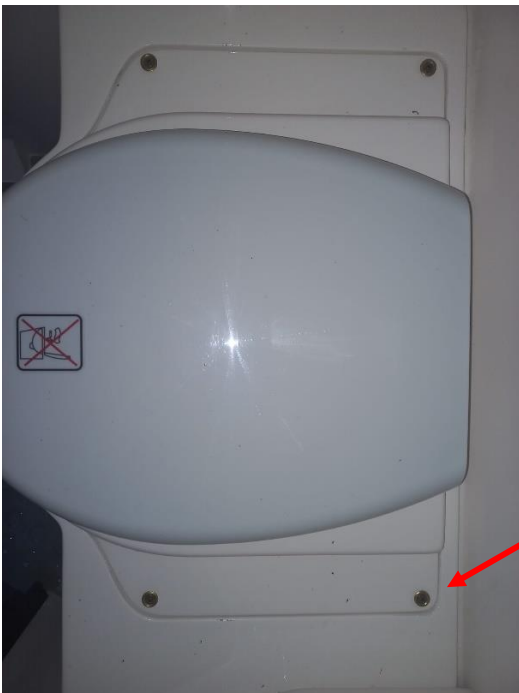
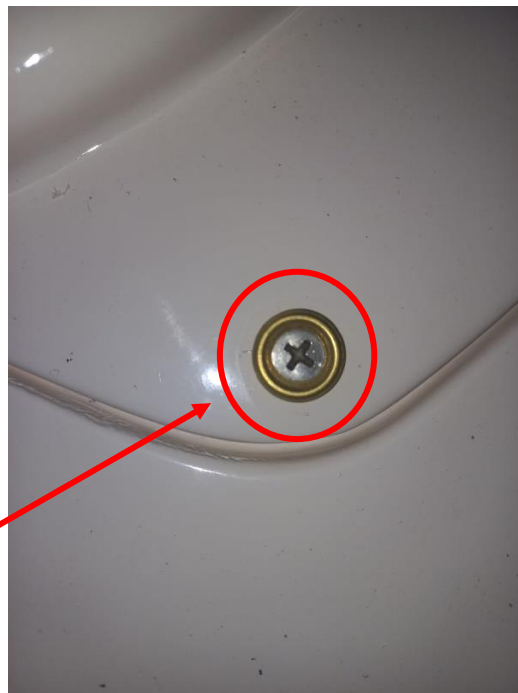
5- Unscrew the screw caps as seen on the image.

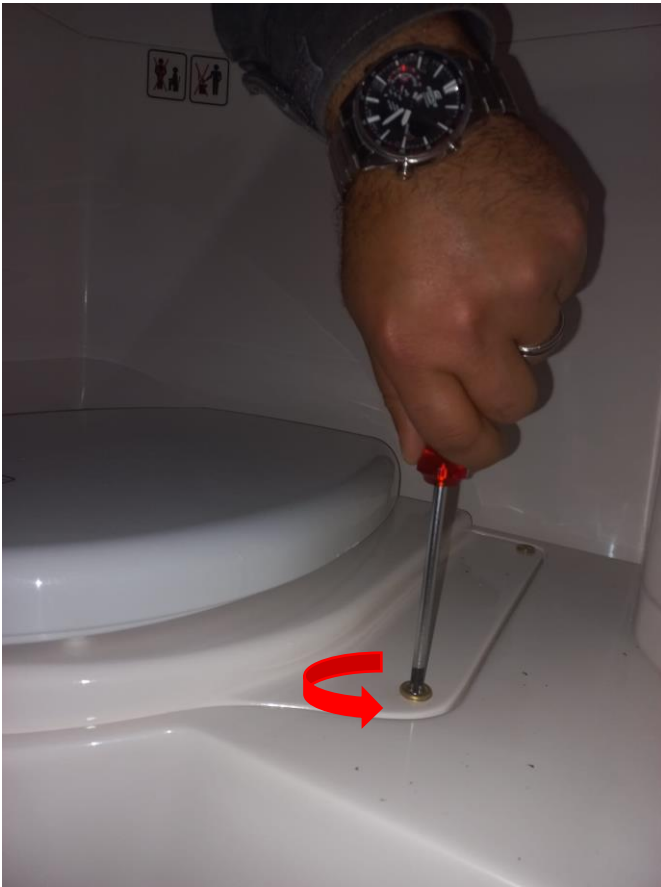
6- Remove the 4 screws with a phillips screw driver as seen in the figure.

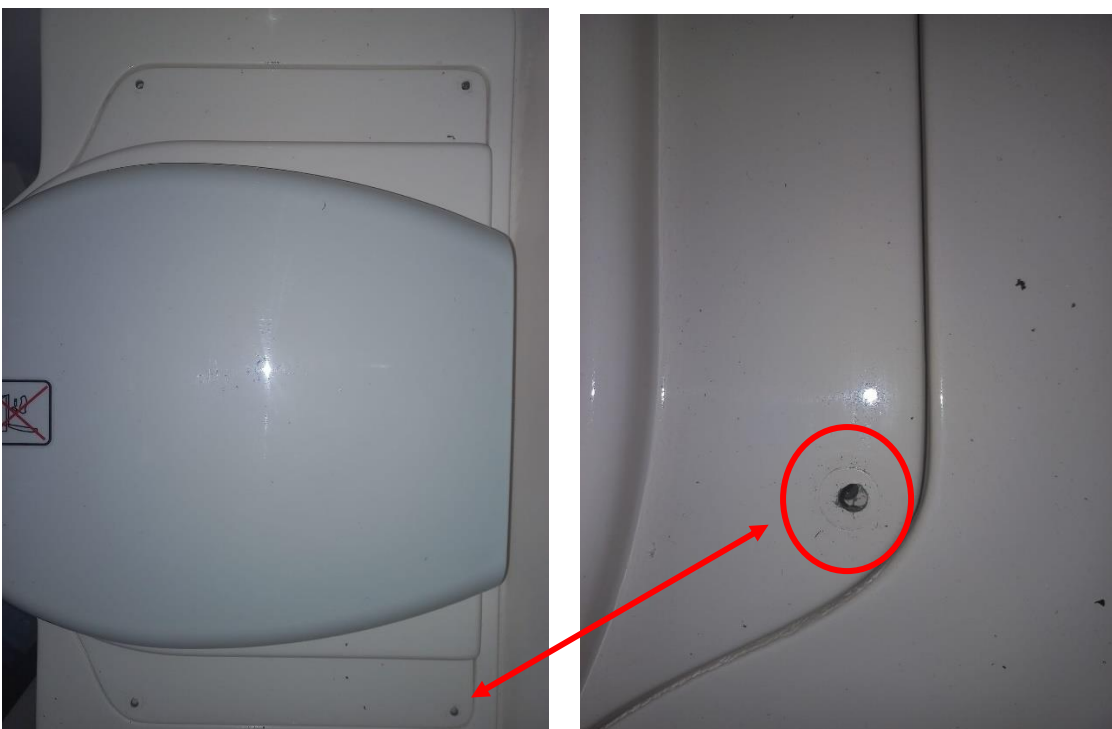
7- Check that all 4 screws have been removed as in the image.

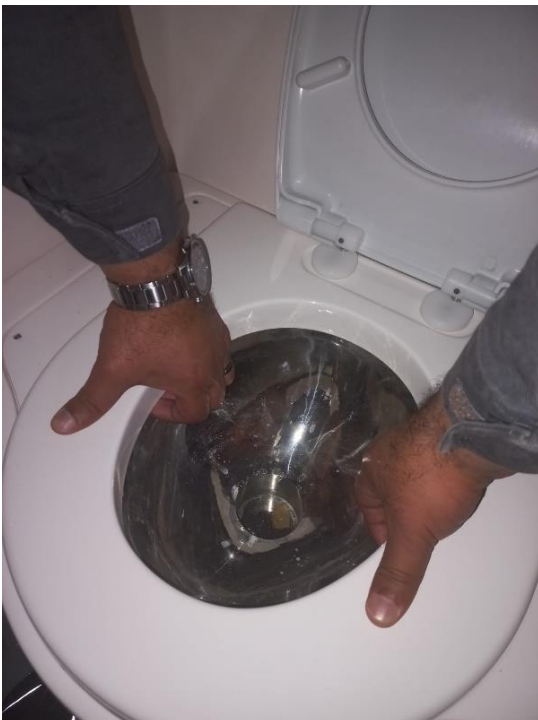
9- Remove the toilet by hand as seen on the image.

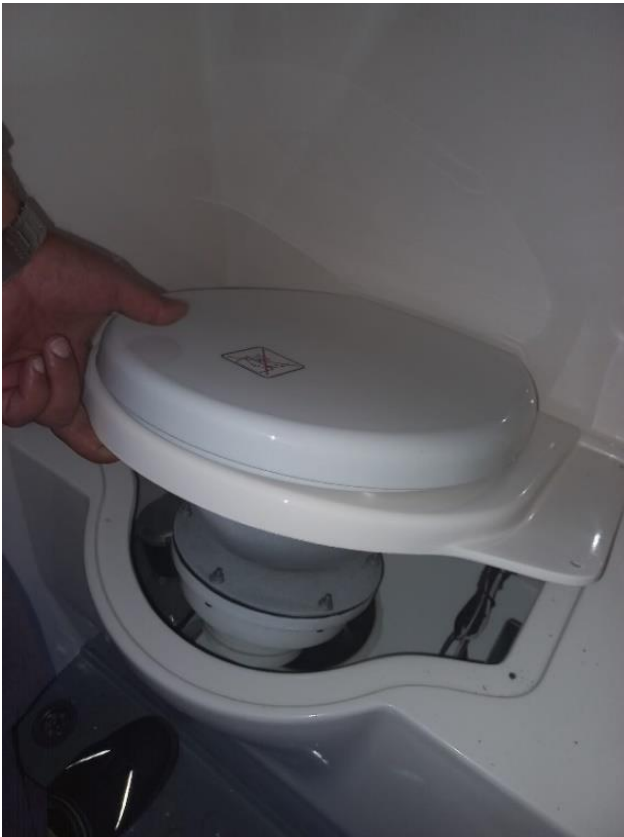
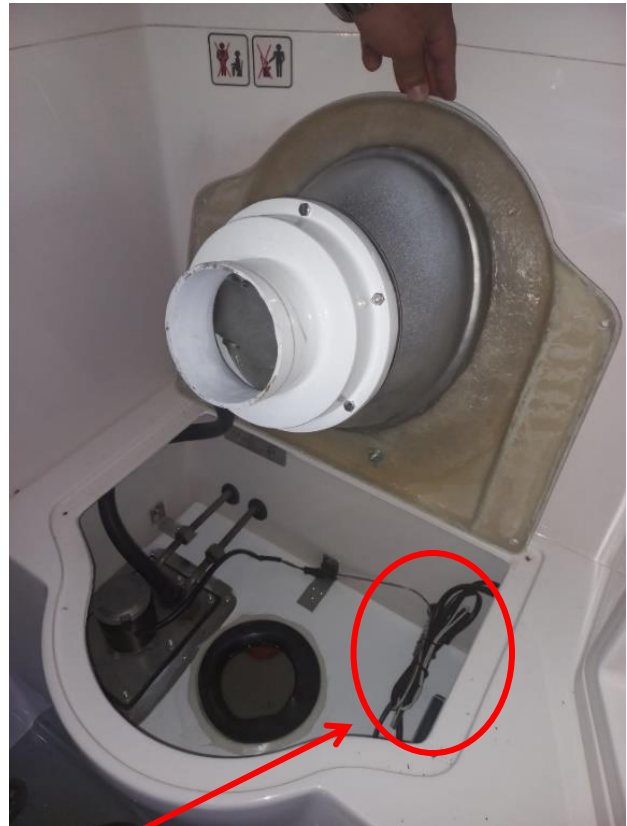
10- Remove the toilet bowl and fix it by leaning against the wall as in the image.

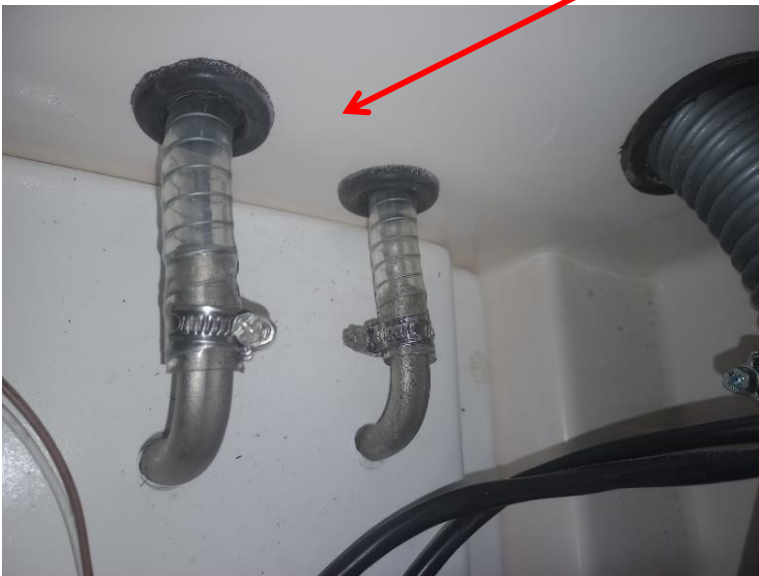
11- Find the assembled galvanized clamps.

This service bulletin is created to prevent water leakage that occurs in connector connections during toilet tank filling.

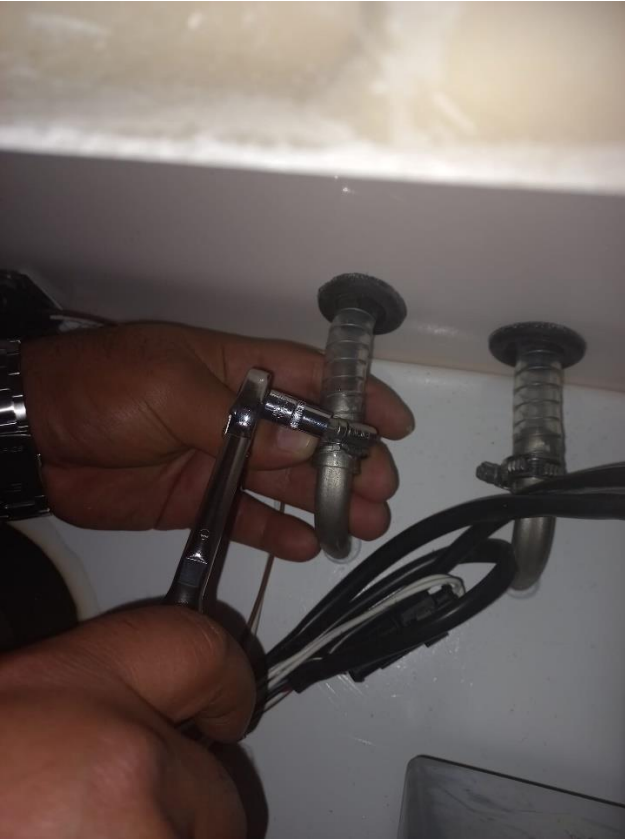
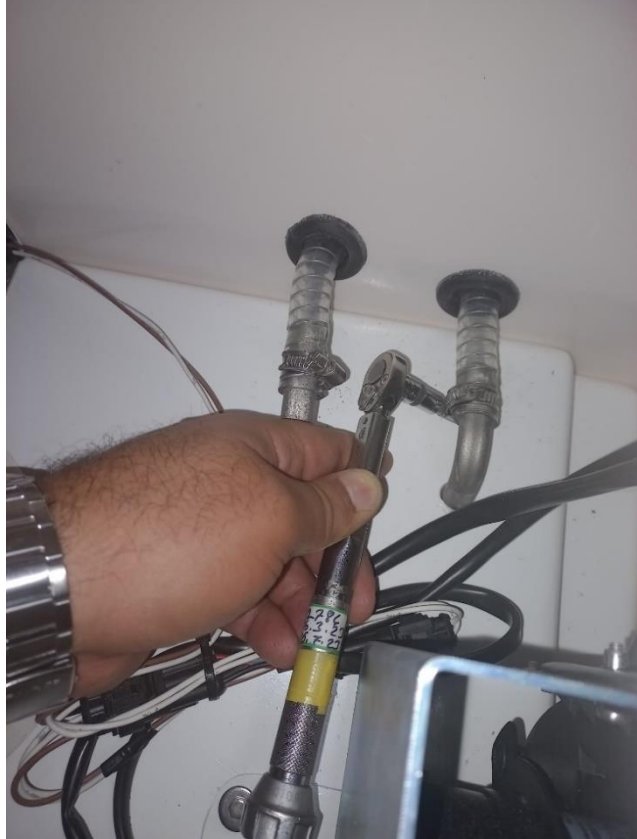
12- Remove the clamps with the torque wrench.

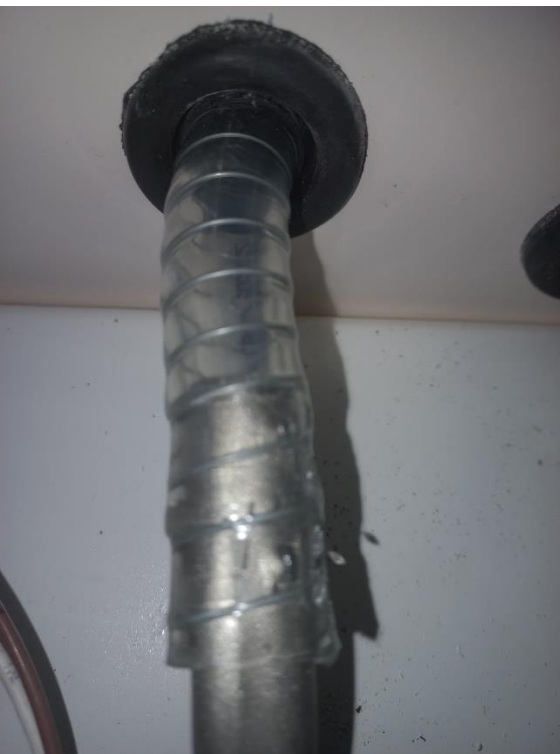
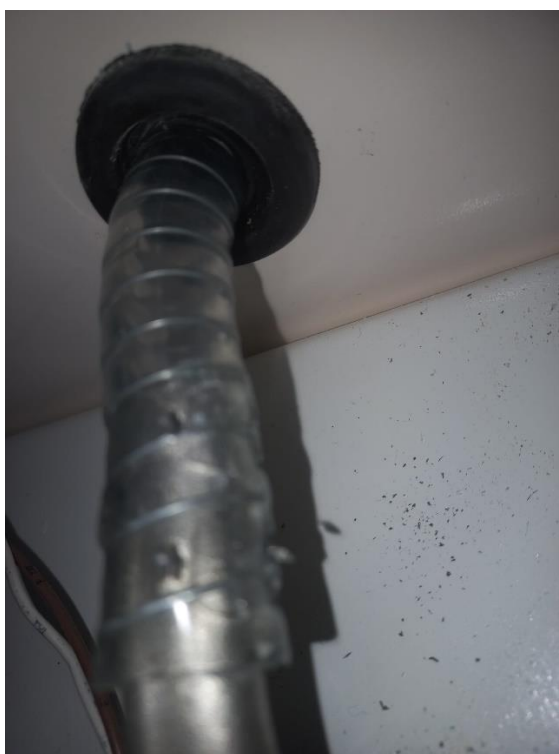
13- Remove the galvanized clamps on the right and left sides.

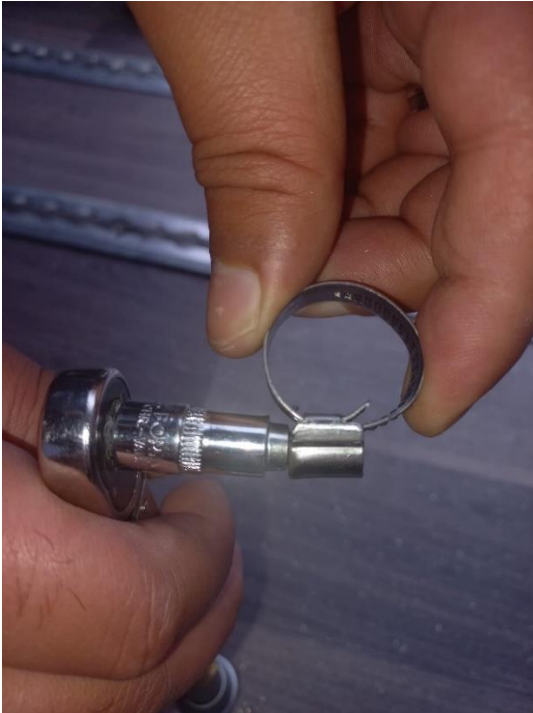
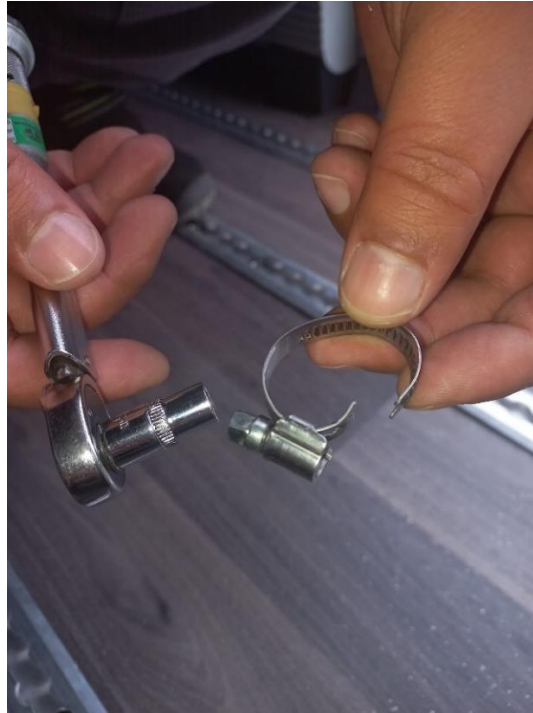
14- Take out the 2 galvanized clamps and do not use them. Use 4 chrome plated clamps instead.

Open the 4 chrome plated clamps with the Torque wrench.

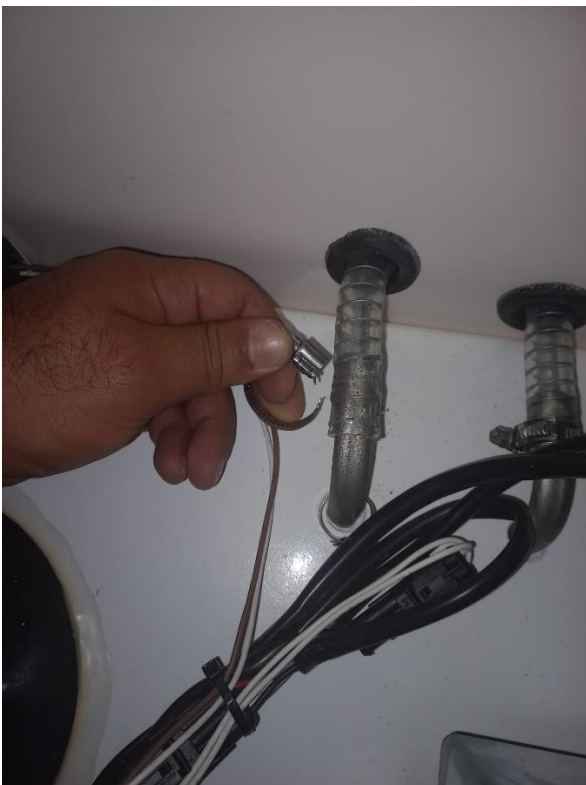
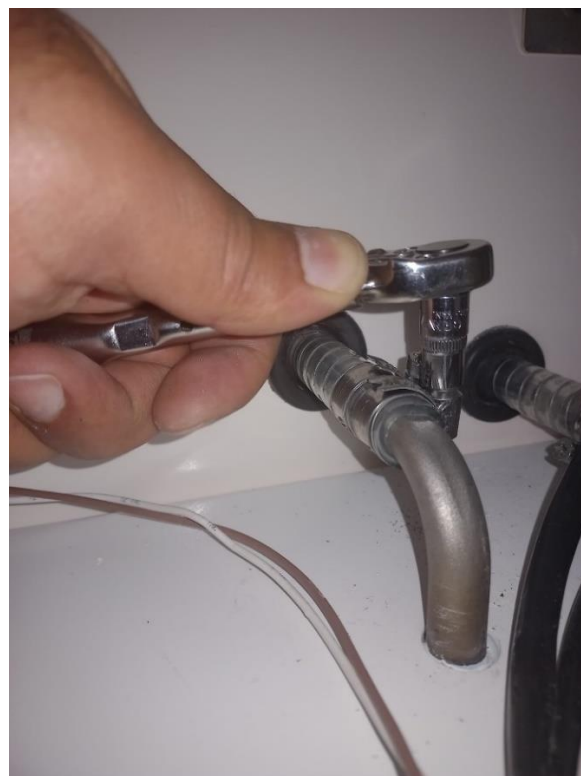
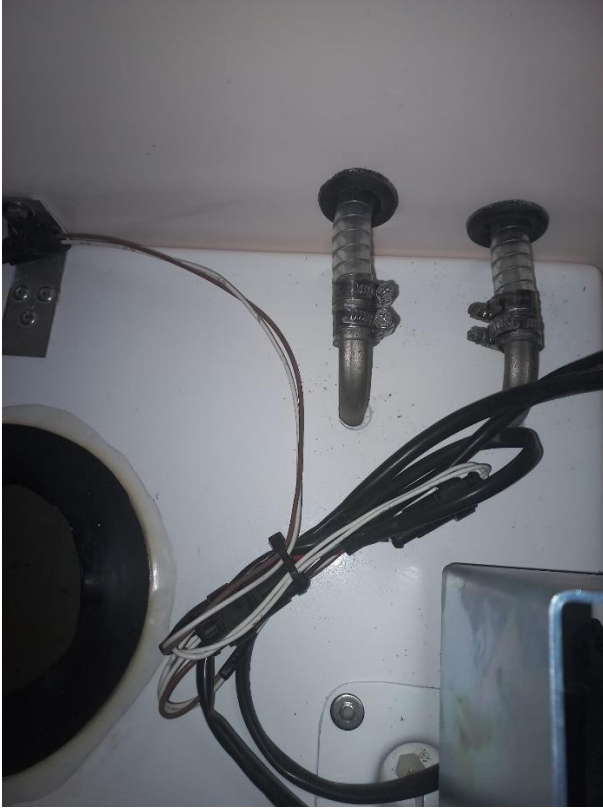
15- Tighten 4 chrome plated clamps adjusted to 5.5 NM as seen on the image.

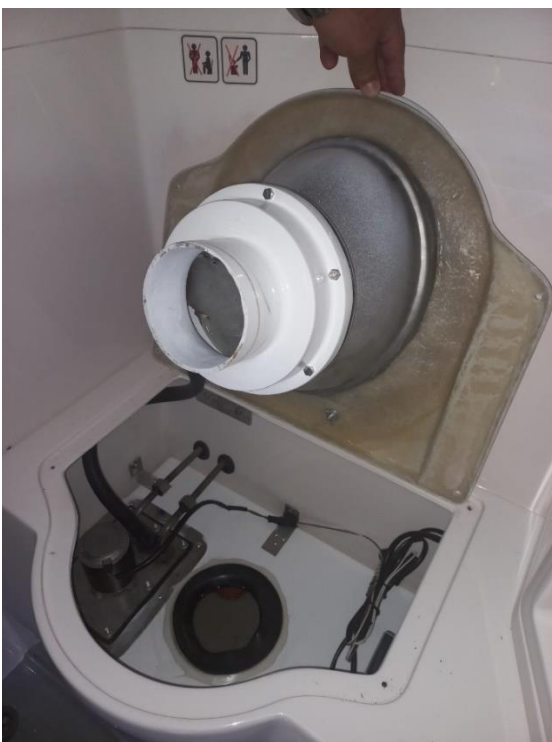
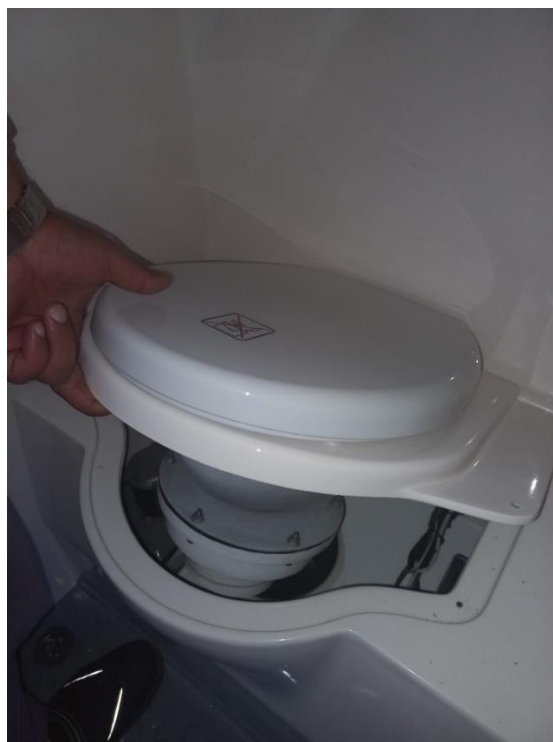
16- After your process is complete, close the toilet bowl and return it to its original position as seen on the image.

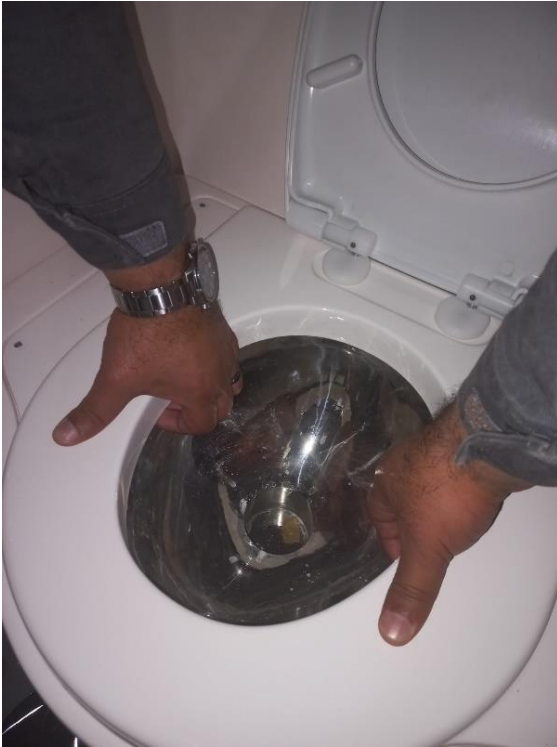
17- Put in position the toilet by hand as seen on the image.

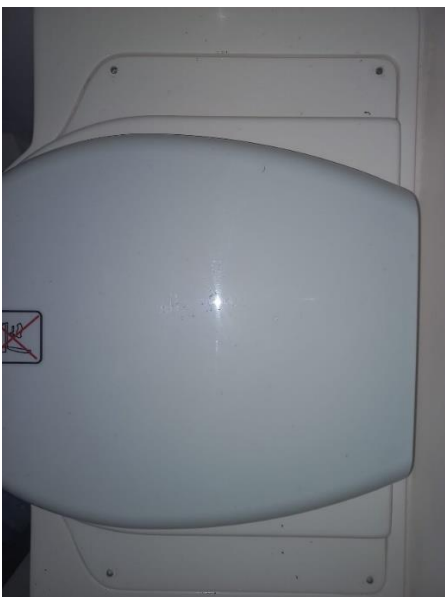
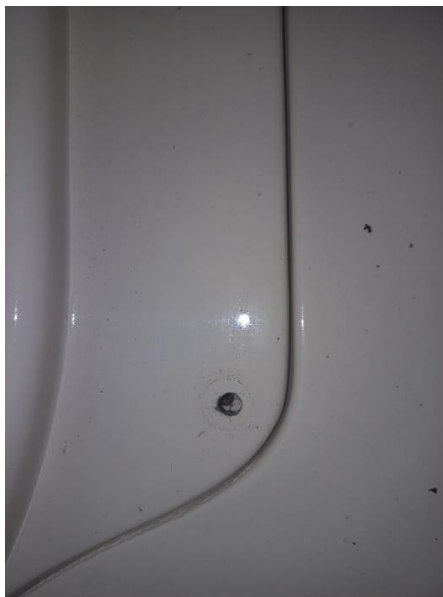
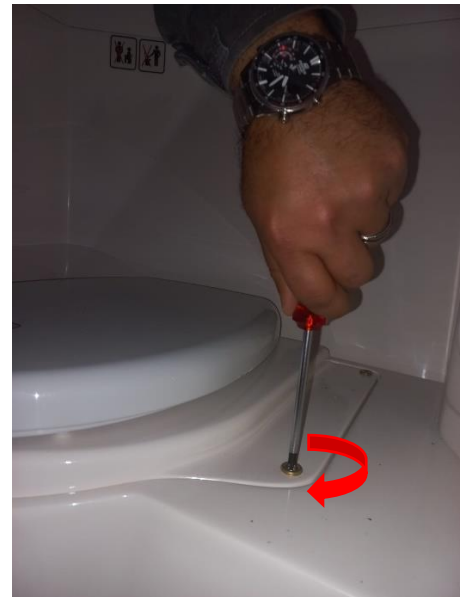
18- Tighten the 4 screws with a phillips screw driver as seen in the figure.

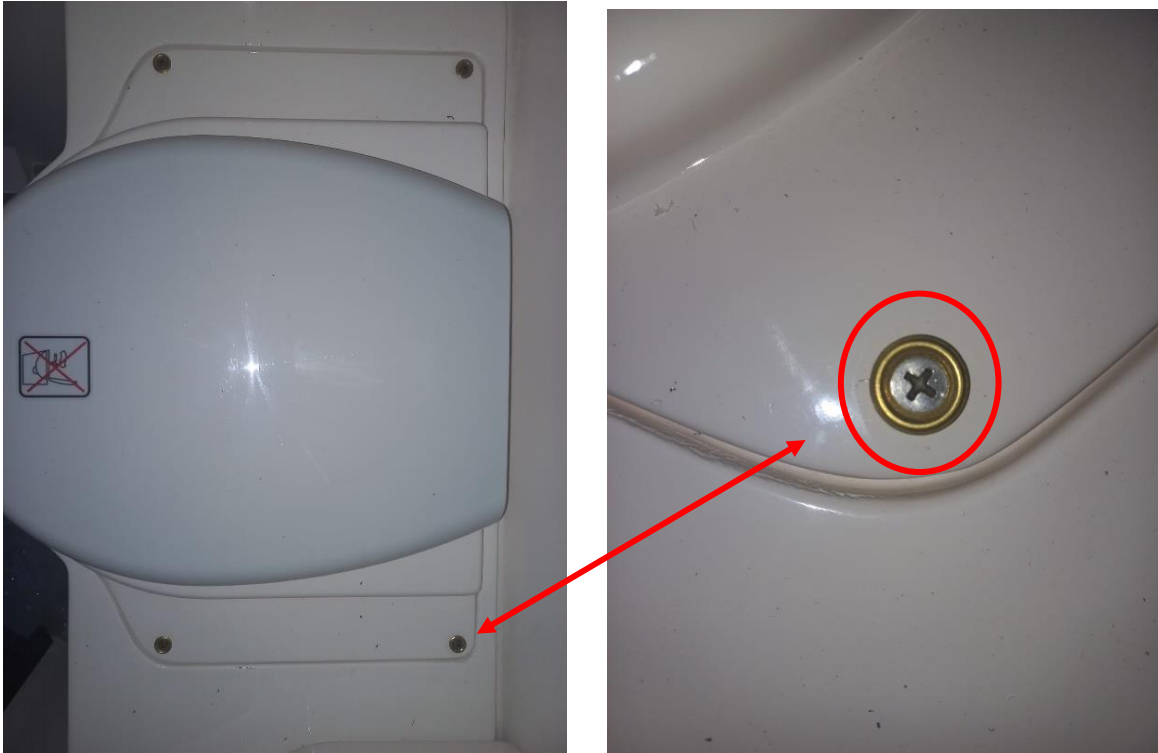
19- Check that all 4 screws have been placed as in the image.

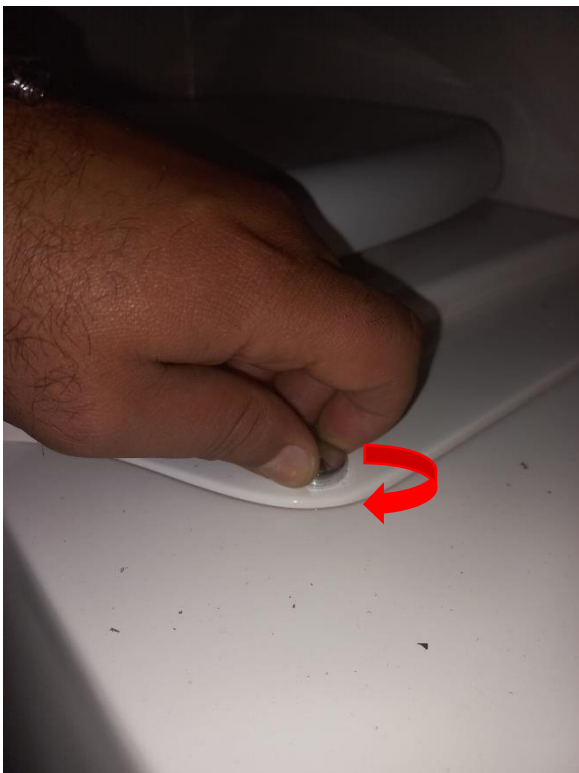
20- Turn the 4 screw caps by hand in the direction indicated by the arrow as seen on the image and place the screw caps.

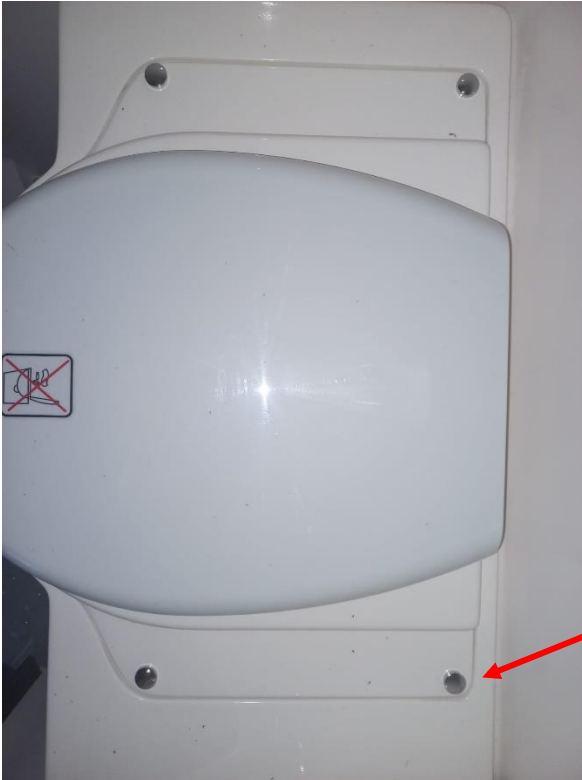
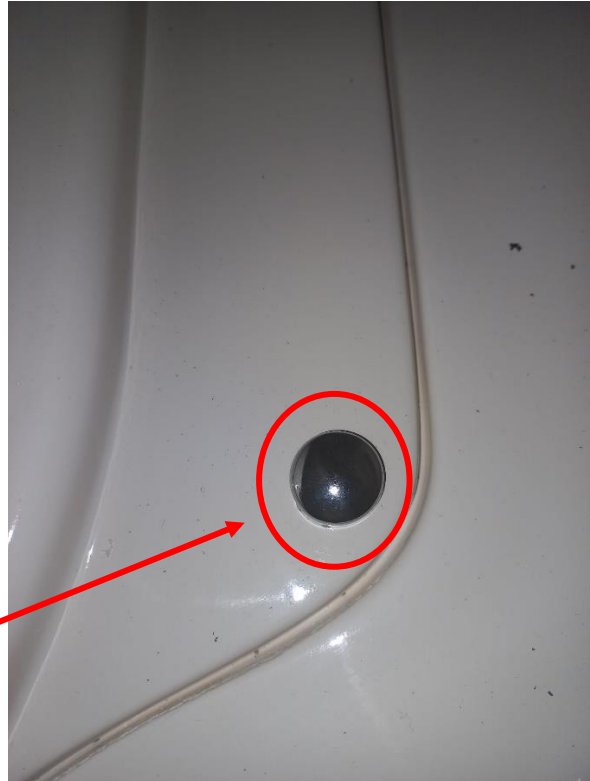
21- Check that all 4 screws cap have been installed as in the image.
