RECREATIONAL VEHICLE SERVICE CAMPAIGN

SERVICE ADVISORY 23-443

SERVICE ADVISORY # 23-443

2700BH Mid-Deck

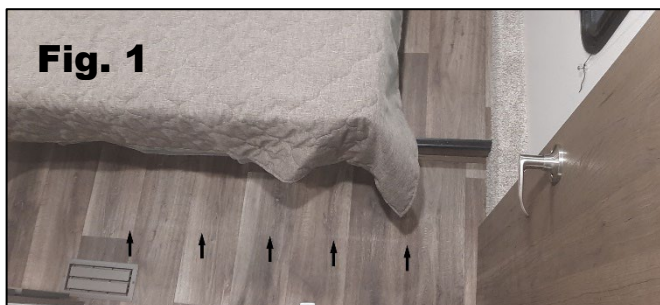
In the bedroom at the foot of the bed, verify that the floor is uneven. See Figure 1.

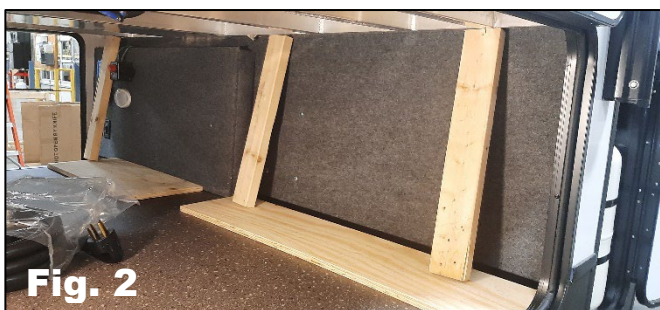
Measure the distance from the floor of the pass-through to the frame of the mid-deck. Cut four to five 2"x4"s using that measurement. Place a piece of 3/8" or larger plywood on the pass-through floor and place the 2"x4"s evenly across the pass-through floor as seen in Figure 2. The off-door-side may require a 2"x4" from the ground to the frame of the mid-deck.

Using a hammer, move each 2"x4" shim into place and slowly lift the mid-deck into place checking the top of the decking at the foot of the bed to make the decking even, this is easiest to do with two people.

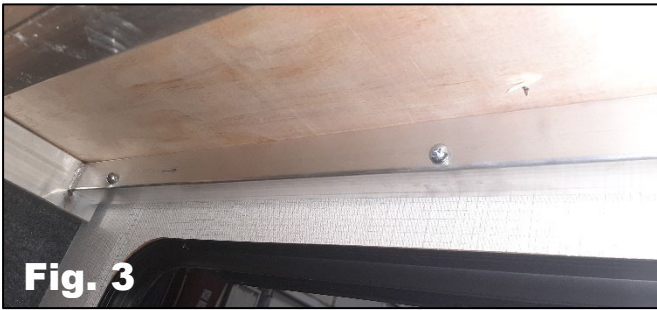
In the pass-through compartment on the door-side and off-door-side, remove the front two screws from the mid-deck that are run into the sidewall. See Figure 3.

Once the deck is in place and flush in the bedroom, re-install the screws into the sidewall on the door-side and off-door-side, moving the screw back or forward by 1/2" from the original placement.

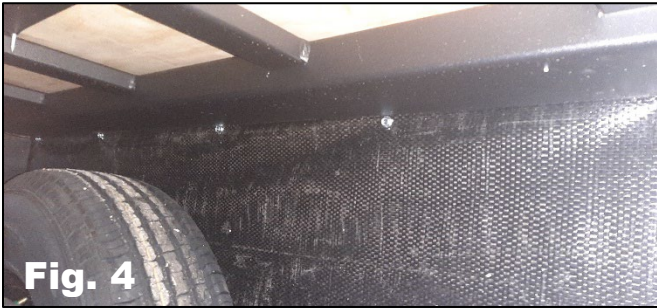
In the front compartment, remove the six screws in the wall above the spare tire. Note: a 3/8" thin wall socket may be required. See Figure 4.

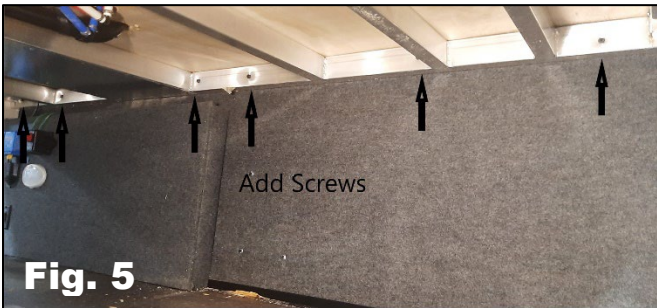
Predrill (7/32") and install the 6 – KRV # 103179 - Screw - 1/4" - 20 - 4" - Phil - Flat - Type F – Plain screws from inside of the pass-through compartment into the aluminum mid-deck frame and into the frame of the upper deck as seen in Figure 5.
