SIB 62 02 23

BLACK SQUARE APPEARS IN RPM GAUGE AFTER PROGRAMMING

F90 (M5 Sedan)	F91 (M8 Convertible)	F92 (M8 Coupe)	F93 (M8 Gran Coupe)
F95 (X5 M Sports Activity Vehicle)	F96 (X6 M Sports Activity Coupe)	F97 (X3 M Sports Activity Vehicle)	F98 (X4 M Sports Activity Coupe)
G80 (M3 Sedan)	G82 (M4 Coupe)	G83 (M4 Convertible)

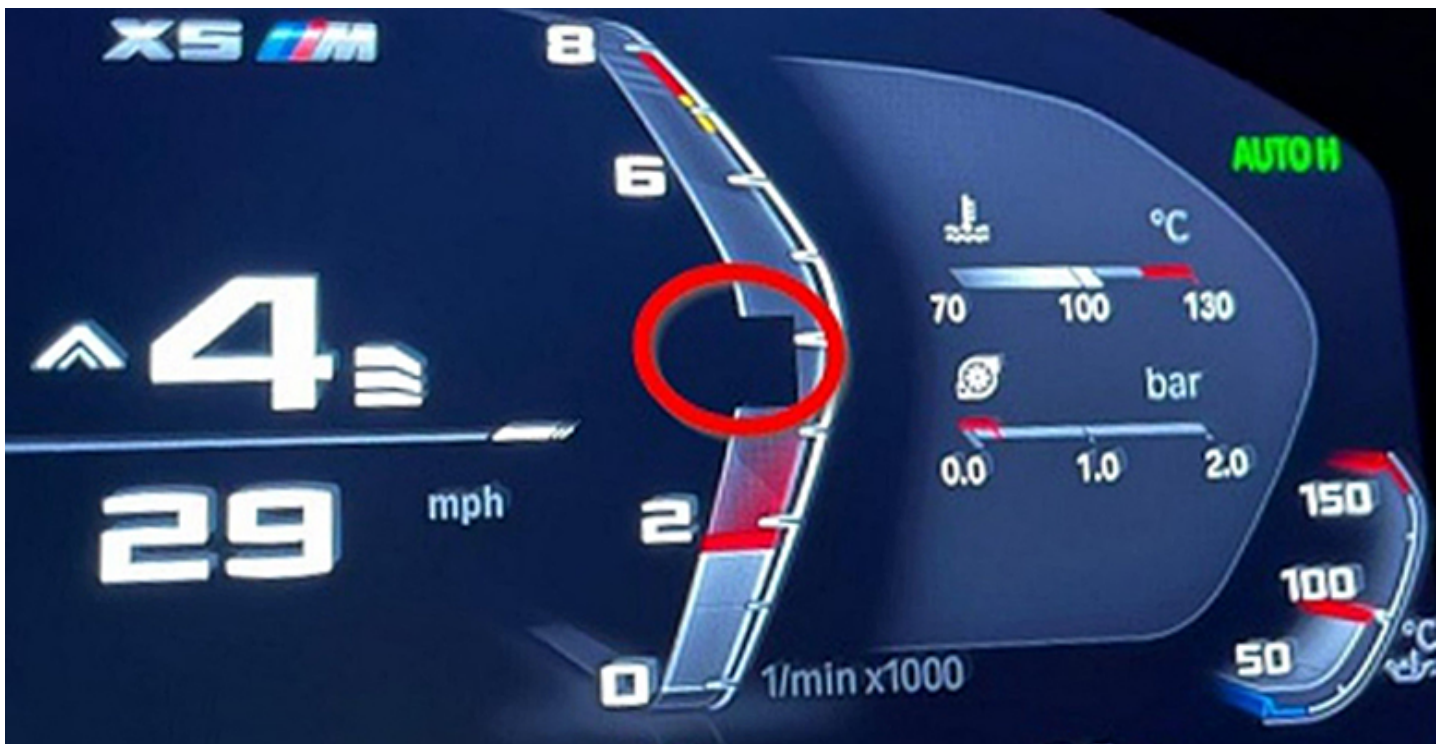
In SPORT mode, a black square appears in the RPM gauge (tachometer) section of the instrument cluster display.

Unfavorable response from the KOMBI if the vehicle isn't allowed to enter a full sleep cycle after programming.

Reset the vehicle data in head unit (HU-H).

In the event this situation occurs after programming, the Vehicle Data will need to be reset. This process can be performed through the Vehicle Menu in the I-Drive.

Use the following path in the Central Information Display:

- Vehicle
- Settings

- General Settings
- Reset Vehicle Data
