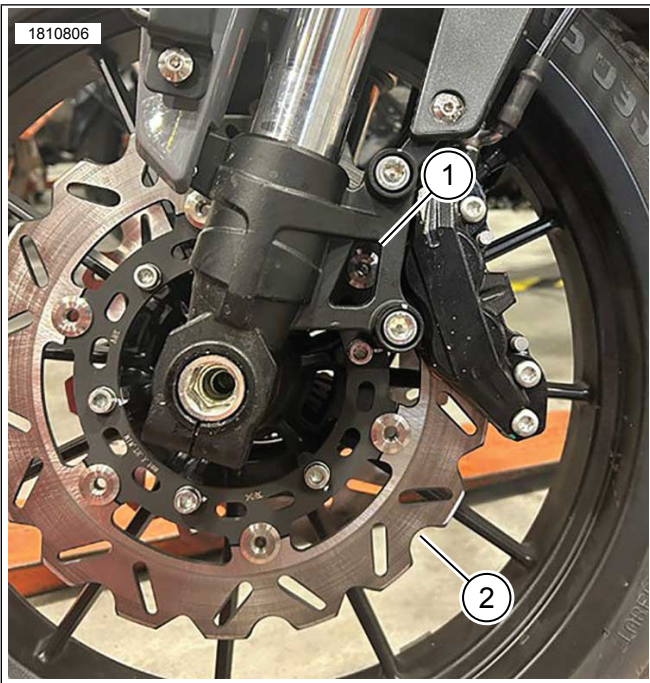
Figure 1. Correct Fork Lower

1. Gap in fork
2. Full wear on rotor

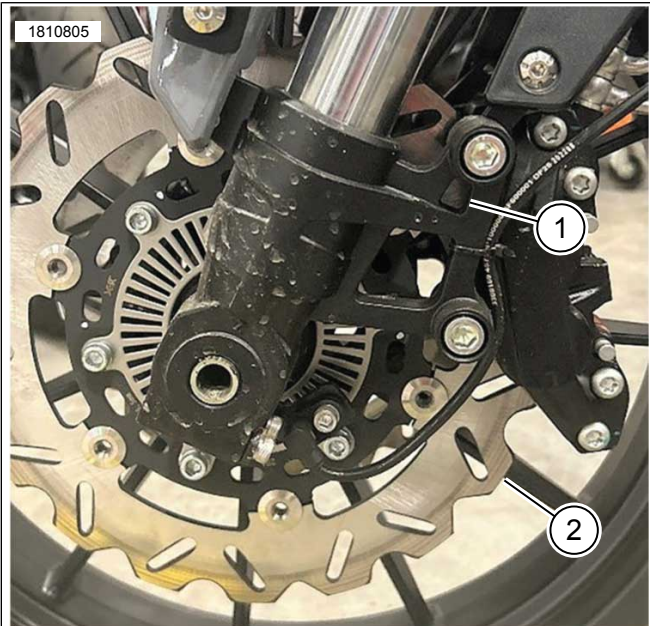
Figure 2. Incorrect Fork Lower

1. Gap in fork
2. Outer wear on rotor
