| <b>HYUNDAI</b><br><b>Technical Service Bulletin</b> | <b>GROUP</b><br><b>STEERING</b> | <b>NUMBER</b><br><b>23-ST-003H</b> |
| <b>SUBJECT:</b> 2015-2017MY SONATA AND SONATA HYBRID/PLUG-IN HYBRID MDPS (WARRANTY EXTENSION TXXO) | | |

**THIS TSB SUPERSEDES 22-ST-001H TO CLARIFY TSB INCLUDES 1.6T SONATA (LFA) VEHICLES AND ADD WARRANTY NOTES 3 AND 4.**

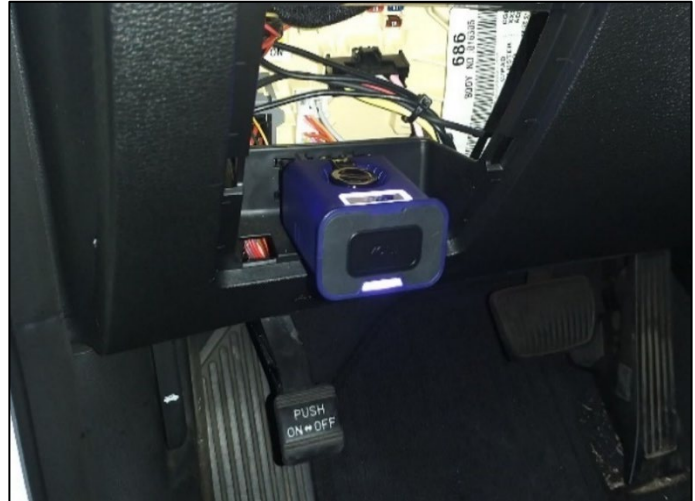
1. Locate the OBD2 port on the driver's side dash panel. Connect GDS to vehicle via VCI.

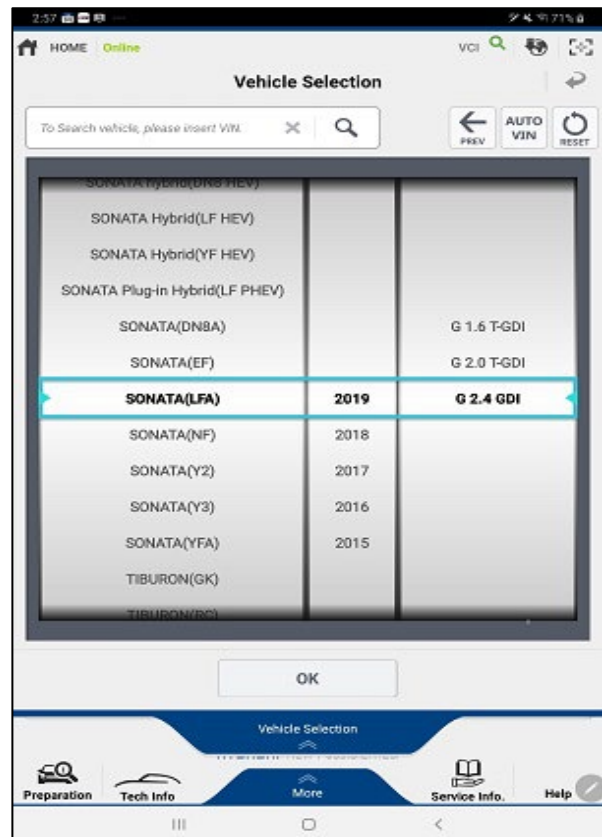
2. Select the vehicle type, then check all systems for diagnostic trouble codes (DTCs).

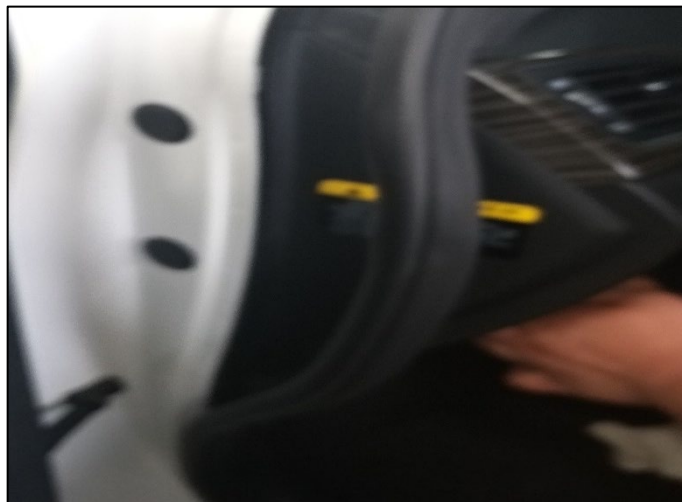
1. If applicable, record the customer's radio presets and turn the ignition switch OFF.

Disconnect the negative (-) 12V battery terminal and wait at least 30 seconds.

Open the driver's front door and pull back the weather stripping.

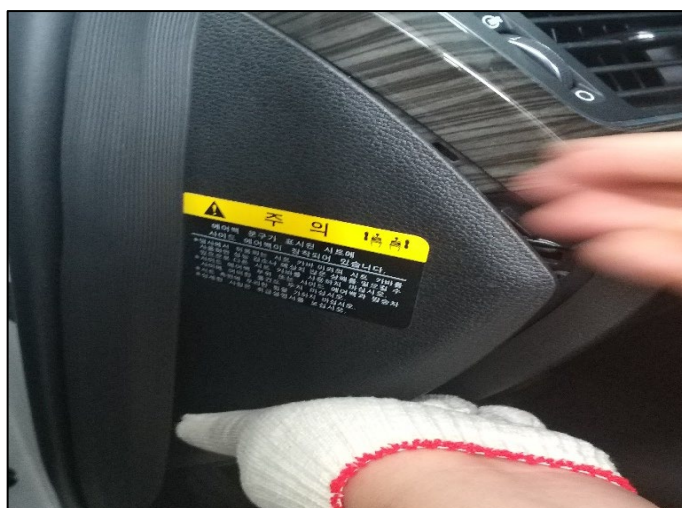
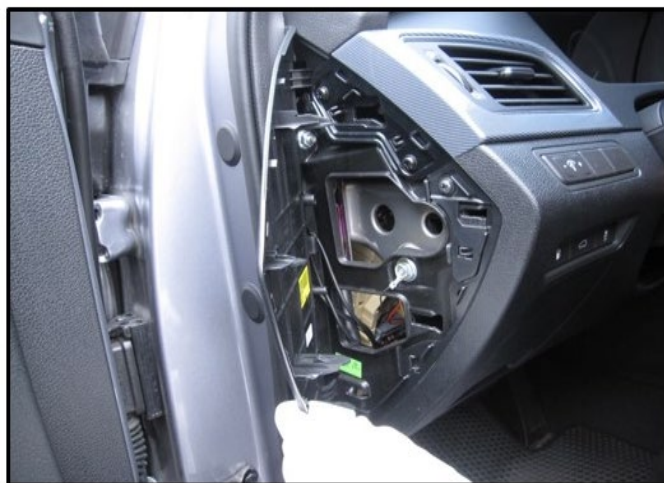
2. Remove the dash side cover.

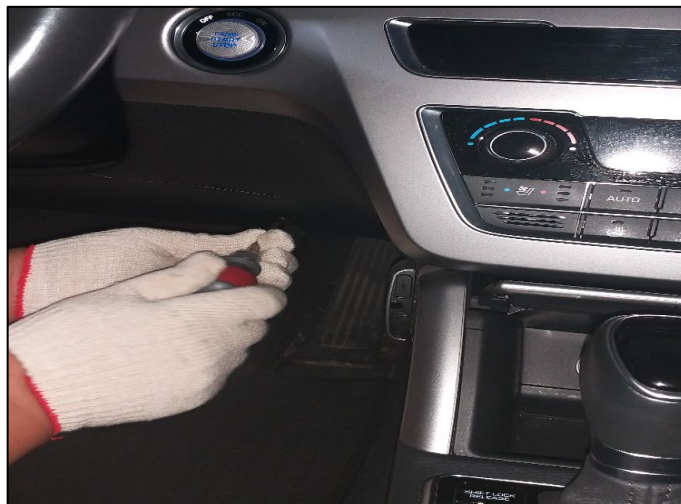
4. Remove the cover to access the bolt on the lower dash. Remove the bolt.

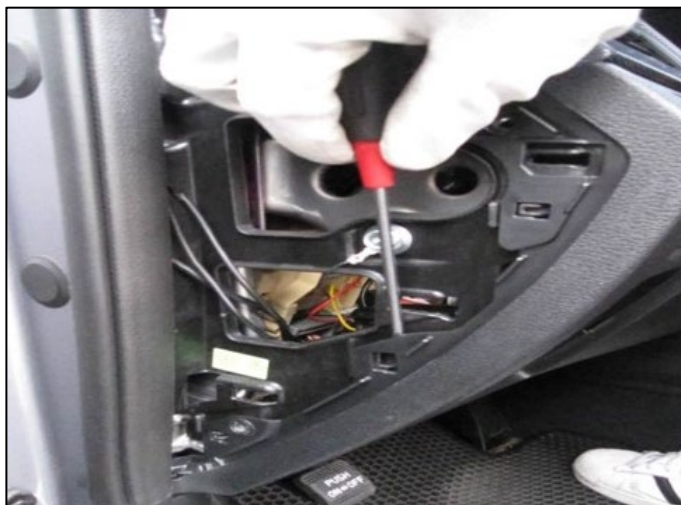
5. Unfasten the retaining hook on the side of the dash.

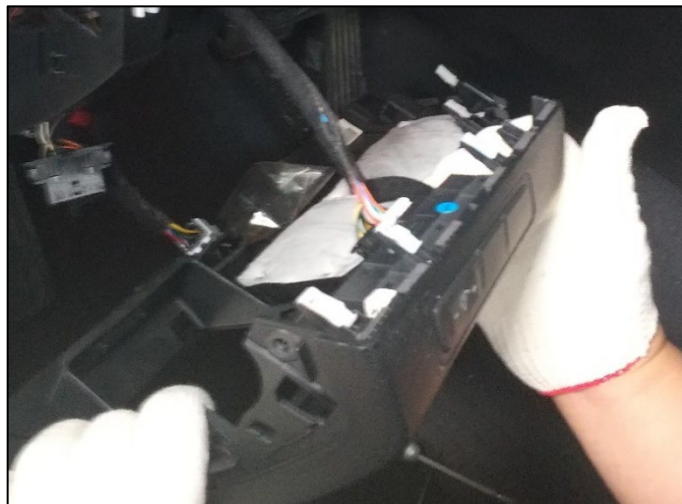
6. Remove the lower cover assembly and disconnect the associated wiring harnesses.

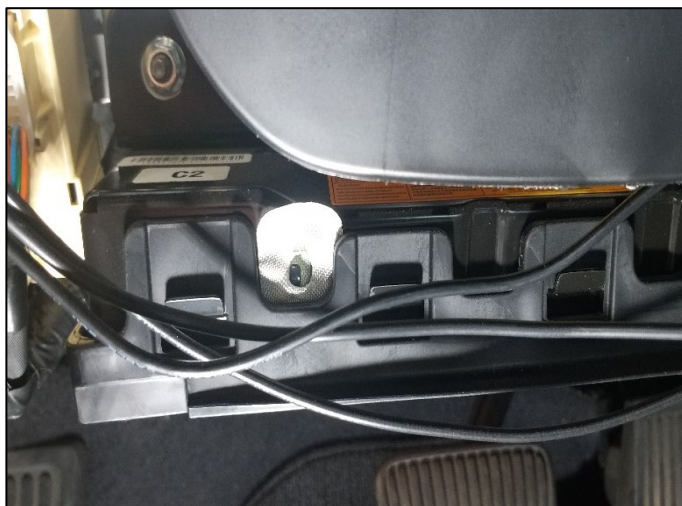
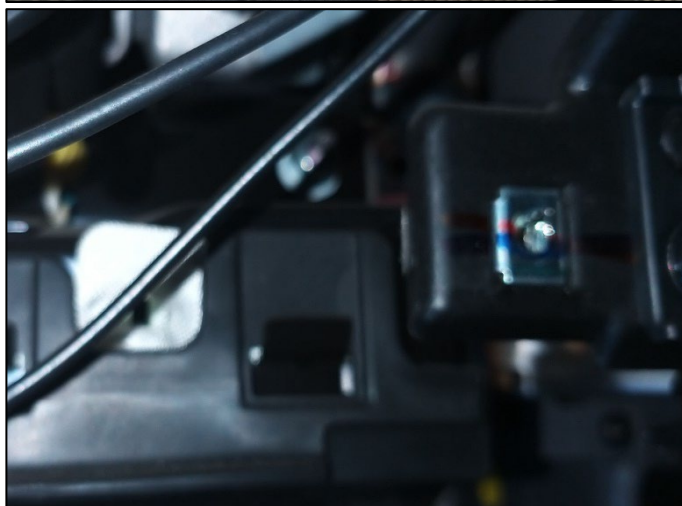
7. Remove the mounting bolts for the driver's knee air bag.

***Tightening Torque:***  
***8 ~ 12 N.m. (0.8 ~ 1.2 kgf.m, 5.9 ~ 8.8 lbf-ft)***

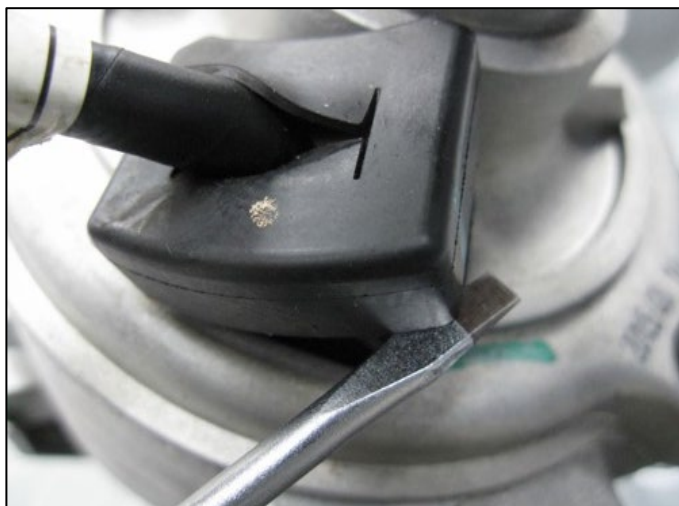
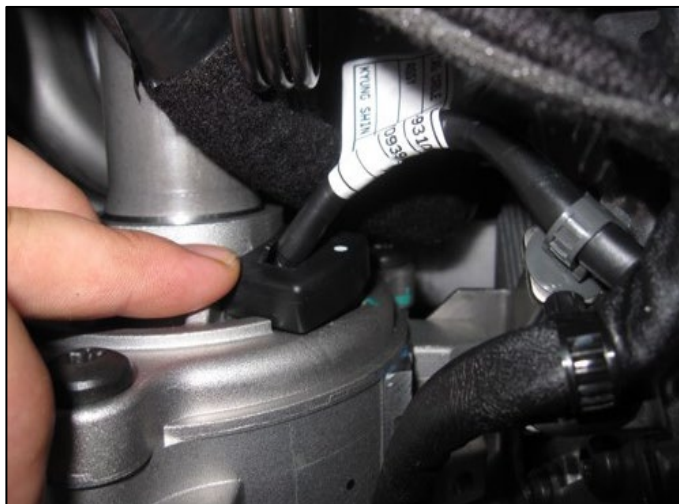
9. Remove the cable protection cover on the torque sensor cable and disconnect the connector.

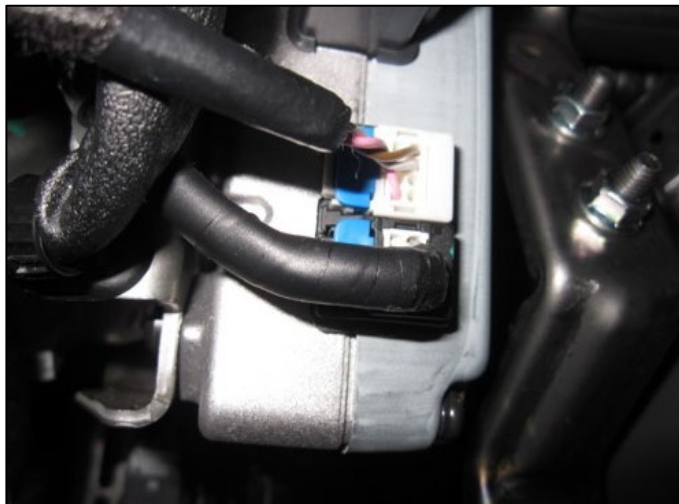
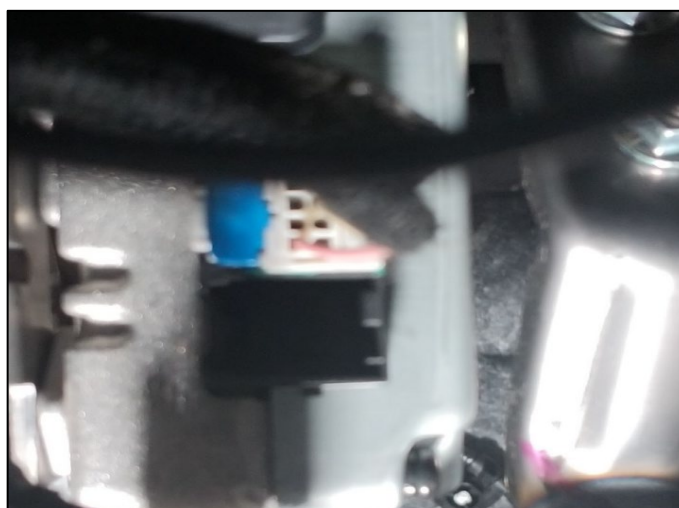
10. Remove the ECU side connector double lock and connector using the flat screwdriver.

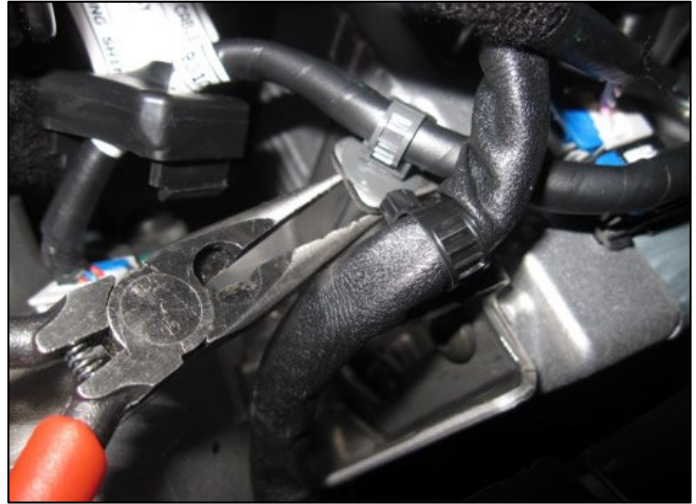
11. Remove the torque sensor cable fixing clip using the long-nose pliers.

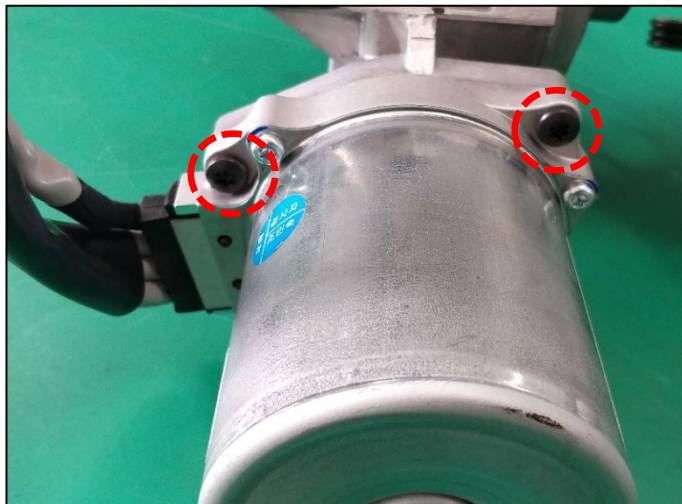
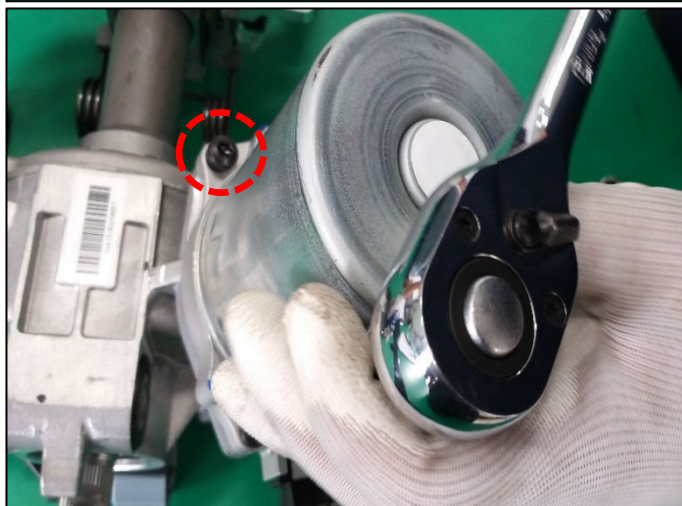
2. Remove the C-MDPS motor mounting screws.

***Tightening Torque:***

**8 ~ 12 N.m. (0.8 ~ 1.2 kgf.m, 5.9 ~ 8.8 lbf-ft)**

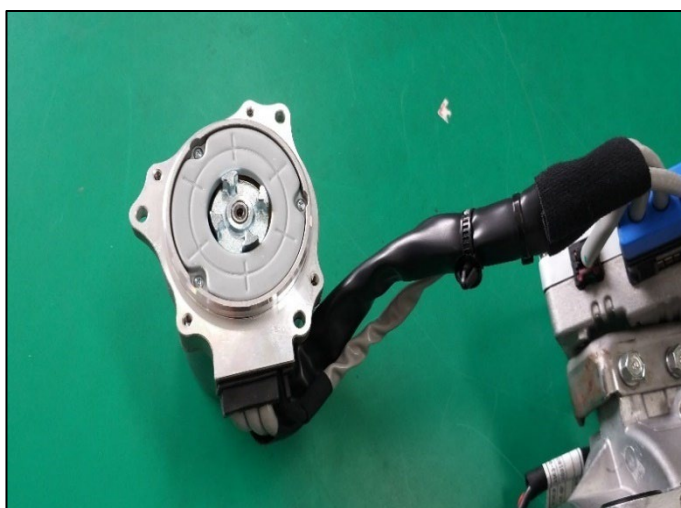
4. Remove the MDPS motor assembly.

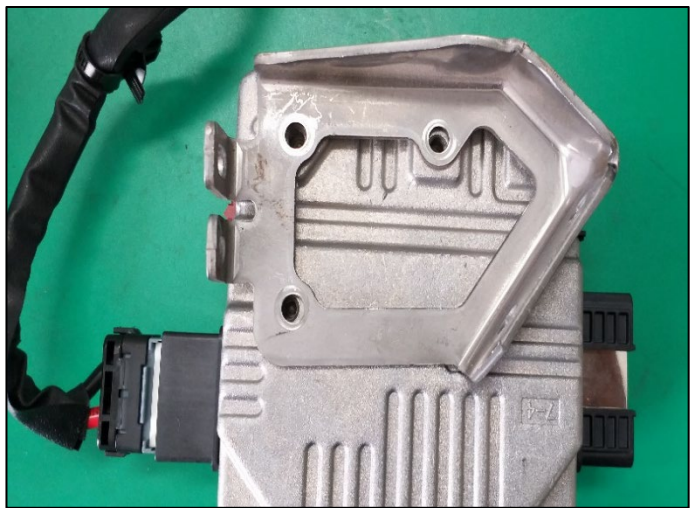
7. Remove the MDPS ECU.

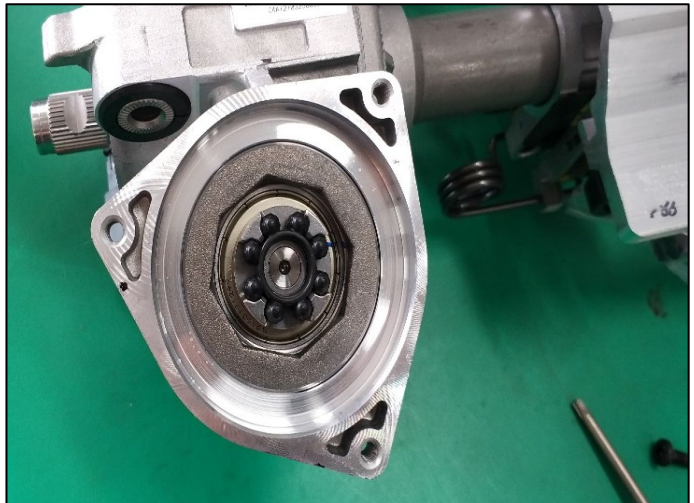
8. Remove the MDPS rubber coupling.

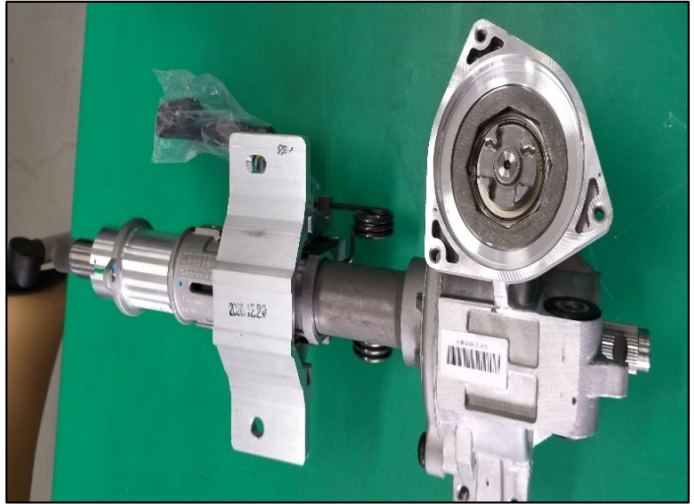
9. Install the removed MDPS ECU, motor, and coupling to the new column & housing assembly.

Install the MDPS assembly into the vehicle in reverse order of removal.

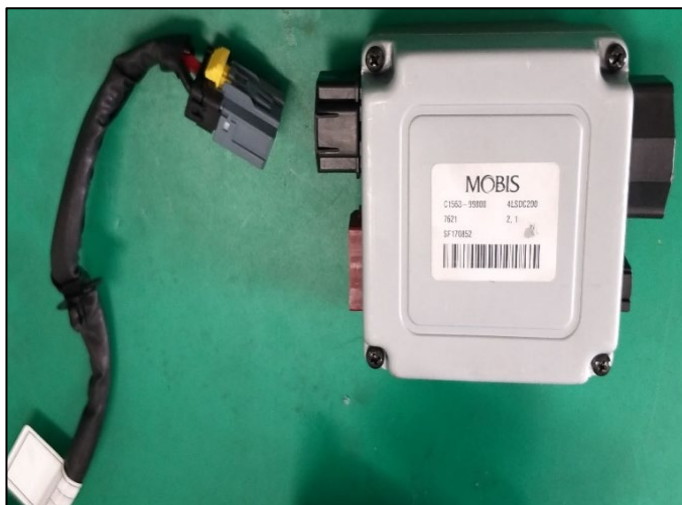
5. Remove the MDPS ECU.

Install the new MDPS ECU in reverse order of removal.

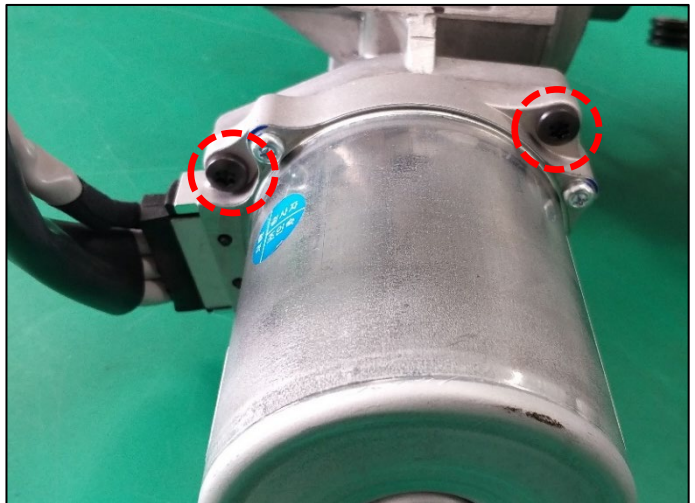
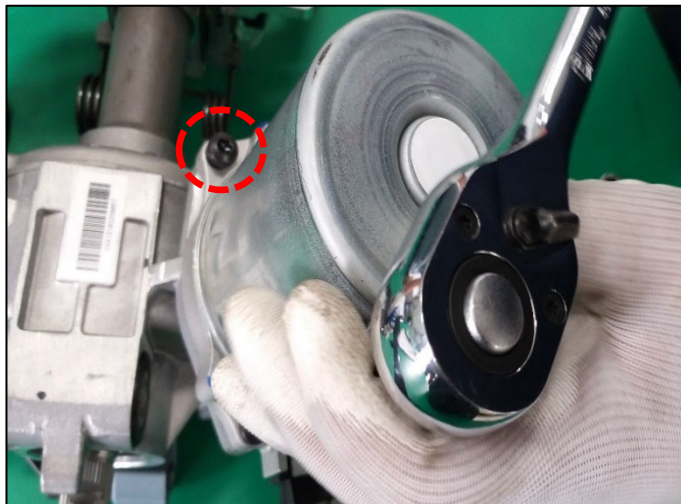
2. Remove the C-MDPS motor mounting screws.

***Tightening Torque:***

**8 ~ 12 N.m. (0.8 ~ 1.2 kgf.m, 5.9 ~ 8.8 lbf-ft)**

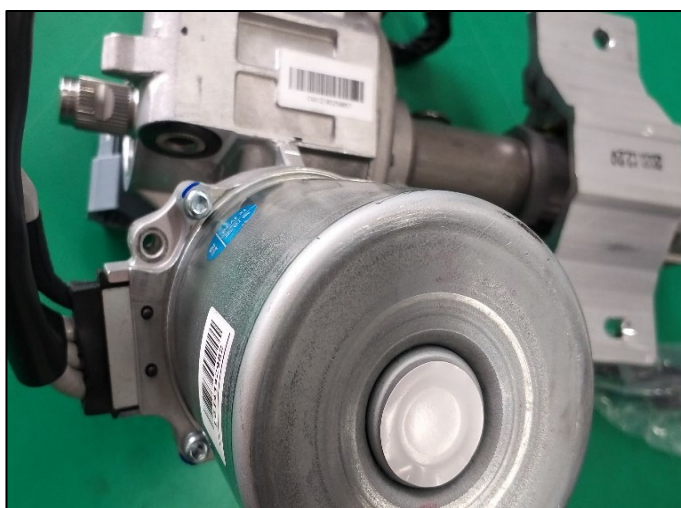
3. Remove the motor from the assembly.

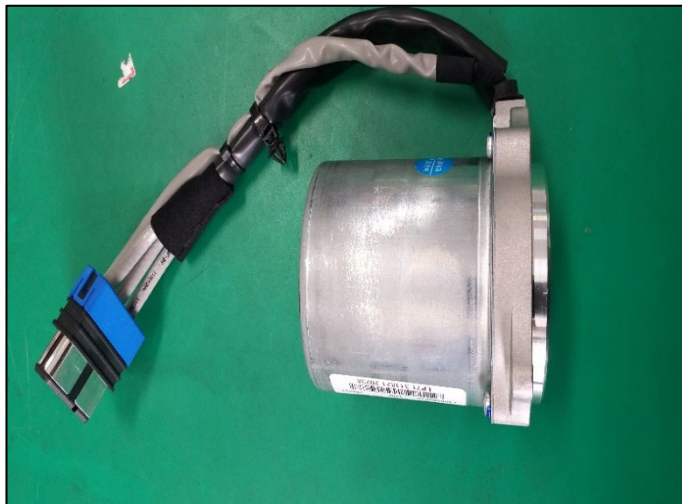
5. Remove the motor assembly.

Install the new motor assembly in reverse order of removal.
