# HYUNDAI

## Technical Service Bulletin

23-01-030H

EXHAUST PIPE MOUNTING REVISION  
(SERVICE CAMPAIGN T9R)

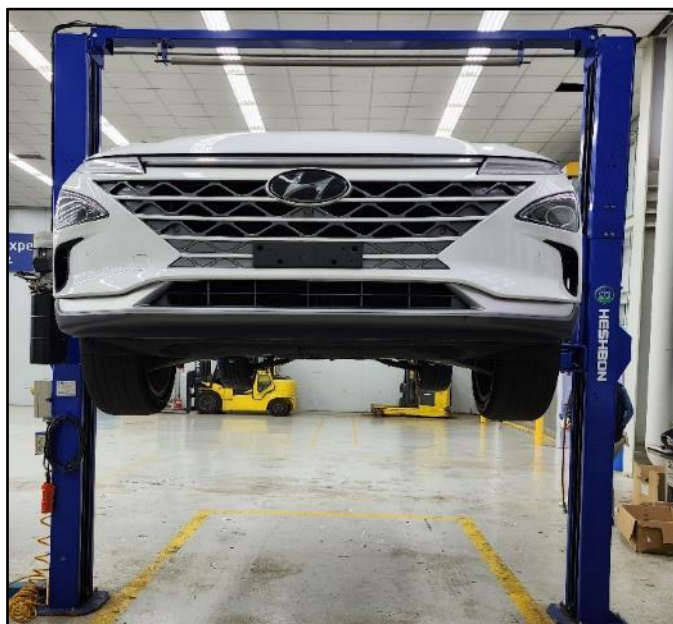
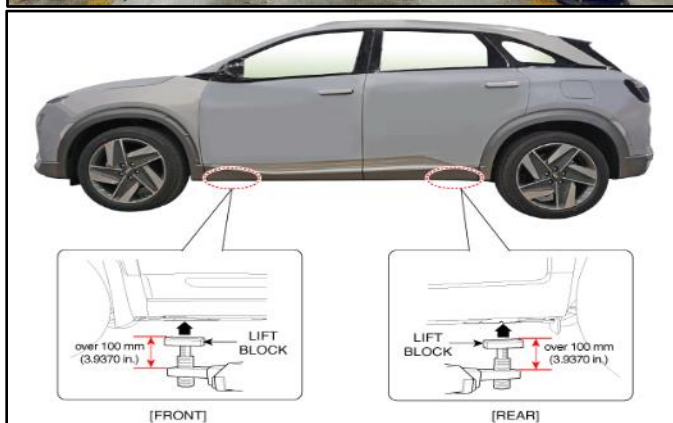
1. Raise the vehicle using a vehicle lift.

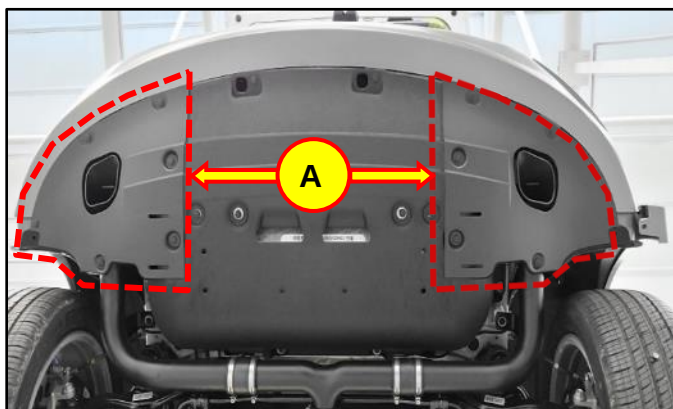
2. Remove the LH and RH tailpipe undercovers (A).

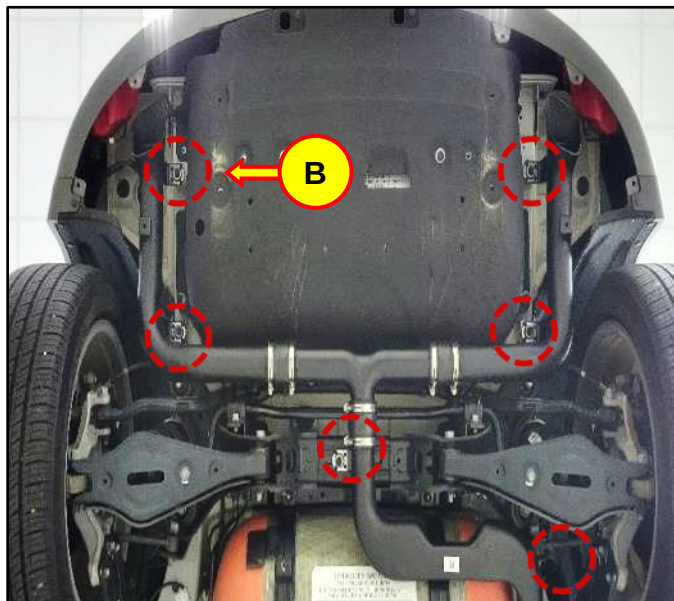
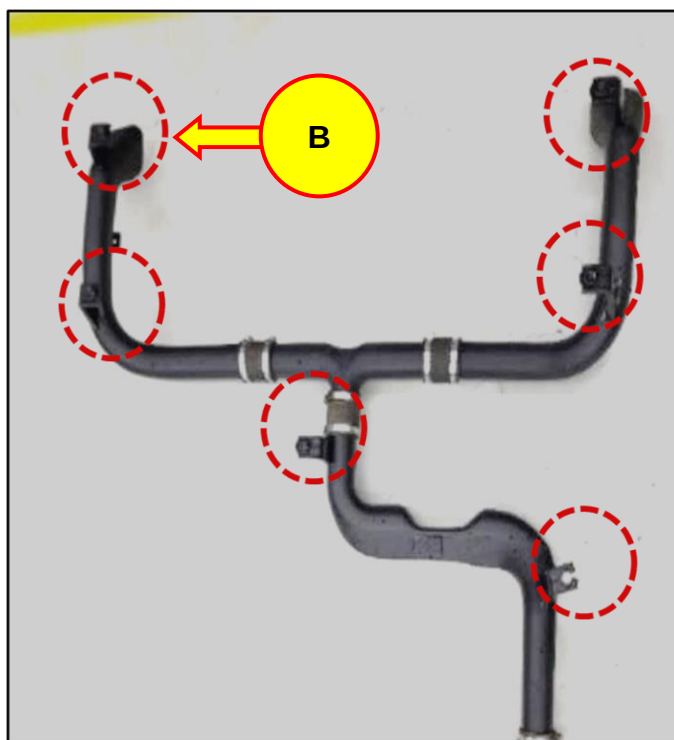
3. Steel plates will be installed on the exhaust system support brackets at six (6) locations on the exhaust system. (B)

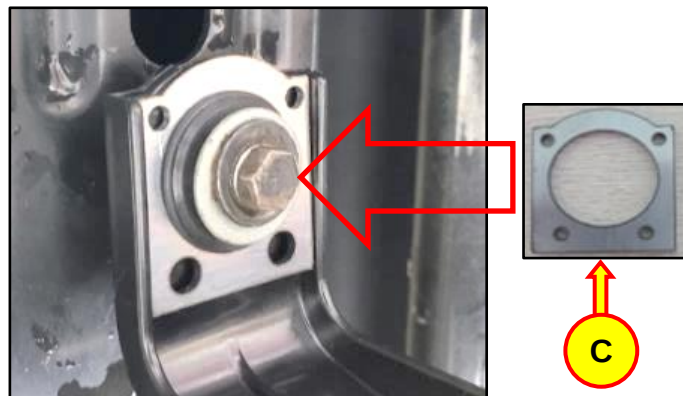
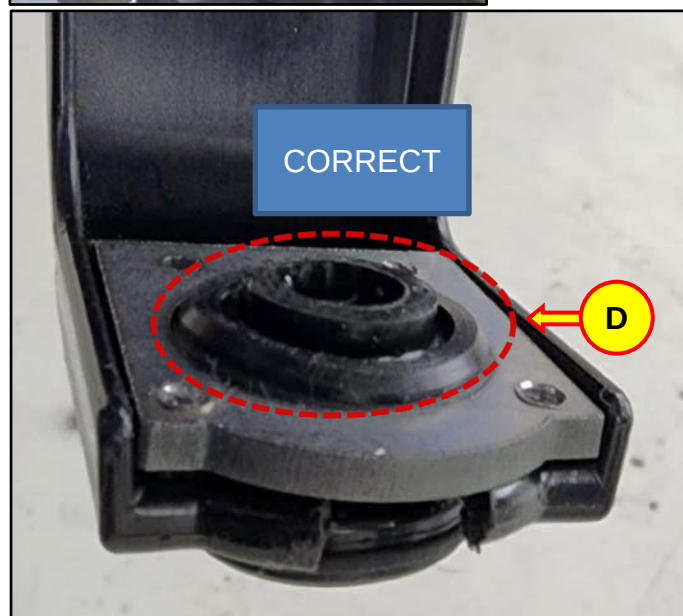
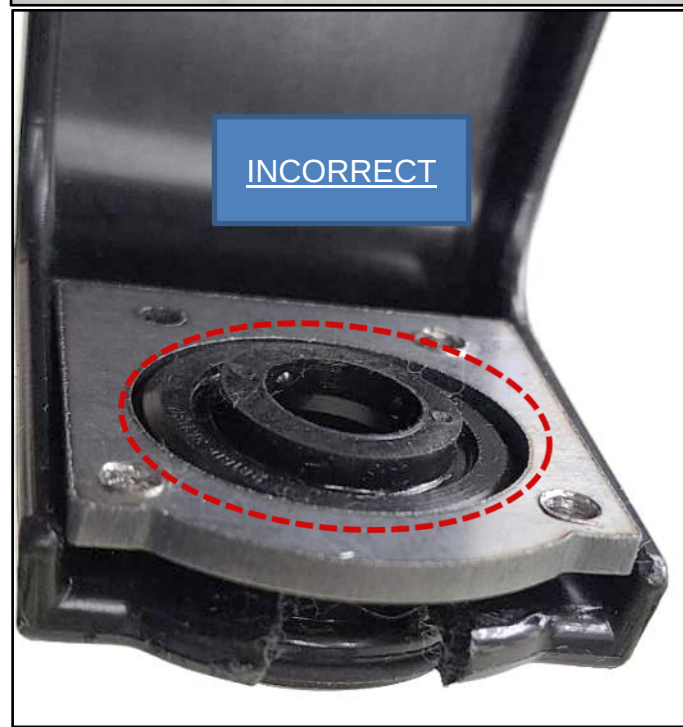
4. Install the steel plate (C) onto the tailpipe fixing bracket.

- When inserting the steel plate, make sure the insulator (D) protrudes out of the steel plate.

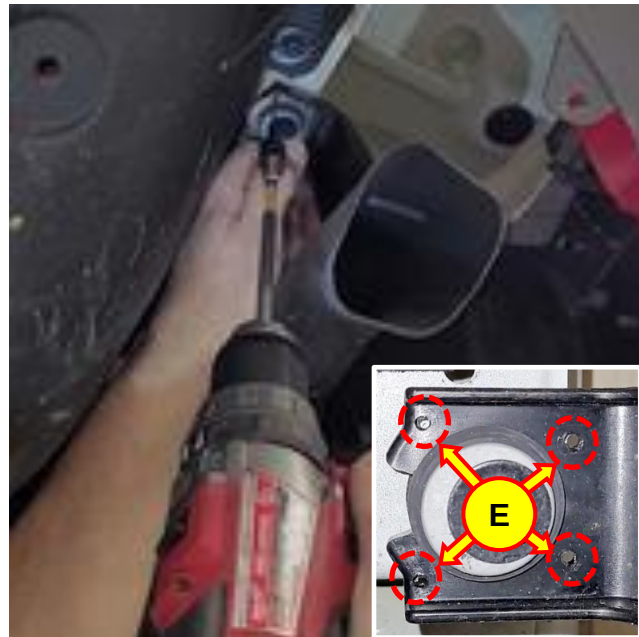
5. While holding the supplied steel plate in proper position on the exhaust bracket, use a brushless drill motor and drill a 3/32" hole in the plastic exhaust bracket at each of the four (4) screw mounting locations (E)

A 3/32" drill bit is preferred, do not use a drill bit larger than 3mm.

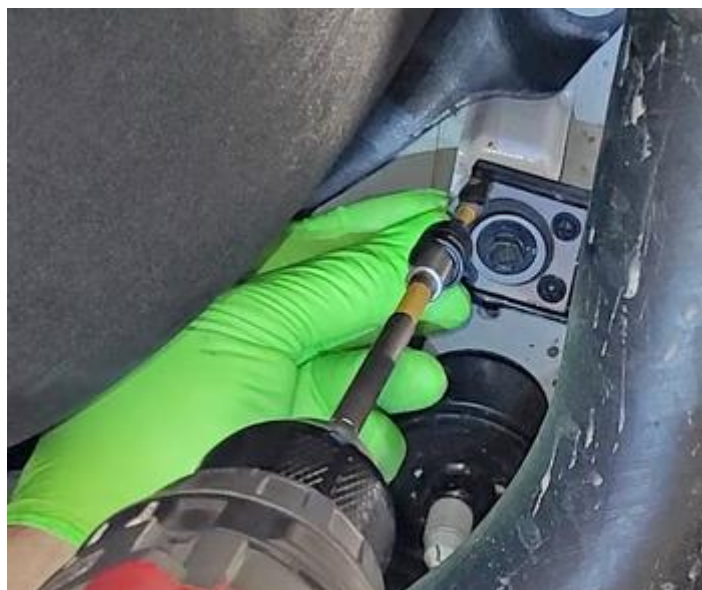
6. While holding the steel plate flat against the exhaust bracket, use a brushless drill motor and install the four supplied screws into the steel plate.

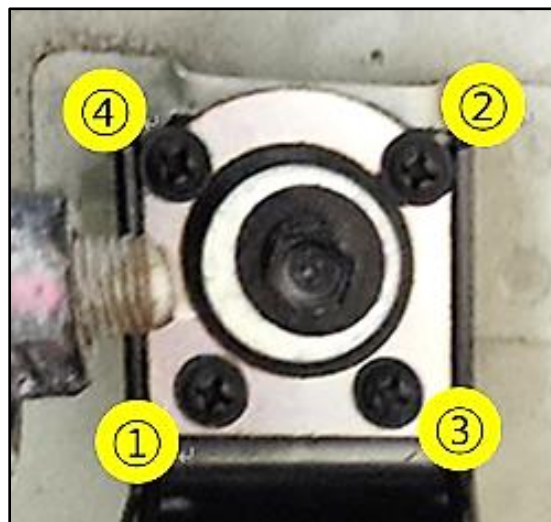
7. Follow the sequence indicated in the photo when installing the screws.

Fasten the screws in the order indicated in the image.

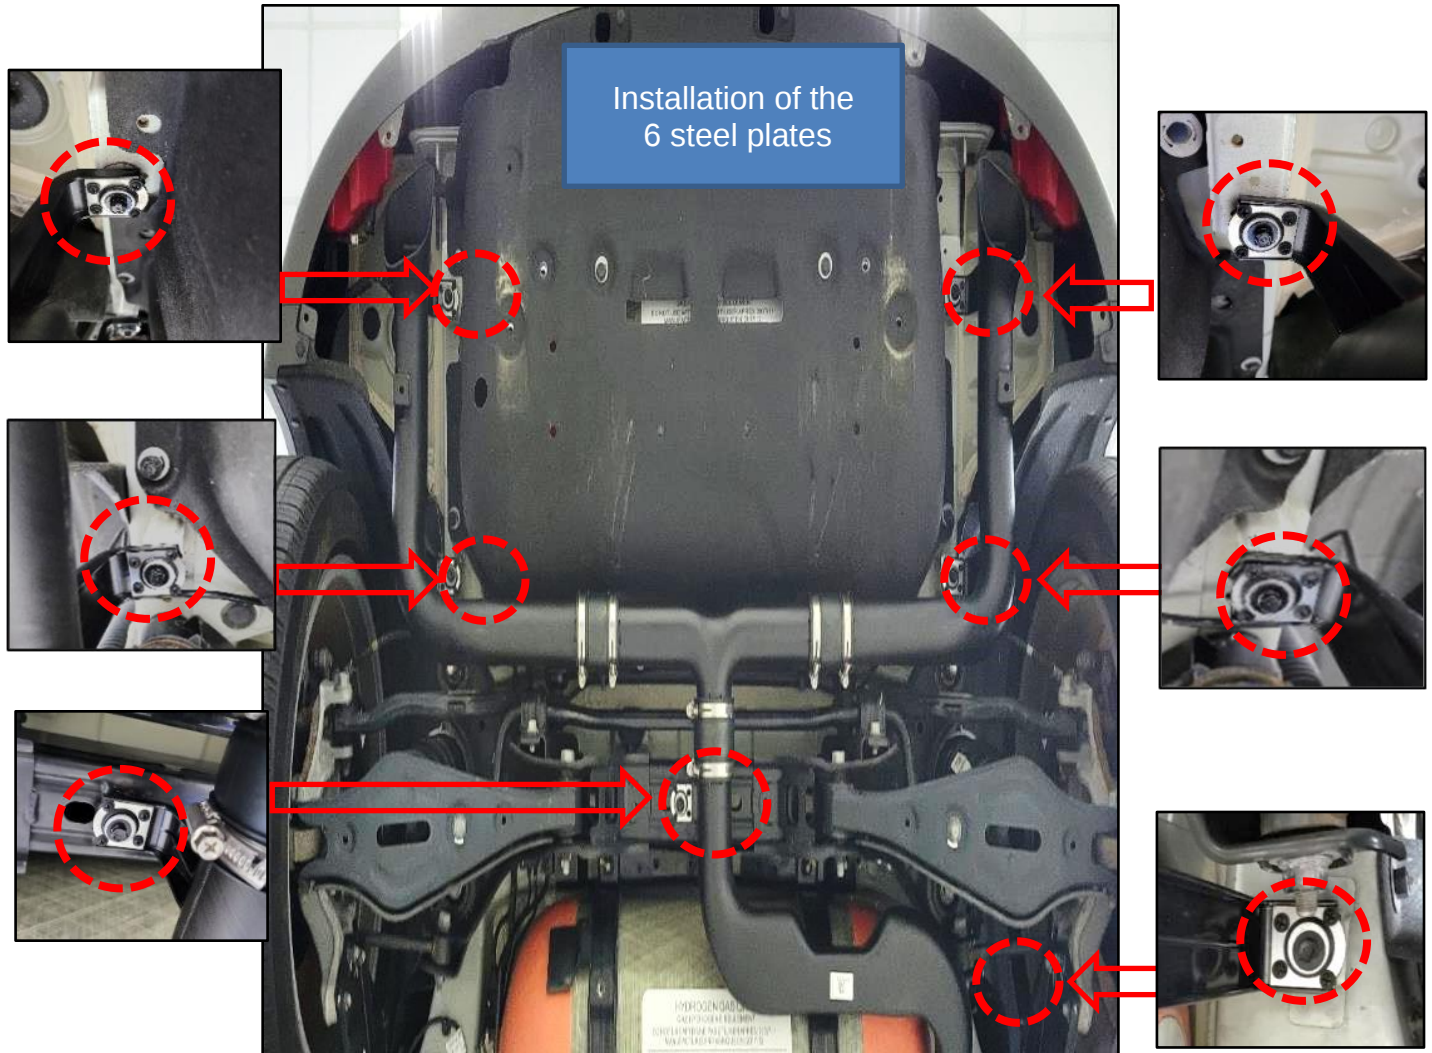
8. Repeat steps five (5) through seven (7) at each of the exhaust bracket locations identified in the photos below.

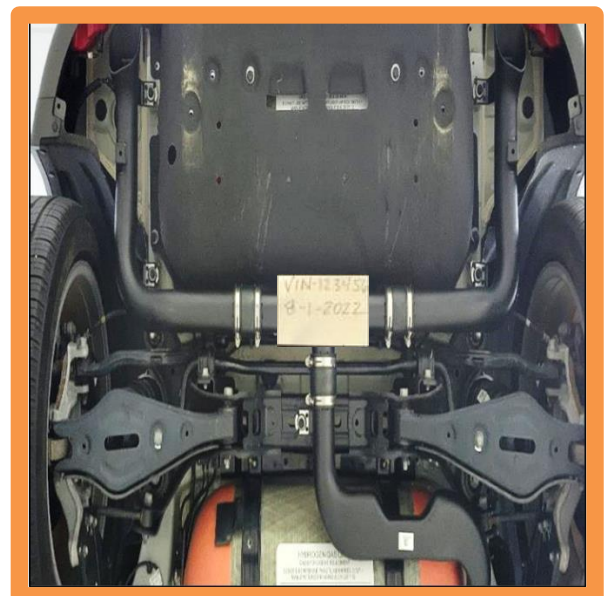
9. After all brackets are installed, use STUI to record a photograph of the installed brackets.

Using STUI, photograph the installed six (6) steel brackets. Include in the photo a piece of paper containing the last six (6) digits of the VIN and date of repair. Ensure the photo is in focus and captures the installed brackets and the note. Upload the photo to STUI.

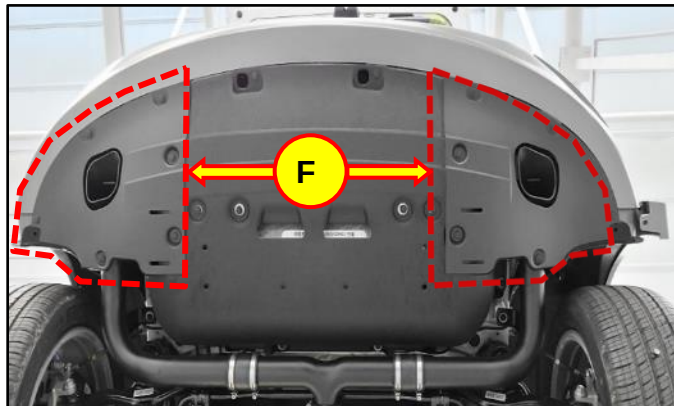
10. Reinstall the LH and RH tailpipe undercovers (F).
