<b>Sent on</b>	04	25	2023	<b>Expires on</b>	06	25	2023
<b>From</b>	Special Tools / Tool & Equipment Program						
<b>Subject</b>	Urgent: Stop Use of Laser Marked Seal Guides for A/C Compressor Seal Install

**TOOL UPDATE NOTICE**

We have identified a potential concern with GUIDE, AC COMP SEAL 07AAG-5AAA100, which was a part of 6CVC SEAL REPLACEMENT KIT, 07AAC-5AAA1Z0 that was recently sent to all Honda dealers.

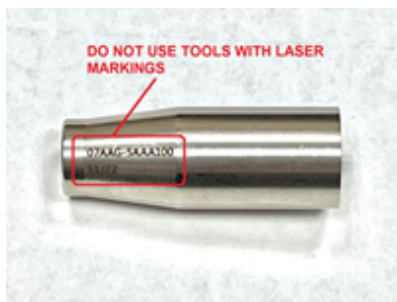
These tools have the tool number and manufacture date laser marked on a critical surface that may contact the new A/C compressor seal during installation. The added roughness of the laser markings may cause damage to the seal and potentially result in an oil and/or refrigerant leak.

**DO NOT USE these laser marked seal guides.**

A replacement seal guide without laser markings will be shipped to your dealership shortly. The Service Bulletins will be put on hold until the replacement seal guides arrive at dealerships.

Please remove the marked seal guide from the Special Service Tool Cabinet and surrender it to your Service Manager. These seal guides will need to be shipped back to AHM using an included prepaid shipping envelope, when the replacement guides arrive.
