Service Bulletin

Subject: Underbody Component Corrosion

Models: 2023 and Prior GM Passenger Cars and Trucks (Excluding Medium Duty Low Cab Forward)

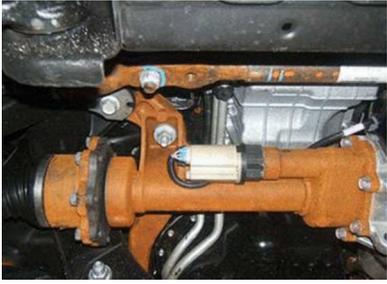
Front axle housing

No repair or consideration should be given for this condition. Surface corrosion on unprotected components will vary with age and exposure. Corrosion on these components has no detrimental impacts, either in short or long term durability.

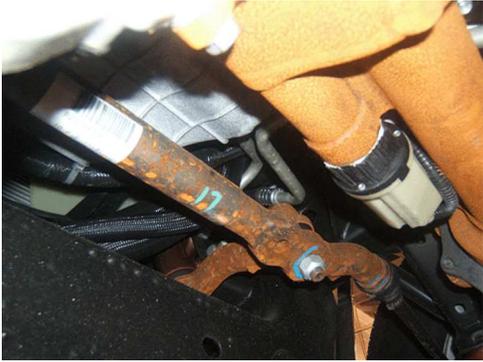
Steering linkage

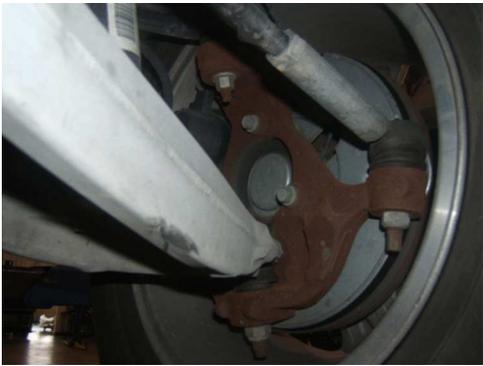
Steering knuckle

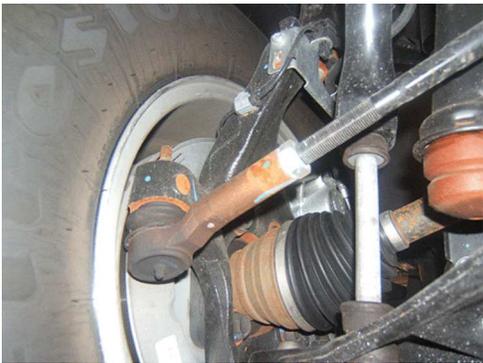
Tie rod end

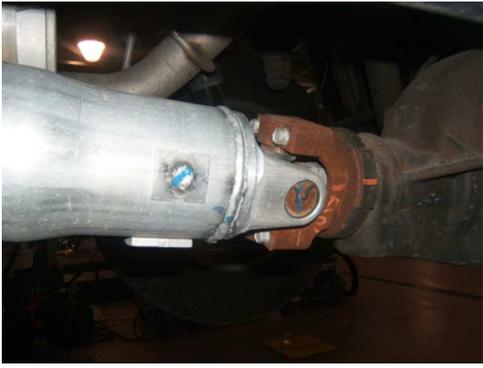
Propshaft yoke

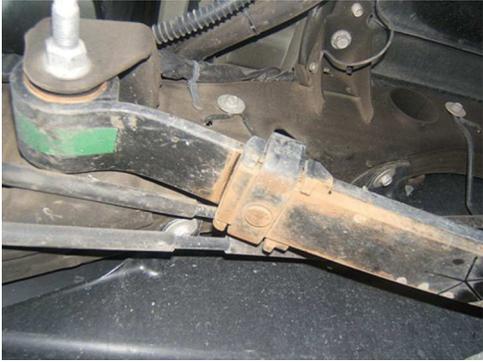
Leaf spring

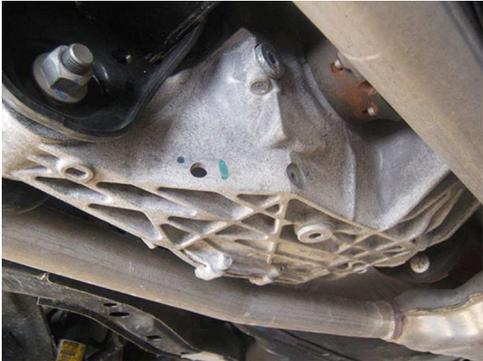
Rear differential housing

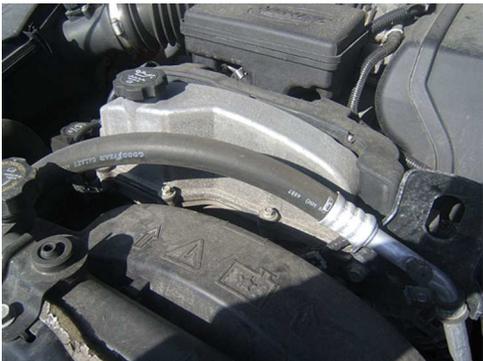
Under hood components

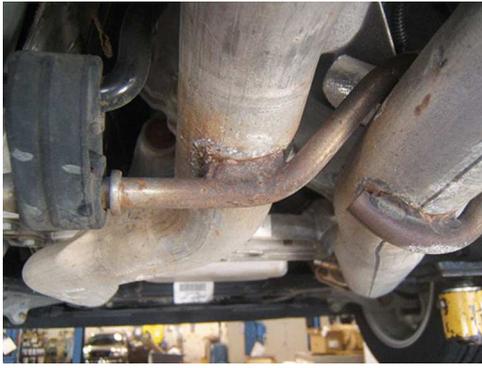
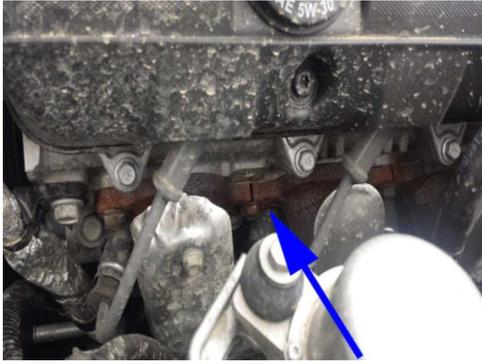
Exhaust system components

Note: During transit between the plant and the dealer, some of the exhaust system components may corrode as a result of salt exposure. These exhaust parts are made of a bare mild-grade stainless steel that will oxidize, or appear rusty. Over time, these components will have a uniform rust-like discoloration, which should be considered a normal condition.
