| <b>Tesla, Inc.</b><br>Service Bulletin | | <b>Reseal Trunk Lid to Prevent Water Ingress</b> | |
| <b>SB-23-10-002</b><br>April 17, 2023 | <b>R1</b> | | |

On some Model 3 vehicles, water may have leaked inside the trunk area through the trunk lid.

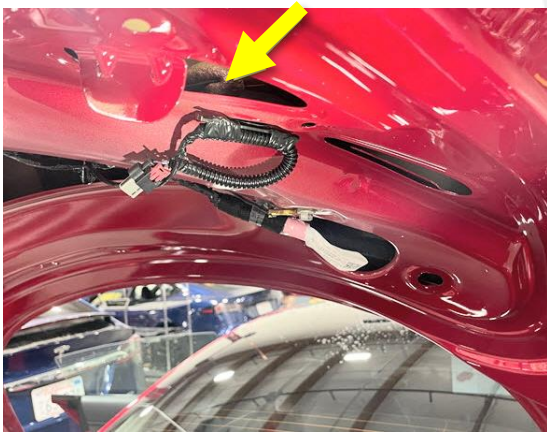
Figure 2 – LH factory foam inside trunk lid; RH similar

1. Remove the trunk lid trim (refer to Service Manual procedure [15111902](#)).
2. Remove the LH and RH rear fog/reverse lights (refer to Service Manual procedure [17402702](#)).
3. Remove and discard the factory foams (x2) (Figures 1–4) located under the LH and RH lamp can panels inside the trunk lid.

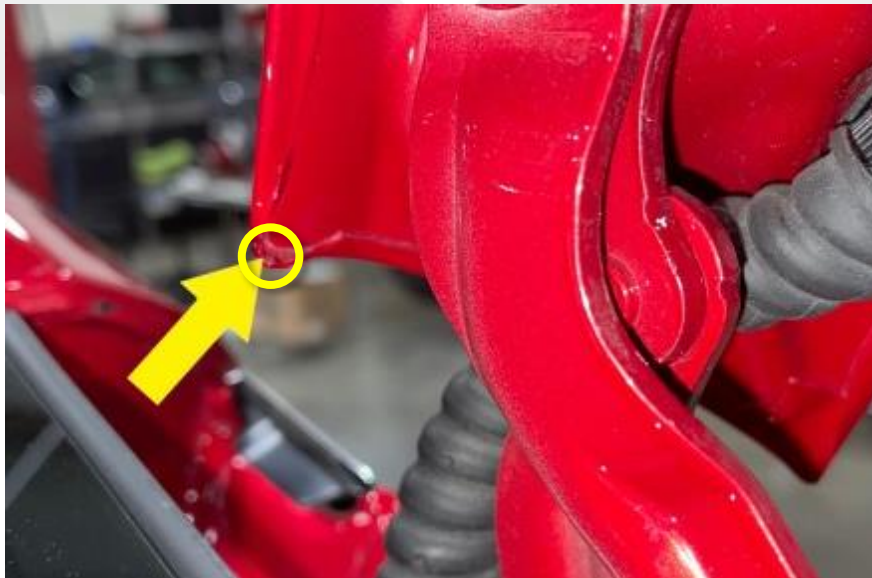
Figure 24 – Example of pin hole

8. Inspect the trunk lid seams: Locate openings and pin holes in the highlighted areas (Figures 22–27).

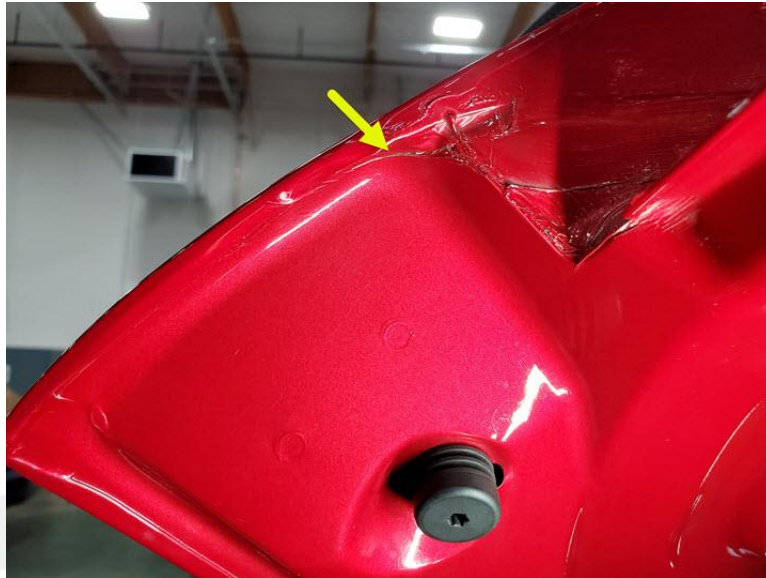
Figure 26 – Example of trunk lid seam
