Slide out bulb seal and schwintek slide out motor

Bulletin Type:	TSB	Publication Date:	May 2023
Bulletin #(s):	23-100	Make(s):	Starcraft
Job Code(s):	9802518	Model(s):	Super Lite TT
Flat Rate(s):	0.50 Hr. Labor – Bulb Seal and Schwintek Motor Repair	Model Year(s):	2023

Incident:	Slide-out Water Leak
Affected Units:	2023 Starcraft Super Lite TT
Parts Kit:	Parts Kit #: 23-100
	1 - SEAL,BULB EXT 1.20 BLK D-SEAL SLIDE-IN MOTOR,SLO IN-WALL H TRQ
	1 - 500:1 LIPPERTS/SCHWINTEK
	1 - SEALANT,GEOCEL CLR 2300 VBS
Misc. Tools & Supplies:	Drill Bit
Parts Return Information:	N/A

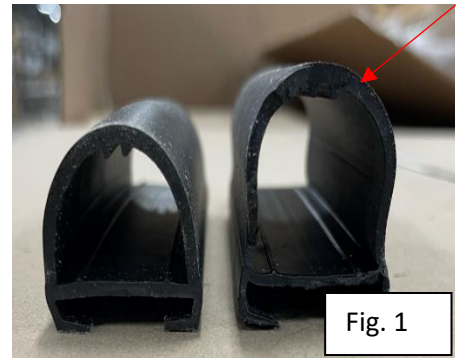
Fig. 1

1. Proceed with the installation instruction if the larger bulb seal on the outside slide-out as shown by the red arrow in figure 1 is not present.
