Thor Motor Coach Technical Service Bulletin

TSB #	TSB 23-02		
Description/Title:	Optional replacement of side-facing seatbelts to shorter belts		
Affected Product Line(s):	Certain model year Sequence 20J, Dazzle 2JB, Twist 2JB, Palladium 1920, Tranquility 19L & 19LT, Talavera 1920, Tellaro 20J, Sanctuary 19L & 19LT, Fraserway Dazzle 2JB, Fraserway Twist 2JB, Rize 18M, Scope 18M		
Service Campaign #:	RC000295	Released Date:	
Codes:	Inspect with Repair: TMCTS80280W	Document Date:	5/1/2023
Time Allowed:	Inspect with Repair: .3 per set of seatbelts	Document Revision:	A

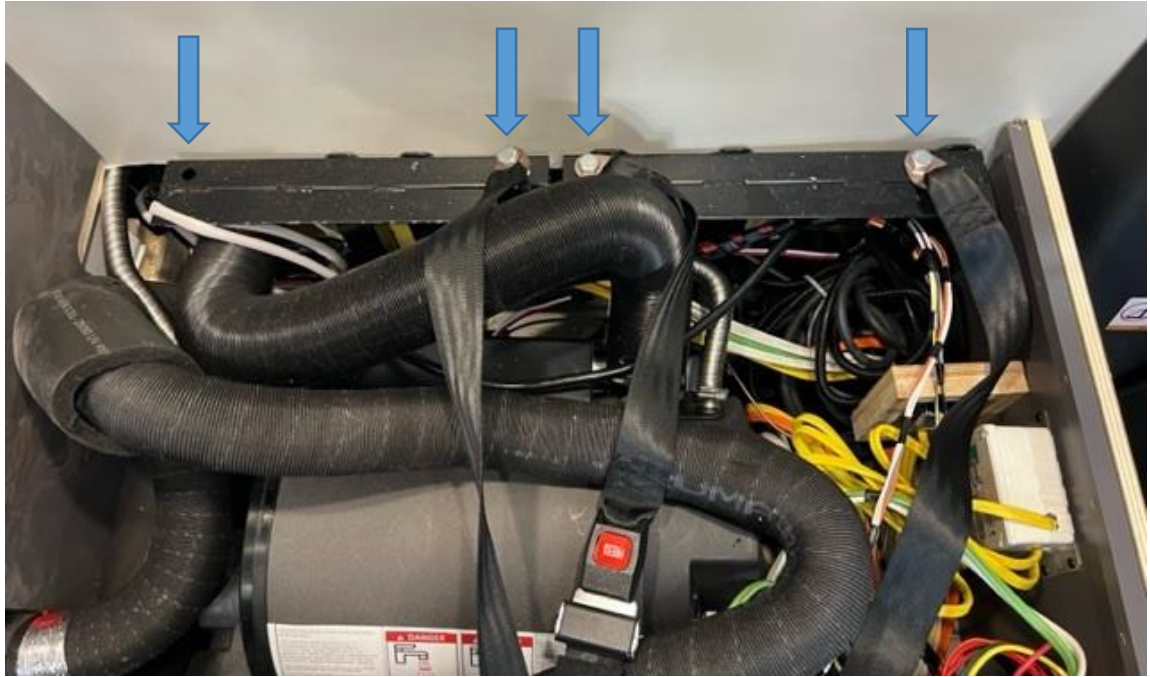
6. Arrows in picture above show the location of the bolt for the seatbelts under the seat base and one bolt and washer/nut removed on the far left.
7. Below picture shows the correct orientation for the seatbelt bracket and proper installation of the bolt, washer/nut.

1. Remove the cushions and take the seat base off using a screw gun.
2. Use ratchet and 3/4" socket with a 3/4" wrench to remove the bolt & washer/nut from each side of the seat belt.
3. Install new seatbelt tightening the washer/nut and bolt down hand tight. Torque the nut and bolt down to 30 +/- 5 FT-LBS.
4. Repeat this process for each additional seatbelt being replaced.
5. Reinstall the seat base and cushions. Throw away the seatbelts that were removed.
