Subject: N222385510 - Special Coverage
Front Exhaust Pipe

Models: 2021 Buick Enclave
2021 Chevrolet Traverse

Special Coverage

N222385510 Front Exhaust Pipe

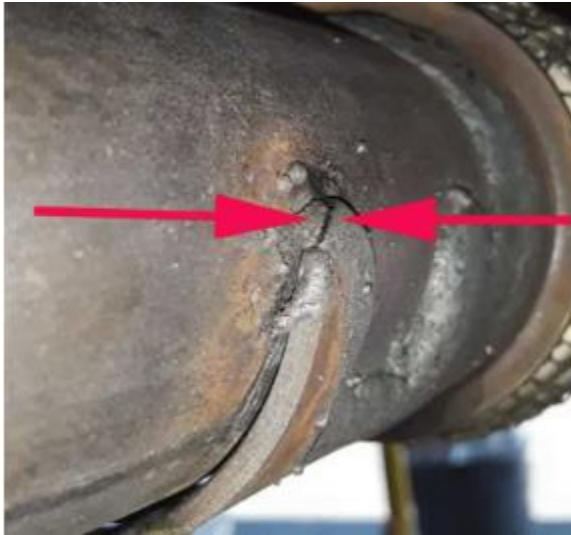
5414377

2. Inspect the front exhaust pipe (the one that has the flex section built in) for damaged, cracked, or broken welds as shown in the photos above.
 - If no damage is found, no further action is required.
 - If damage is found, replace the damaged exhaust section. Refer to *Exhaust Front Pipe Replacement* in SI.

Correction	Dealers are to replace the front exhaust pipe as necessary. The repairs will be made at no charge to the customer.
