GROUP	MODEL
Voluntary Service Campaign	2012-2017MY Rio (UB) 2017-2018MY Forte (YD/YDm)
NUMBER	DATE
SC264	May 2023

## APPLICATION OF ADDITIONAL ANTI-CORROSION MATERIAL (SC264)

This bulletin provides information to apply additional anti-corrosion material to the underbody components on certain 2012-2017MY Rio (UB) and 2017-2018MY Forte (YD/YDm) vehicles produced within the date ranges shown below and originally sold or currently registered in one of the 28 states where heavy amounts of road salt are used. The 28 states where heavy amounts of road salt are used are: AK, CT, DC, DE, IA, IL, IN, KS, KY, MA, MD, ME, MI, MN, MO, ND, NE, NH, NJ, NY, OH, PA, RI, SD, UT, VT, WI and WV.

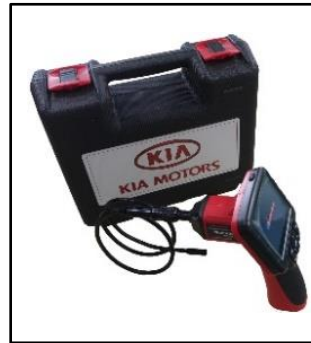
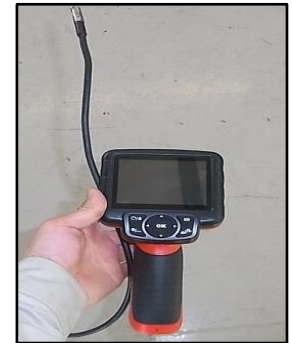
- After applying cavity wax to components, use the borescope (1K545 4D200QQK) to check for proper wax coating through the component service holes.

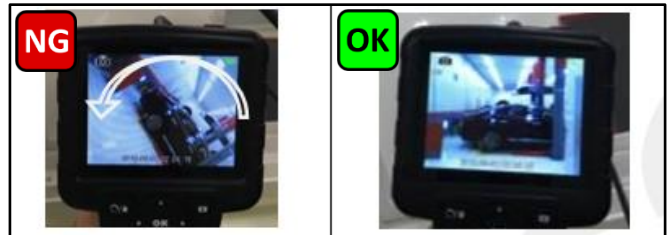
- Power up and calibrate the display orientation direction by gripping the probe and turning as required. (Apply and align the 90-degree angle adapter, as needed, for picture quality.)

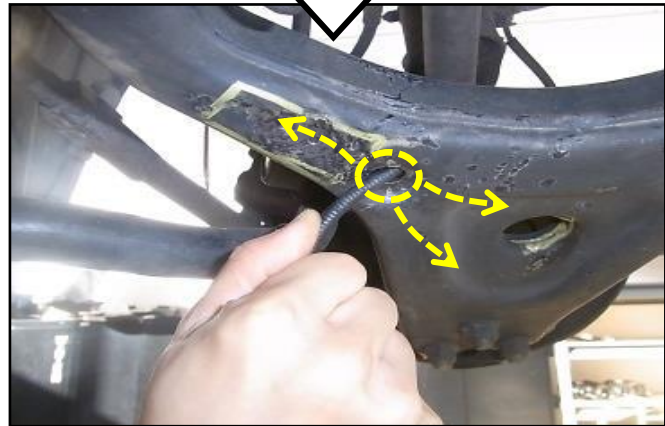
7. Rotate the camera in order to check all angles for proper wax application inside the inspected components, and to obtain your images that will be used for warranty claim submission.

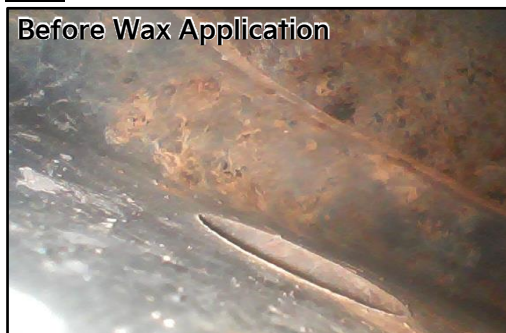
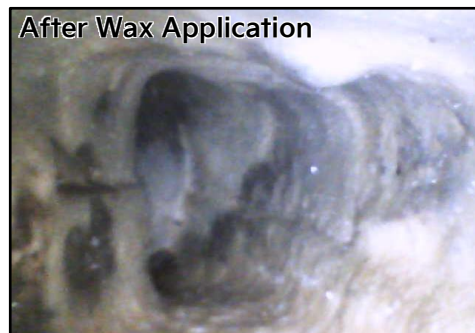
**Note:** See examples below of "before" and "after" wax application.

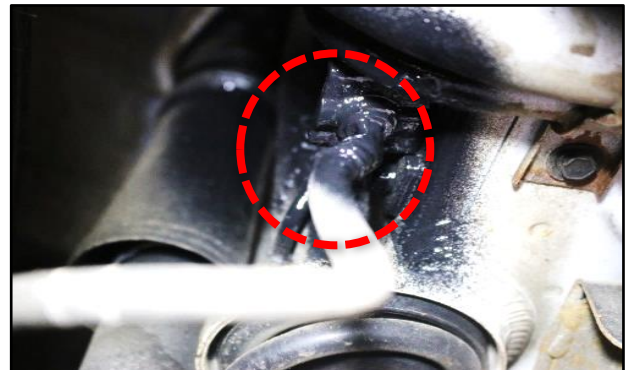
3. Be sure to completely coat the four (4) brake hose anchor clips on both sides, front and rear of the vehicle.
