STAR ONLINE PUBLICATION

Case Number: S2324000007

Symptom/Vehicle Issue: Customer Indicates Low Air Flow Coming From Rear Vents.

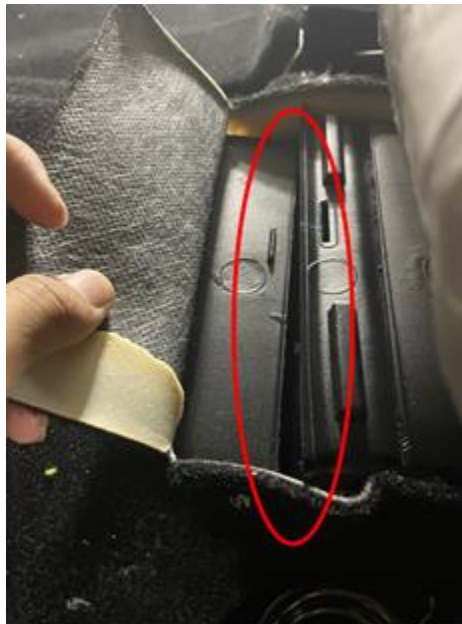
Customer Complaint/Technician Observation: Upon inspection it can be found that the rear center console vents have minimal air flow. Verify vents are fully opened, if vents are opened and low air flow is found further inspection is necessary.

Discussion: Remove the center console and inspect the rear air duct to ensure proper connection is made. If it is found that the air ducts under the console are misaligned (see below), connect the two ducts and ensure they are properly seated into each other. Reassemble the vehicle and retest for proper operation.
