<b>REFERENCE:</b>	TSB: 07-001-23 REV. A GROUP 07 - Cooling	<b>Date:</b>	April 4, 2023	<b>REVISION:</b>	07-001-23
<b>VEHICLES AFFECTED:</b>	2022 - 2023 (M1) Jeep Compass 2022 - 2023 (H1) Jeep Commander This bulletin applies to vehicles built on or after May 3, 2022 (MDH0503XX) and on and before November 7, 2022 (MDH1107XX) equipped with the 2.0L I4 Turbo Diesel Engine (Sales Code EBT).	<b>MARKET APPLICABILITY:</b>			
		<input type="checkbox"/> NA		<input type="checkbox"/> MEA	
		<input checked="" type="checkbox"/> SA		<input type="checkbox"/> IAP	
		<input type="checkbox"/> EE		<input type="checkbox"/> CH	
<b>CUSTOMER SYMPTOM:</b>	Possible overheat light on instrument cluster. Coolant leak from hose that contacts exhaust heat shield.				
<b>CAUSE:</b>	Coolant hose not secured in its retainer.

This bulletin involves repositioning or possibly replacing an engine coolant hose that may contact the exhaust manifold heat shield.

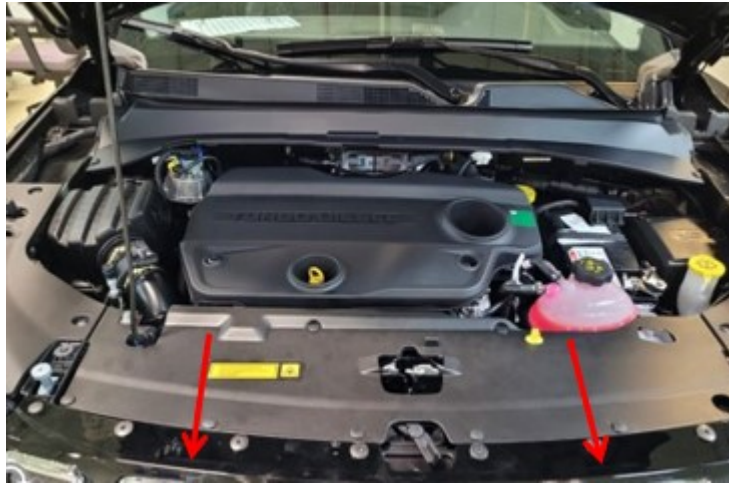
**Fig. 1**  
**Radiator Close Out Panel**

1. Open the hood and remove the radiator close out panel (Fig. 1) .

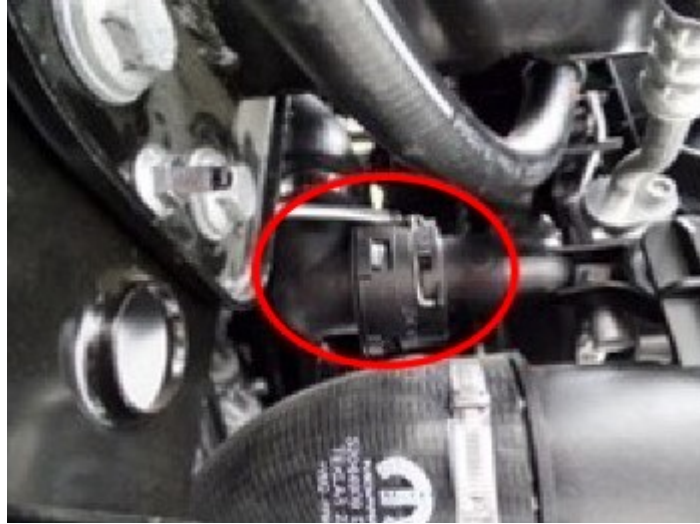
**Fig. 5****Quick Disconnect At Radiator**

1. Replace hose:
  - a. Remove engine belly pan. Refer to the detailed service procedures listed in DealerCONNECT>Service Library under: 13 - Frame and Bumpers / Under Body Protection / Belly Pan / Removal
  - b. Drain cooling system. Refer to the detailed service procedures listed in DealerCONNECT>Service Library under: 07 - Cooling / Standard Procedure.
  - c. Disconnect lower radiator hose quick disconnect at radiator. (Fig. 5) .

- g. Remove hose assembly.
2. Install new hose assembly.
- a. Install hose into hose retainers.
  - b. Connect lower radiator hose clamp at engine.
  - c. Connect lower radiator hose quick disconnect at radiator.
  - d. Connect quick disconnect at lower coolant reservoir.
  - e. Refill cooling system. Refer to the detailed service procedures listed in DealerCONNECT>Service Library under: 07 - Cooling / Standard Procedure.
  - f. Install engine belly pan. Refer to the detailed service procedures listed in DealerCONNECT>Service Library under: 13 - Frame and Bumpers / Under Body Protection / Belly Pan / Installation

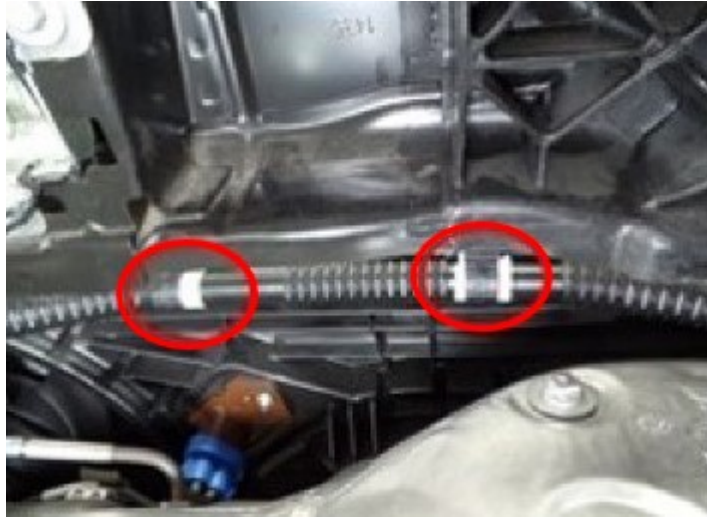
**Fig. 7**  
**Hose At Retainers**

- e. Remove hose from hose retainers. (Fig. 7)
