Technical product information

Topic	High pitched whistle from the engine - Warning light within the DIP - Engine not running smoothly - Numerous DTC's
Market area	Bentley: worldwide (2WBE)
Brand	Bentley
Transaction No.	2059379/4
Level	EH
Status	Approval
Release date

High pitched whistle from the engine - Warning light within the DIP - Engine not running smoothly - Numerous DTC's

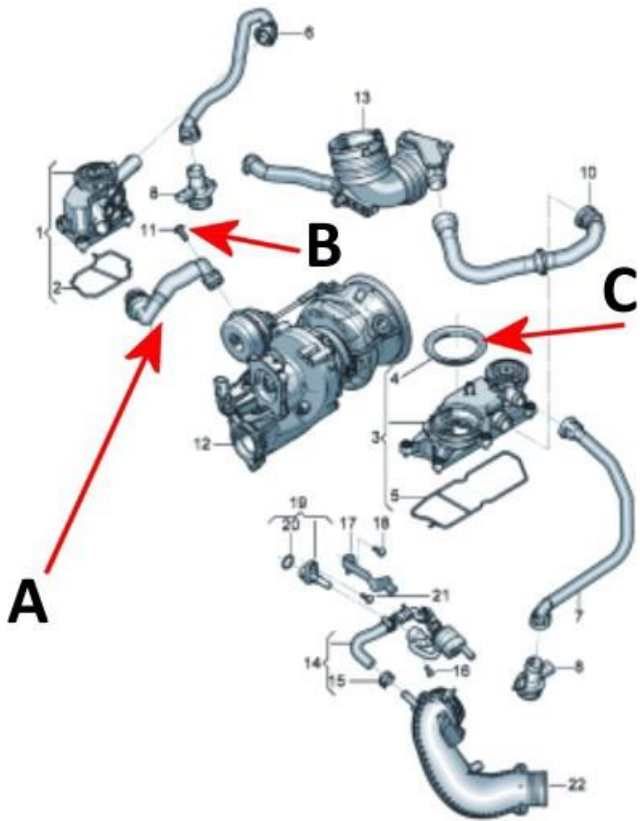
2) Referring to Figure 2 - Replace the Bank 1 breather line (Point A) and fixing (Point B) – Refer to applicable sections from Rep.Gr 10 - Oil mist separator bank 1 - To remove and fit

- Replace the oil filler pipe seal to the Bank 2 oil separator (Point C)

Air intake leak due to a broken one-way diaphragm valve from within the Bank 1 breather line

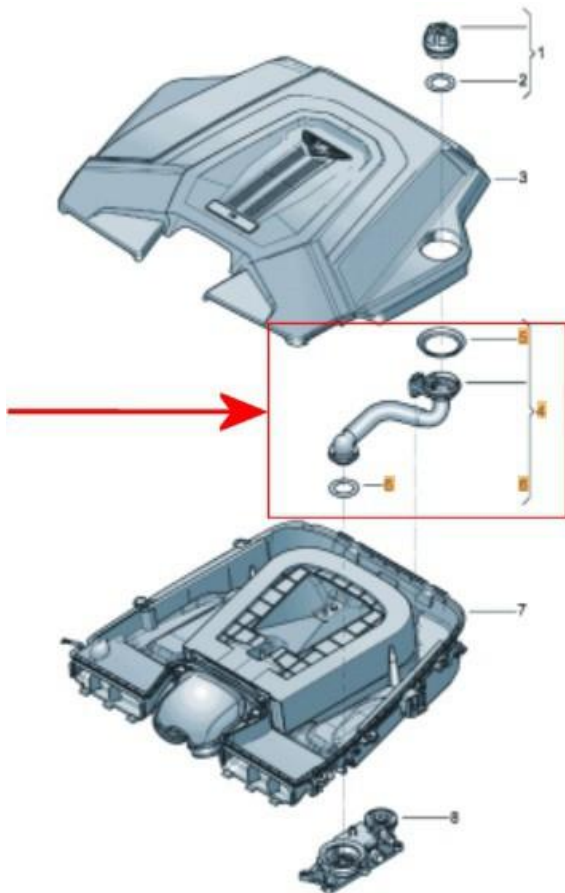
Figure 3

Replace the oil filler pipe including all seals (Figure 3) – Refer to applicable sections from Rep.Gr 10 - Oil mist separator bank 2 - To remove and fit
