### 93 Electric drive motor/power electronics condensation inside cover

93 23 07 2070348/1 May 16, 2023.

Model(s)	Year	VIN Range	Vehicle-Specific Equipment
e-tron quattro	2019 – 2023		
e-tron Sportback quattro	2020 – 2023	All	Not Applicable
e-tron s quattro	2022 – 2023

# **Technical Service Bulletin**

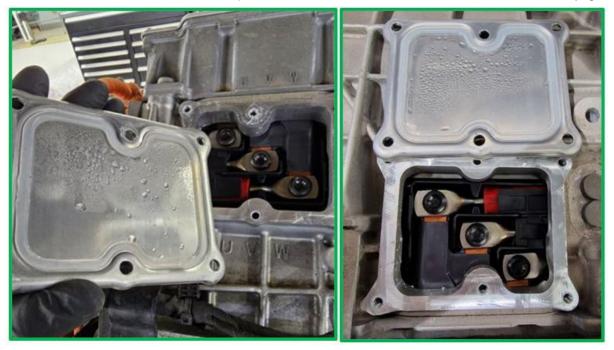
Condensation is found on the cover for power electronics connections in the electric drive motor (Figure 1).

Figure 1. Condensation on the cover of power electronics connections.

The condensation appears due to temperature differences and humidity. If the concern is only condensation, this will not lead to further issues.

Do not perform additional repairs if water condensation is detected on the inside of the cover for power electronics connection to the motor.

It is important to check that there is no coolant in the area around the bolts. If there is coolant in the connection area this TSB does not apply and this condition will require diagnosis.
