May 19, 2023

Warranty Extension: 2016-2021 Civic A/C Compressor Shaft Seal Leak (1.5T, 2.0, 2.0T)

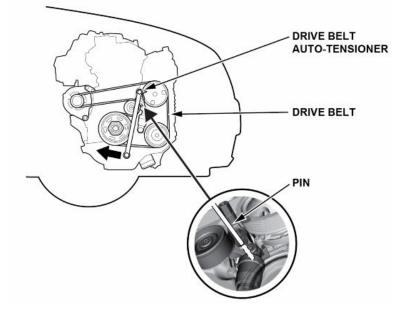
Inspect for oil on the clutch area of the compressor while in the on-car position.
NOTE: If oil is stuck to the clutch area of the compressor, then proceed to the repair procedure. Inspect for oil.

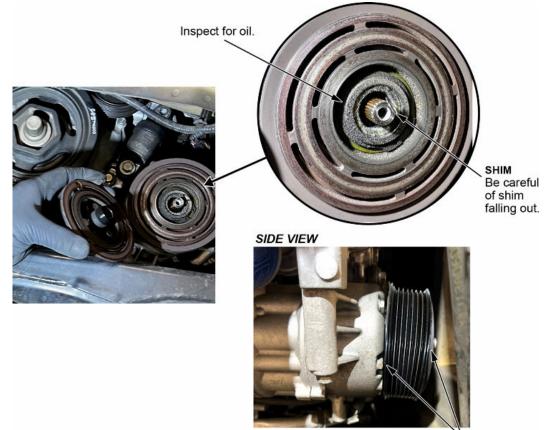
- If oil is present on the hub/armature plate, then proceed to the repair procedure.
- If no oil is present, then proceed to step 6.

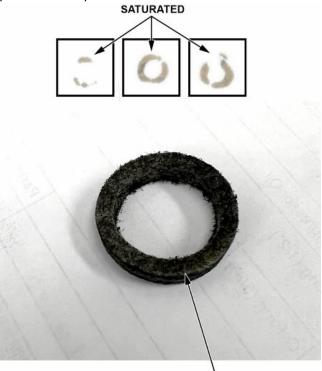
Observe for excess oil.

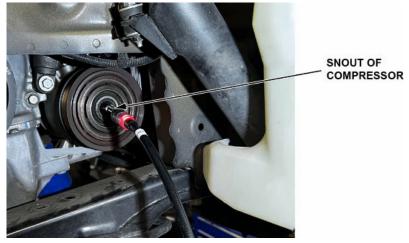
If no oil or leak is found, reassemble the hub/armature plate with the original bolt and torque to (17 N·m or 13 lb-ft).
If this is a second time and no leak is found, reassemble the hub/armature plate with a new bolt and torque to (17 N·m or 13 lb-ft).

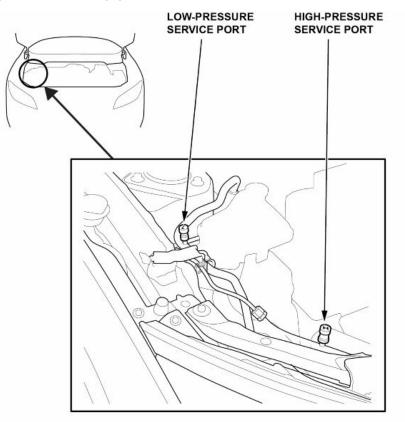
2. Recover the A/C refrigerant.

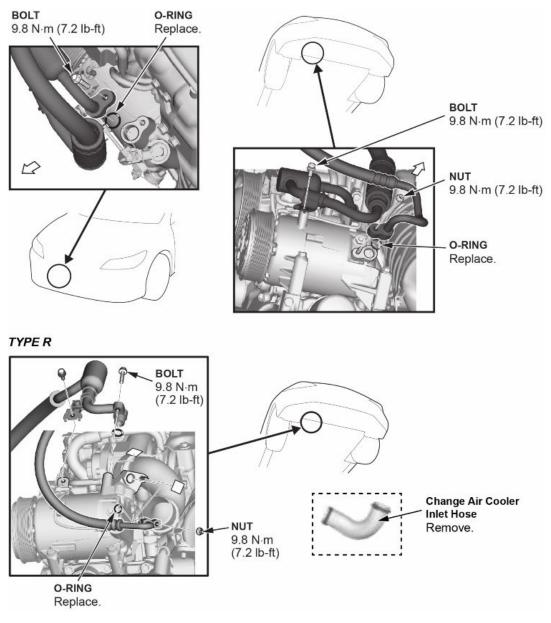
4. Remove the A/C compressor.

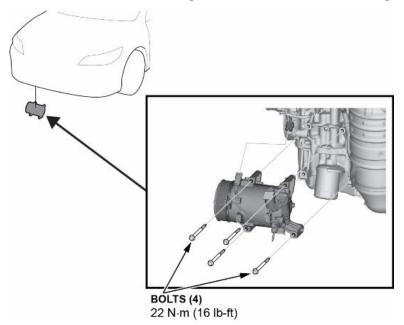
If not already removed, remove the clutch center flange bolt (10 mm), tightened at 17 N·m (13 lb-ft).
NOTE: Make sure to wear proper PPE before continuing with the repair procedure.

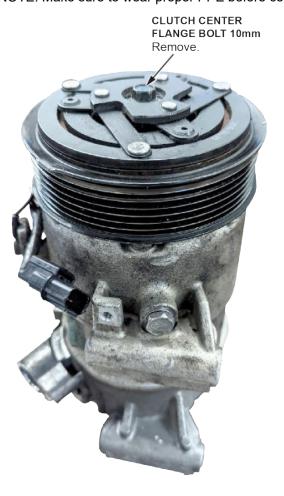
6. If not already removed, remove the clutch, carefully, to not drop/lose any shims (usually 1–2 shims).

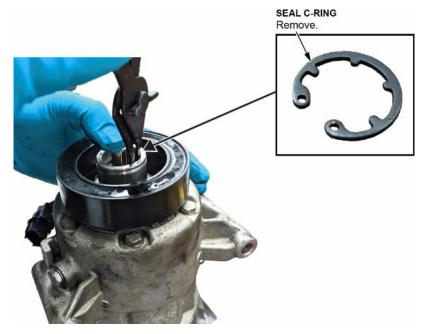
11. Thoroughly clean the bore and shaft with a lint free cloth.

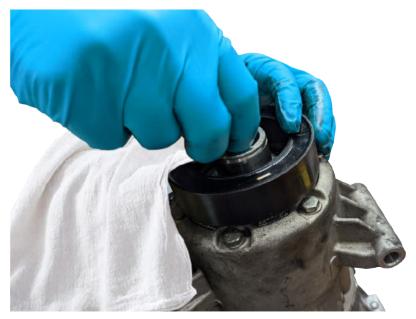
12. Remove the side bracket.

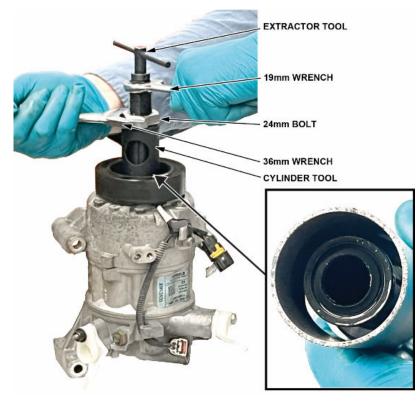
23. Thoroughly clean the bore and shaft with a lint free cloth.

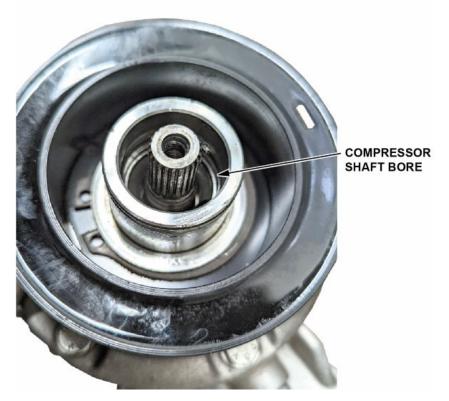
- 24. Inspect the compressor shaft bore for visible damage; Inspect the seal guide for contamination or damage.
- 25. Lubricate the new seal outer surface, seal guide, and bore with new POE compressor oil.

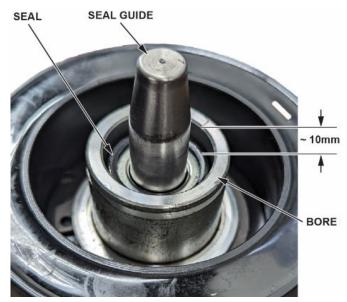
- 33. Remove the press and the adapter tool when successfully completed.
- 34. Clean the pulley and A/C compressor friction surfaces with contact cleaner or another non-petroleum solvent.
