# *TPMS SIGNAL FAULT REPAIR PROCEDURES FORESTER/SUNSEEKER/SOLERA*

The Tire Pressure Monitoring System (TPMS), on some Ford E-450 chassis may experience intermittent loss of signal at one of the wheels and display a fault on the information center of the dashboard.

# REPAIR PROCEDURES

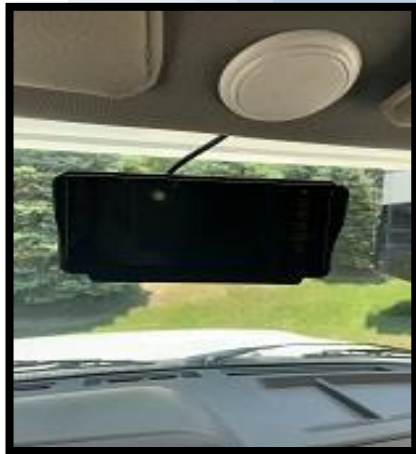
Fig 1

REAR VIEW MONITOR CURRENTLY  
MOUNTED TO THE WINDSHIELD.

The rear-view monitor is Rear View Safety, **Forest River Part # F100290271, RVS Part Number 619NQ**. Figure 1 and 2.

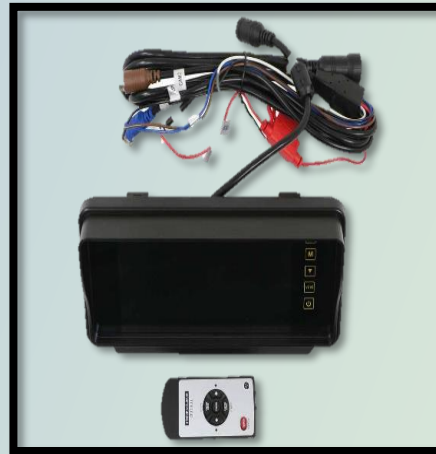
Fig 2

**CAMERA KIT FOREST RIVER PART  
# F100290271 REQUIRED.**

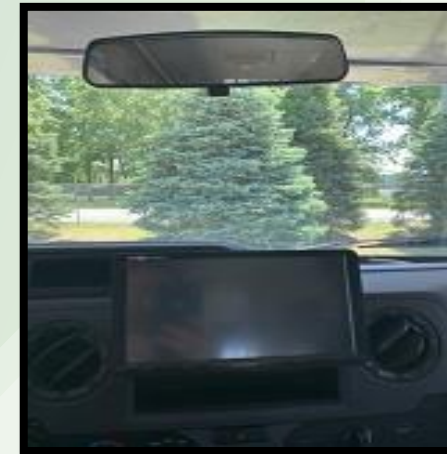
Fig 3

STANDARD REAR VIEW MIRROR  
MOUNTED TO THE WINDSHIELD.

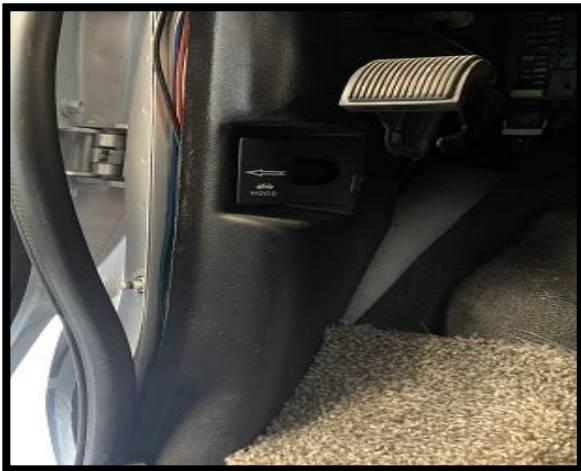
Fig 3

1. The wires that will need to be re-routed are located behind the driver's side left kick panel. Figure 3.
2. Each of the camera wires run from the dashboard down behind the kick panel, under the black plastic step well and are distributed to each camera.
3. Remove the weather stripping from the door and set it aside, (note the position of the stripping).
4. Next remove the lower outer skin from under the dashboard by pulling it straight out and off. These covers are installed using pressure clips. (Use Caution pulling on these clips as they can break). Figure 4.
5. Remove the black inner cover under the dashboard by removing 2 screws and pulling the bottom out. Figure 5.
6. Remove the black step well cover exposing the camera cables. Figure 6.

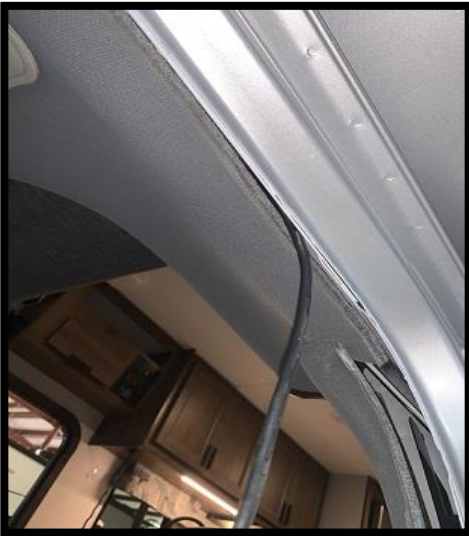
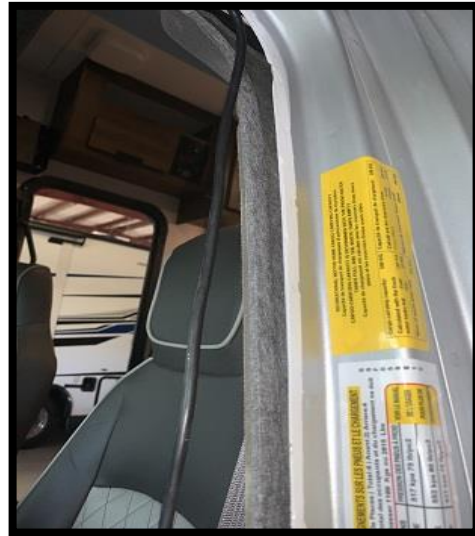
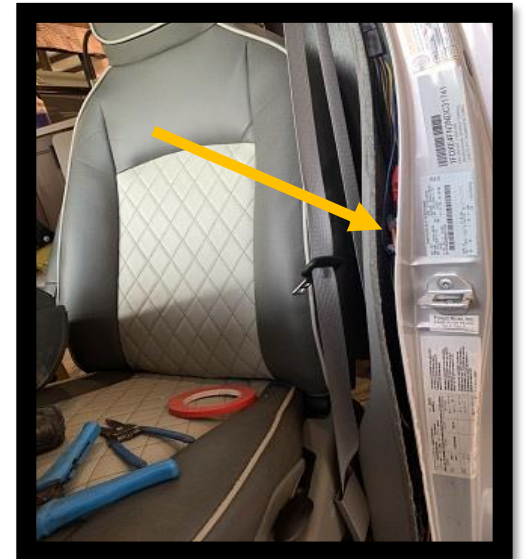
Fig 13

12. Each of the wires will be routed over the top of the driver's door behind the headliner and pillar.
13. There is a factory wiring harness behind the rear pillar that can be used to help secure the re-routed wires. Figure 13.

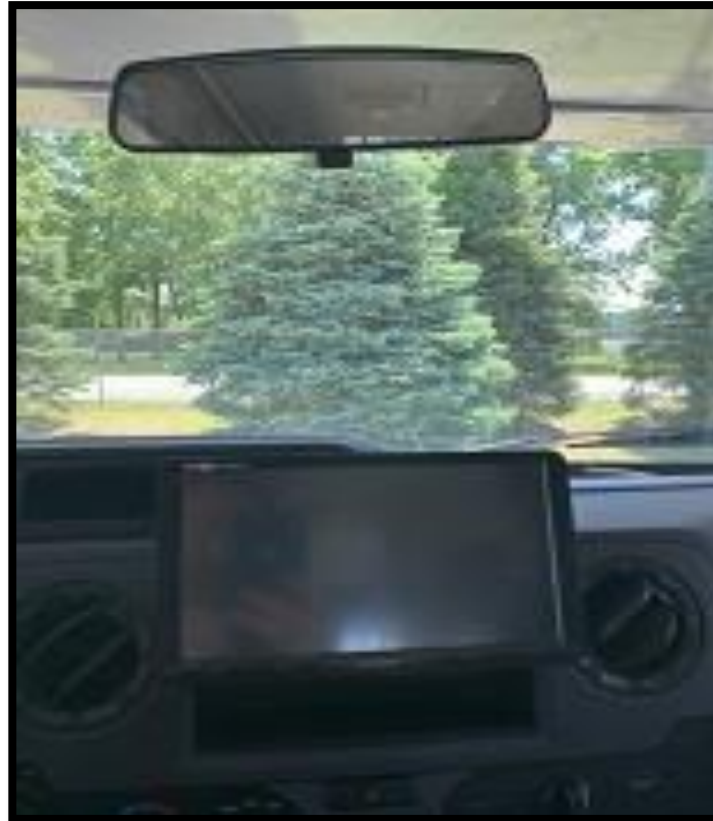
NO MONITOR MOUNTED TO THE WINDSHIELD.

CAMERAS ARE VIEWED THROUGH THE RADIO.

CAMERA KIT FOREST RIVER PART #

F100290271 REQUIRED.

VENDOR PART #RVS-619NQ

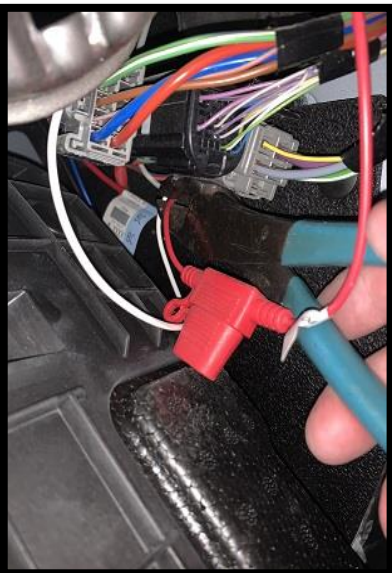
Fig 7

**Note: Remove the keys from the ignition and verify there is no 12-volt power at the fused red wire.** Figure 7.

14. Label and disconnect camera cables and wiring.
15. Remove fuse from holder before cutting red power wire, making sure to cap off open wires. Figure 7.
16. Disconnect the black ground wire. Figure 8.
17. Disconnect the Blue, Yellow, and White wires coming from the multiplex/switcher box at the bell connectors. The yellow and white wires will not be used. The blue wire is the reverse trigger for the rear camera. Figure 9.
18. Remove the camera cables from the multiplex/switcher box. Figure 10, and 11.
19. Disconnect the yellow RCA cable from the multiplex/switcher box cut off the end and secure the wire under the dash as none of these components will be used. Figure 12.

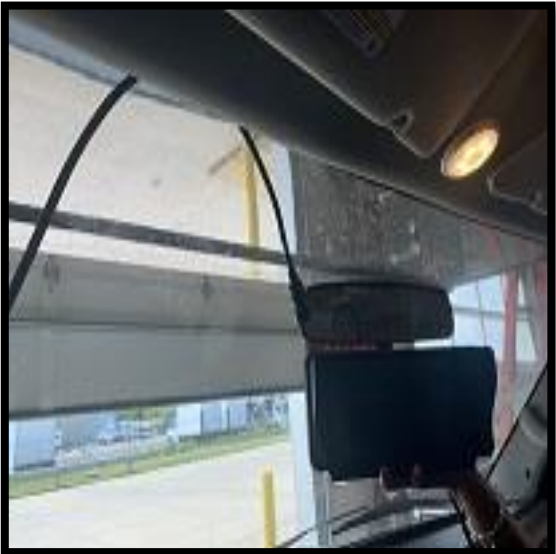
Fig 13

20. Remove the set screw, carefully remove the rear-view mirror and install back-up monitor in its place. Figure 13.
21. Plug in the new harness, to the monitor, there is only one way to plug them together.
22. Carefully pull down the edge of the headliner and tuck the cable behind it. Figure 14
23. Run the cable along the top of the windshield up over the corner post (A-pillar), over the driver's door, and down the rear of the door. Figure 15, and 16.

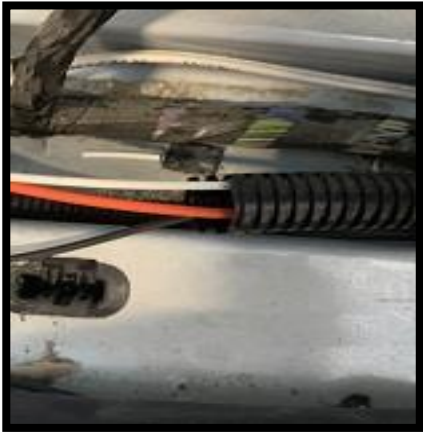
Fig 11

24. Locate the harness under the step well containing the orange, black and white wires. Figure 11.
25. Two wires will have to be extended, the orange wire and the black ground wire at the cable harness that was re-routed.
26. Splice the orange wire extension into the orange power wire located in the 3-wire harness and connect the other end to the red fused power supply for the camera harness. Figure 12 and 13.
27. Re-connect the camera cables in the correct orientation. Channel 2, (blue cable), will be the rear camera. Figure 14.
28. Connect one end the black extension wire to the negative wire at the camera harness, the other end to an eyelet connector and secure it to the chassis under the step well cover.
29. The black wire located in the 3-wire harness with the orange wire will be brought back up and connected to the blue channel 2 wire. This is the reverse trigger wire. Figure 15.

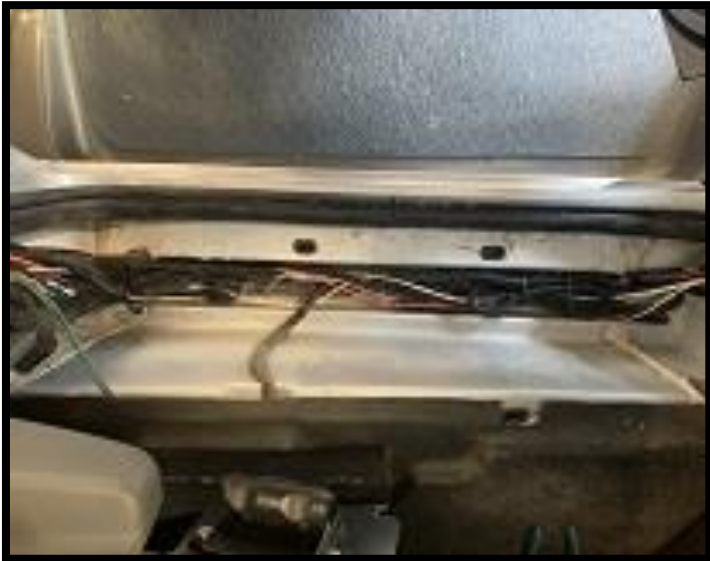
Fig 16

30. Test rear view camera system for proper operation before replacing any covers.
31. Organize all the remaining wiring in the step well to sit in the space and secure carefully with zip ties. Figure 16
32. Re-secure the wiring that was previously removed at the dashboard being careful to keep them out of the out of the way of the plastic covers to be installed.
33. Re-install the black inner cover and gray plastic cover. Figures 17 and 18.
34. Carefully install the door weather stripping and the black step well cover.
