HYUNDAI
Technical Service Bulletin

GROUP BODY	NUMBER 23-BD-009H
DATE MAY, 2023	MODEL(S) TUCSON (NX4A) SANTA CRUZ (NXT)

SUBJECT: FRONT DOOR PULL HANDLE PAINT PEELING

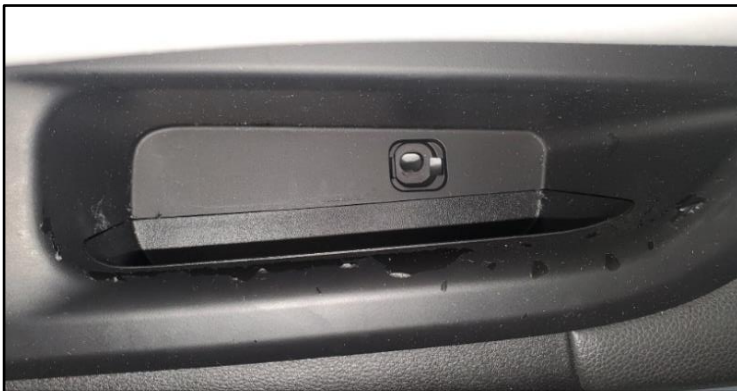
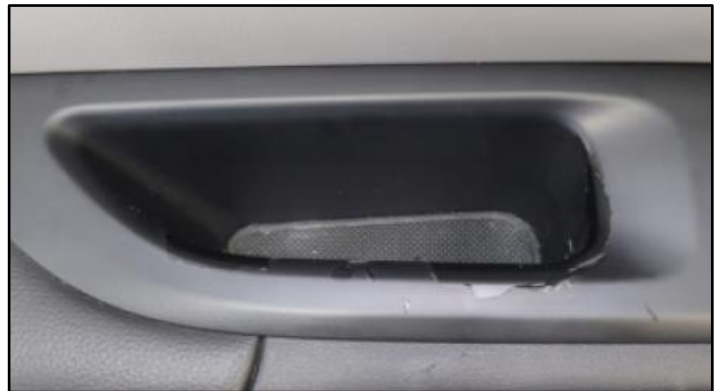
Description: This bulletin provides repair information for a non-glossy front door pull handle that exhibits paint peeling on certain 2022 – 2023MY Tucson (NX4A) and Santa Cruz (NXT) vehicles. If a vehicle exhibits this paint peeling condition, replace the front door trim panel assembly.

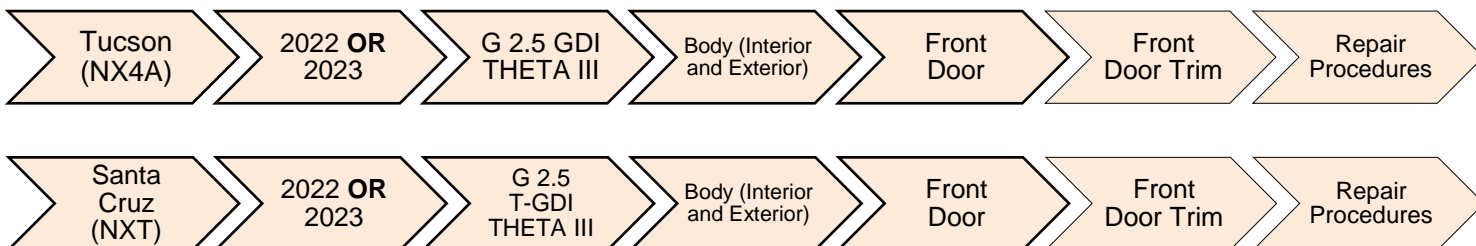
Replacement Guide for the Front Door Trim Panel

Refer to the shop repair procedure to replace the front door trim panel:
