Technical Service Bulletin

GROUP CAMPAIGN	NUMBER 23-01-046H
DATE MAY, 2023	MODEL(S) SANTA FE (TMa)

SUBJECT: ECU/TCU UPDATE - DRIVABILITY (SERVICE CAMPAIGN 981)

DESCRIPTION: This bulletin provides the procedure to update the ECU and TCU software to correct the ROM ID and TCU software to optimize shift quality when accelerating.

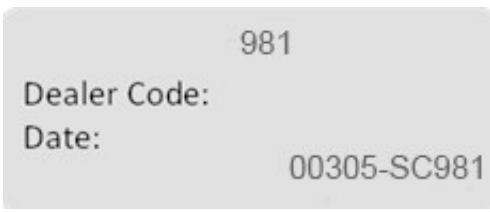
<p>981 Dealer Code: Date: 00305-SC981</p>	Apply to all vehicles regardless of state.
Vehicle Emission Recall - Proof of Correction Card	NP050-09006	1

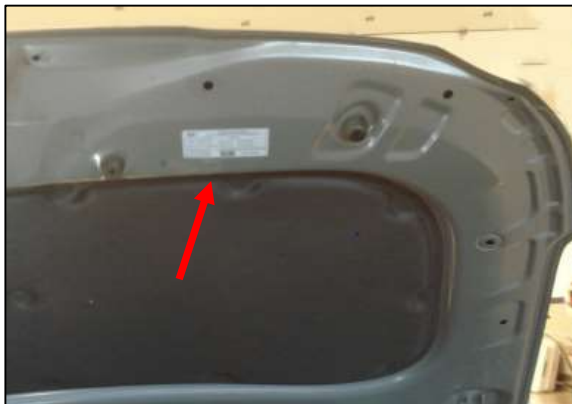
Fill in the information on the 00305-SC981 Campaign Sticker and apply under the existing Emission Label as shown.

Be sure to clean the mounting surface to ensure proper label adhesion.

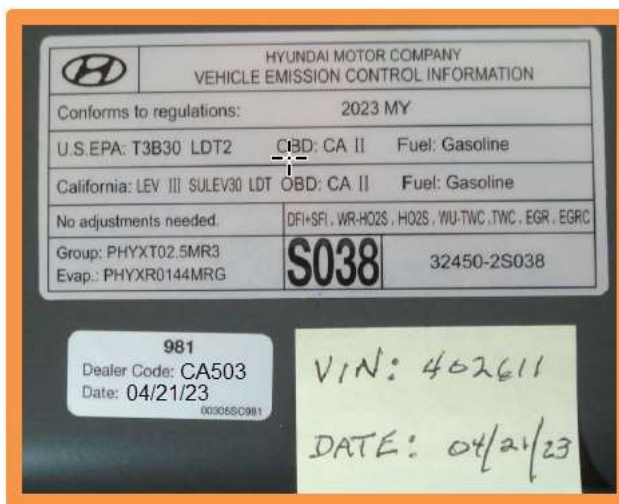
Using STUI, photograph the campaign sticker along with the last 6 digits of the VIN and the date of the repair on a piece of paper.

Upload the photo to STUI.
