## Battery Electric Vehicle (BEV) Cab Heater Diagnostics

# VOLVO VNe

P4290 Phase 1 Cabin Heater Update

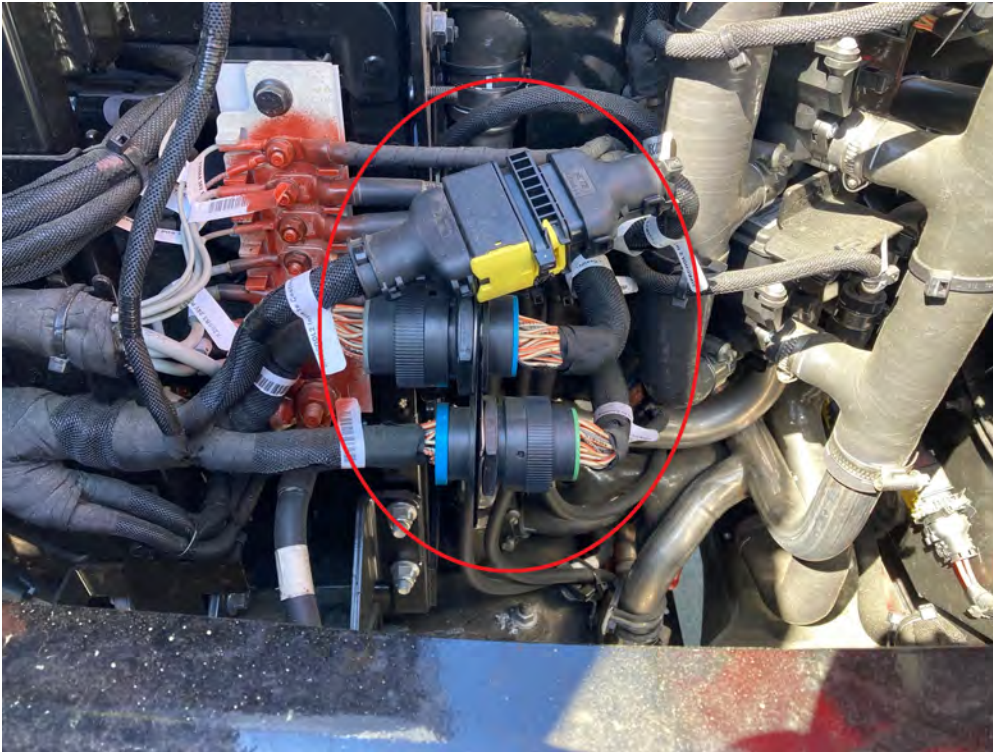
c. Fuse good- Check continuity from fuse to pump for open circuits. The harness comes out of the rear of the ECEC and then goes forward to 2 round connectors. Connector MPBCOOL1 contains the 24v(Pin 7) and ground(Pin 8) wire for the M122.

Visually inspect those connectors for damaged or pushed pins. Test for continuity back to the fuse and from the connector to the pump.

i. No continuity to fuse- Check continuity from ECEC connector to MPBCOOL1 connector.

1. Good continuity- inspect both sides of the connection and replace ECEC if no issues are seen.

2. NO or Poor continuity- check harness for faults and repair/replace as needed.

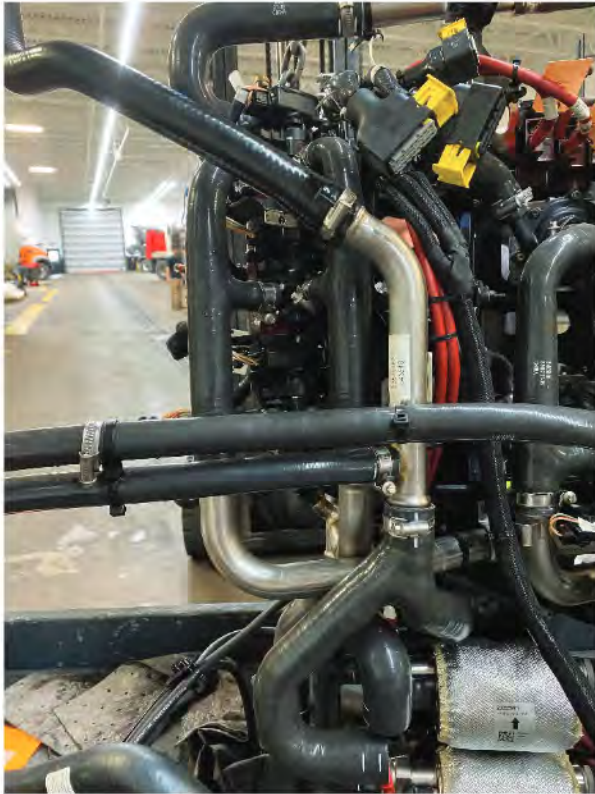
## Original vs NEW

PN: 24052018

PN: 24056986

PN: 24052174

PN: 24078777

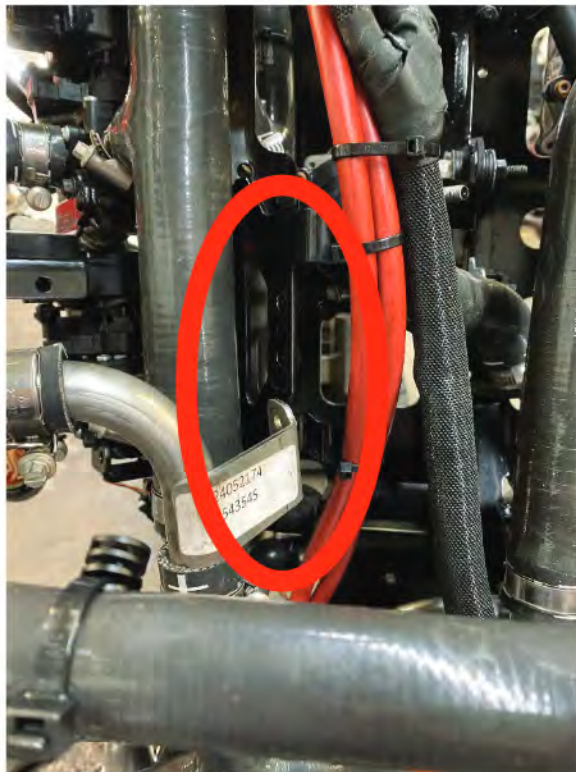
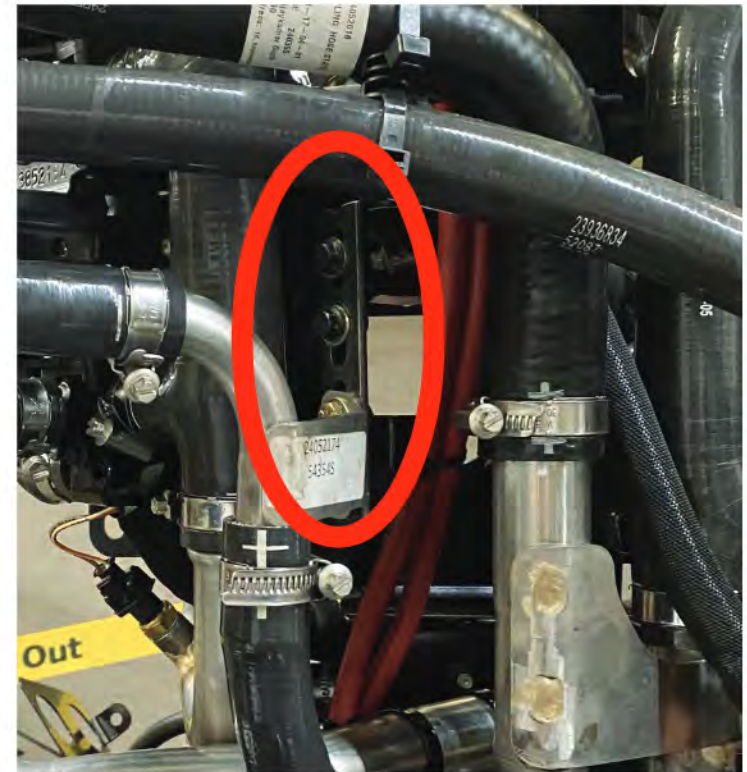
**A Flat bracket may be needed to mount PN 24052174**

**Before Bracket**

**After Bracket**

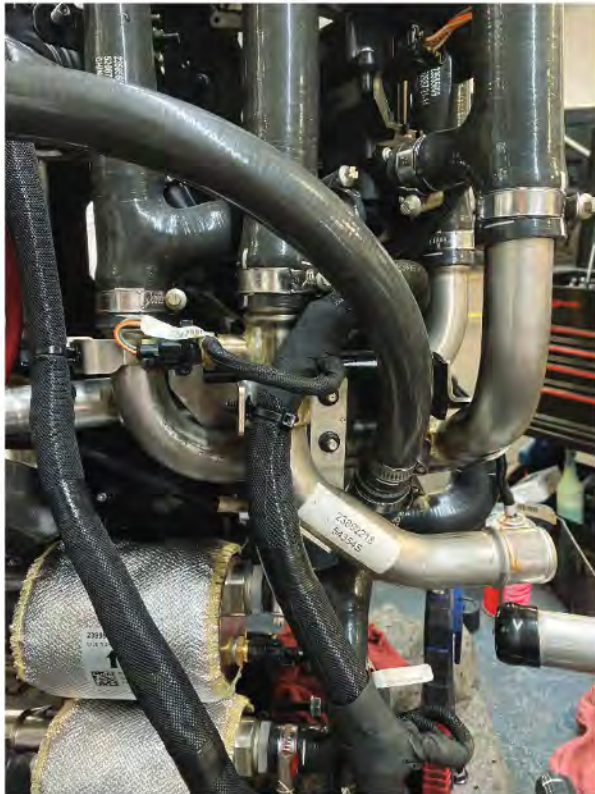
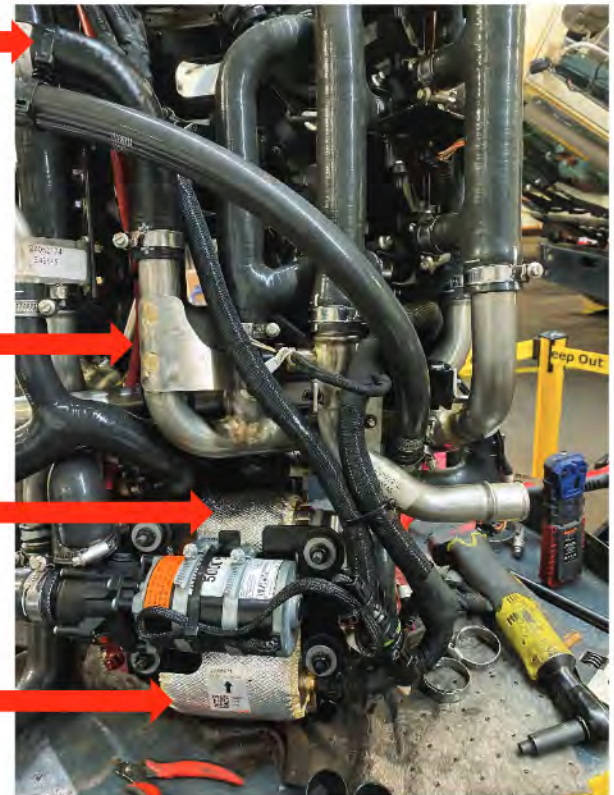
## Original vs NEW

PN: 24052018

PN: 24052967

PN: 23995971

Only front TWO heaters get replaced
