# TECHNICAL SERVICES BULLETIN

Document ID: 8-23-GL-00-005

Bulletin Title: VF8 & VF9\_AGS Pigtail Wiring Harness rework instructions

Date of issue: EN Version 1.0 / 22 May 2023

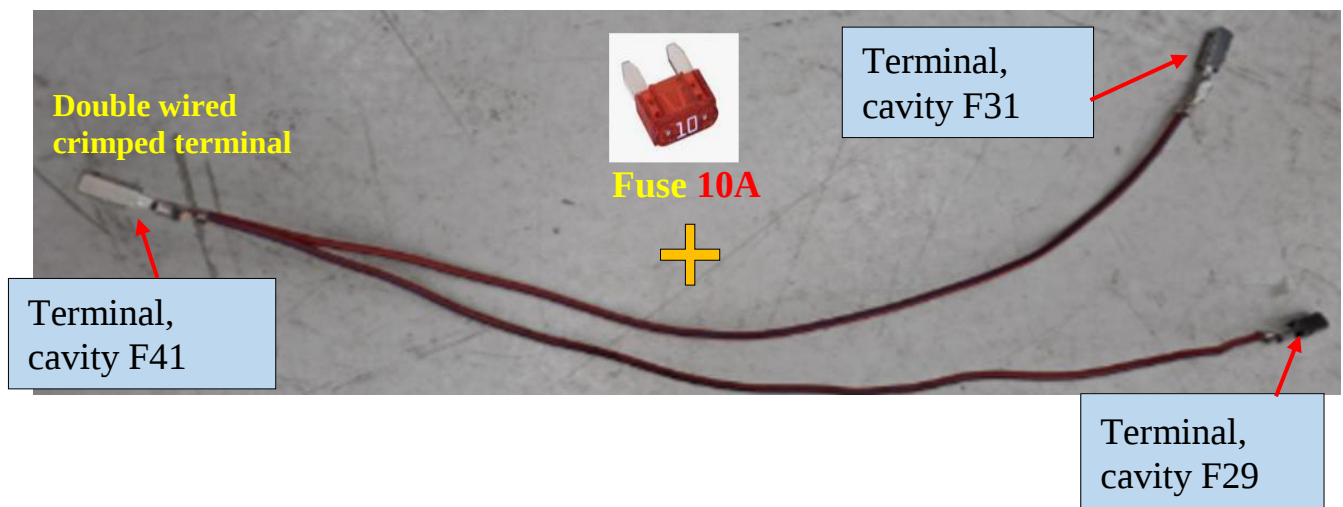
- Below is the AGS pigtail wiring harness & Fuse 10A from the KIT [EEP30209456] used for rework.
