TECHNICAL SERVICE BULLETIN

BT23-006
 NTB23-042
 May 11, 2023

AUTOMATIC BACK DOOR DOES NOT OPEN

APPLIED VEHICLES: 2021-2023 Rogue (T33)

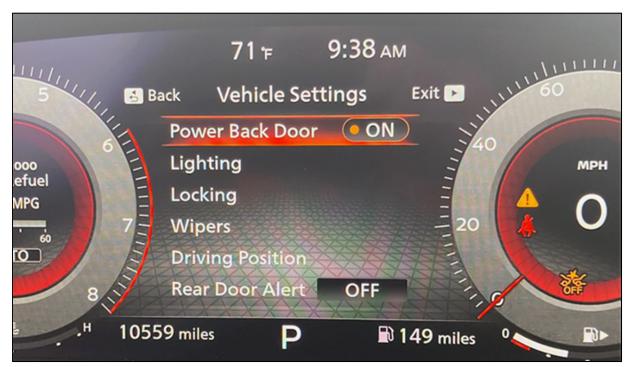
Figure 1

- Confirm that the Power Back Door is set to "ON" in the Vehicle Settings menu of the Vehicle Information Display.
 - a. To access/change the Power Back Door setting, use the scroll dial and the Left/Right buttons on the steering wheel to navigate to the Vehicle Settings menu.
 - b. If Power Back Door is "OFF" toggle to "ON".
