QUALITY ACTION

CAMPAIGN BULLETIN

Rear Seatbelt Lower Anchor

Reference: PC936

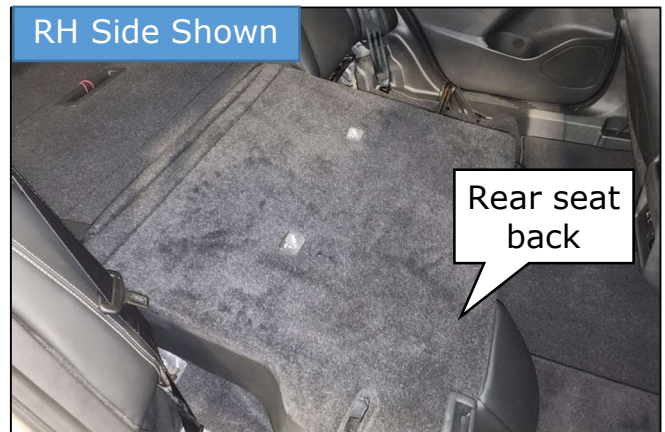
Figure 3

4. Lower the rear seat back assembly.

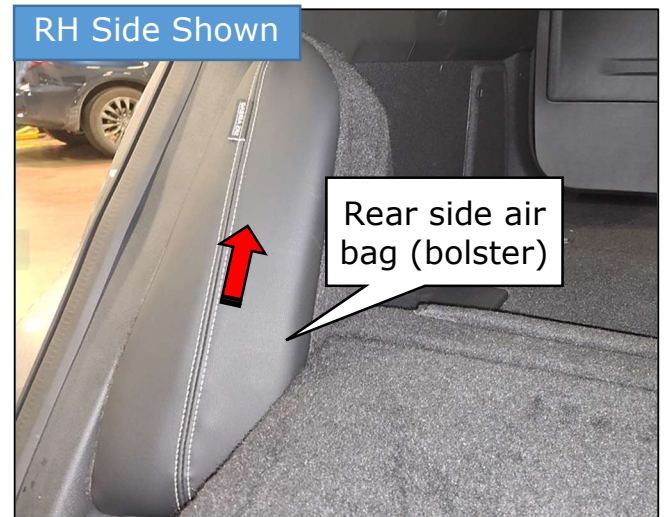
Figure 4

5. Remove the rear side air bag (bolster).
- Push the rear side air bag upward to disengage the upper retainer (Figure 4)
 - Do **NOT** disconnect the rear side air bag connector
 - Remove the rear side air bag and place next to the folded seatback as shown in Figure 5

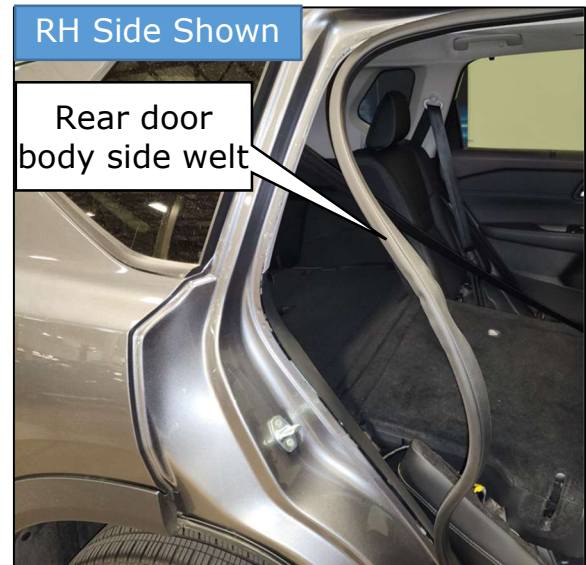
Figure 6

6. Partially remove the rear door body side welt (weather strip) as shown in Figure 6.

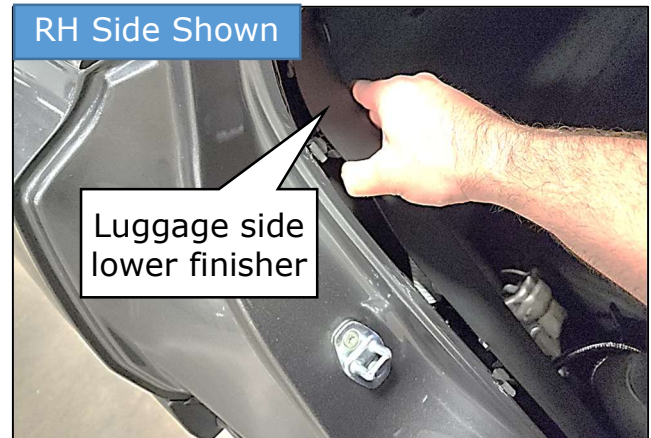
Figure 7

7. Lift the edge of the luggage side lower finisher to separate the retainers from the body as shown in Figure 7.

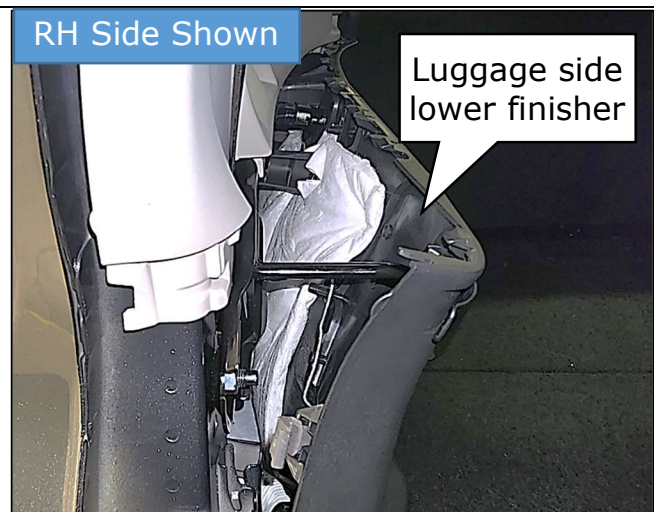
Figure 8

8. Carefully separate the luggage side lower finisher from the upper finisher as shown in Figure 8.

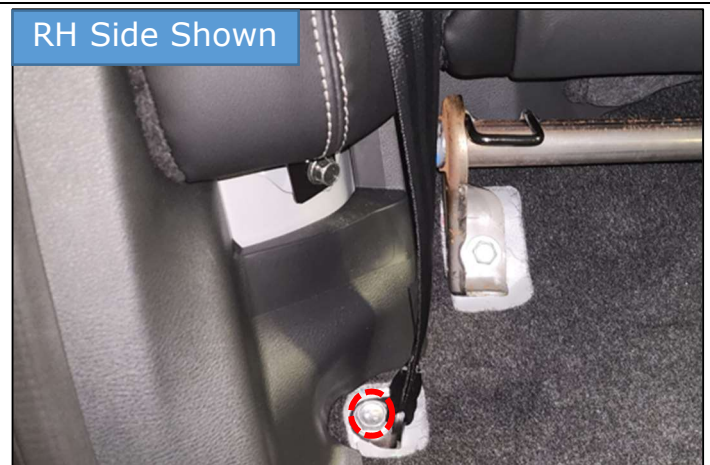
Figure 10

13. Remove the Silver lower seat belt anchor bolt.

- Remove the anchor bolt and washer from the retainer bracket
- Discard the original washer

IMPORTANT:
Do NOT remove black anchor bolts.

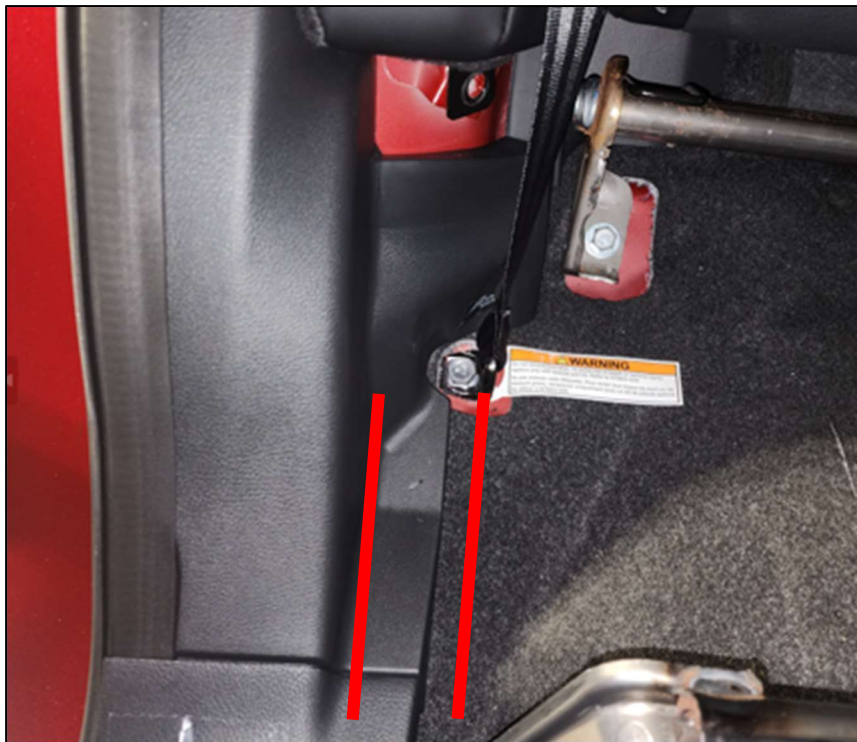
15. Reinstall the lower seat belt anchor.

- Make sure the Seat belt webbing is not twisted
- Make sure the Anchor plate is positioned parallel to the door opening as shown in Figure 12
- Torque to 85N•m (8.6kg-m, **63ft-lb**)
