GROUP	MODEL
Subsequent Repair Action	2011-2013MY Sportage (SL) w/Theta 2.4L MPI
NUMBER	DATE
PI2103Y/Z	June 2023

SUBJECT: **ENGINE REPLACEMENT INSTRUCTIONS FOR DTC P1326 (PI2103Y/Z)**

This bulletin provides information related to the Technical Service Bulletin previously published in (PI2103) titled "Knock Sensor Detection System - ECU Logic Improvement" for certain 2011-2013MY Sportage (SL) vehicles equipped with Theta 2.4L MPI engine, produced from May 6, 2010 through October 7, 2013. Specifically, this bulletin provides instructions on which procedures to follow if, after installation of the KSDS, any one of the subject vehicles below return to the dealer with Diagnostic Trouble Code (DTC) P1326 (Knock Signal Range/Performance).

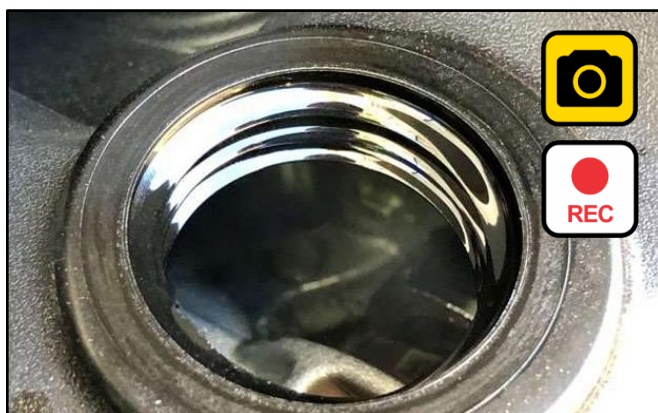
Oil Level Measurement: (Flowcharts B & C → PWA Request)

1. Remove oil filler cap, remove oil drain plug and drain oil into the supplied measuring container SST067BUCK and check oil level.
2. Record oil level reading on the RO.
3. Take photo of the drained oil container using KDS and attach to warranty claim PWA request.

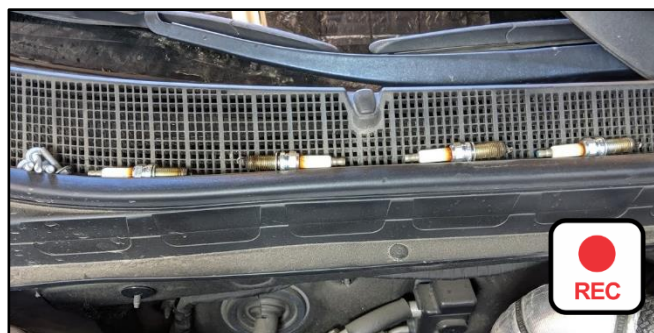
2. Show the removed spark plugs.

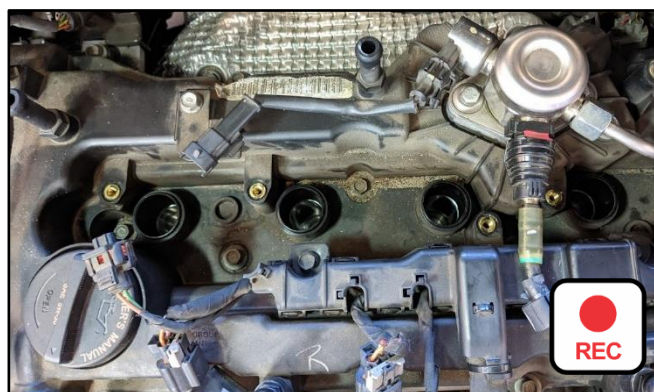
3. Show the empty spark plug holes from the engine.

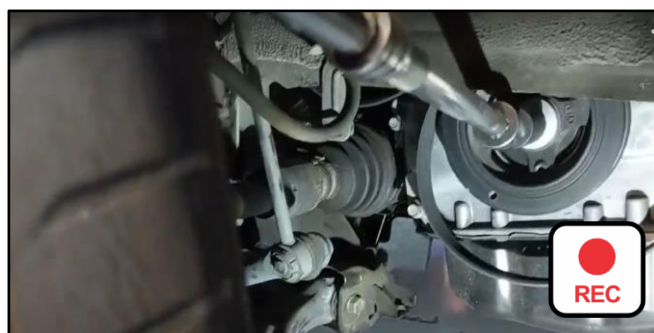
Prepare the vehicle prior to the video by removing the spark plugs and drive belt as well as setting the torque wrench to 94 lb.ft.

5. Show the removed drive belt and attached torque wrench to crank bolt.

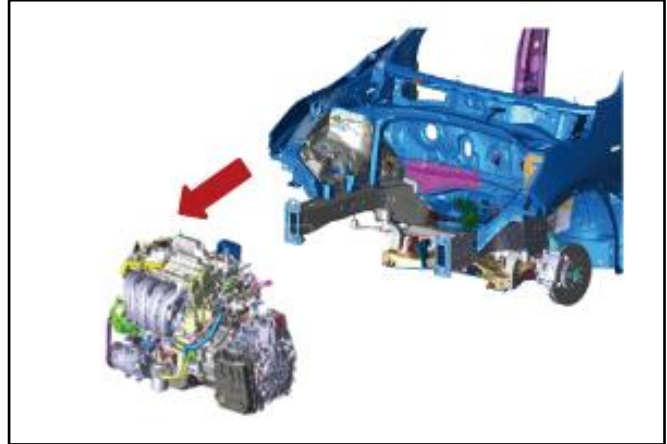
1. Replace the engine assembly by referring to the "Engine Mechanical System → Engine And Transmission (Transaxle) Assembly → Sub & Long Engine Assembly → Repair procedures" chapter in the applicable Shop Manual on KGIS.

2. After removal of the engine from the vehicle, remove all components that will need to be transferred by referring to the applicable Shop Manual on KGIS.
3. **Install all removed components from the old engine block onto the new engine block utilizing all parts from Service Kit(s).**

5. Reinstall the assembled engine and transmission/transaxle into the vehicle.
