GROUP	MODEL
ELE	2022-2023MY Stinger H-MATIC (CK)
NUMBER	DATE
294	May 2023

## TECHNICAL SERVICE BULLETIN

# SHIFT LEVER POSITION INSPECTION & DETENT DAMPER REPLACEMENT FOR REMOTE START FAILURE

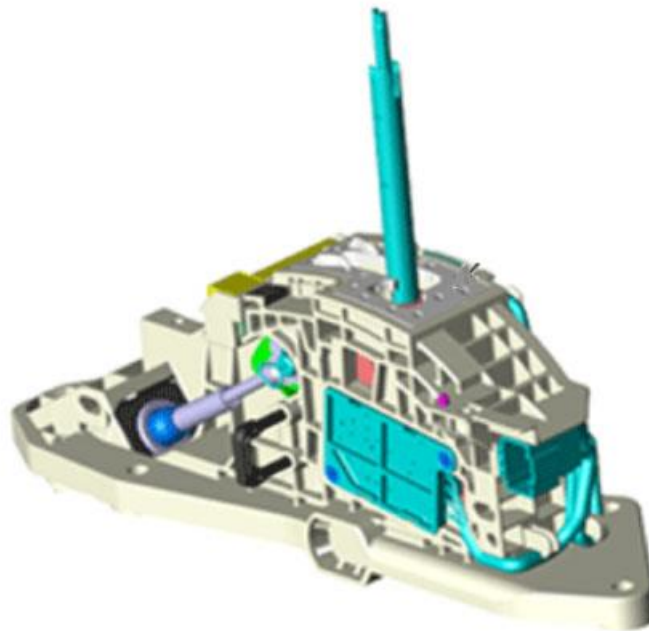
This bulletin provides information to inspect the shift lever position and, if necessary, replace the shift lever detent damper on some 2022-2023MY Stinger H-MATIC (CK) vehicles produced from December 23, 2020 through October 30, 2022. The shift lever detent damper's angled design may cause interference between the detent damper and the shift lever Park 'P' switch resulting in the Integrated Body Control Unit (IBU) not registering 'P'. This can render the Remote Start function inoperative when either using the key fob or Kia Access App. Follow the procedure outlined in this publication to inspect the shift lever position, and, if necessary, replace the detent damper.

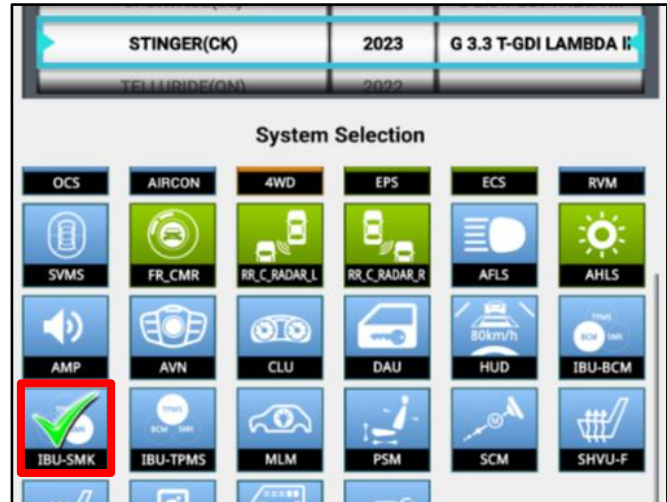
1. Start the engine.
2. Connect the KDS.
3. Select 'IBU-SMK'.

4. Place the shift lever from Park 'P' to Drive 'D'.
  - If 'Gearshift P Position' value shows "ON", proceed to the replacement procedure below.
  - If the 'Gearshift P Position' value shows "OFF", this TSB does not apply. No further action is required.

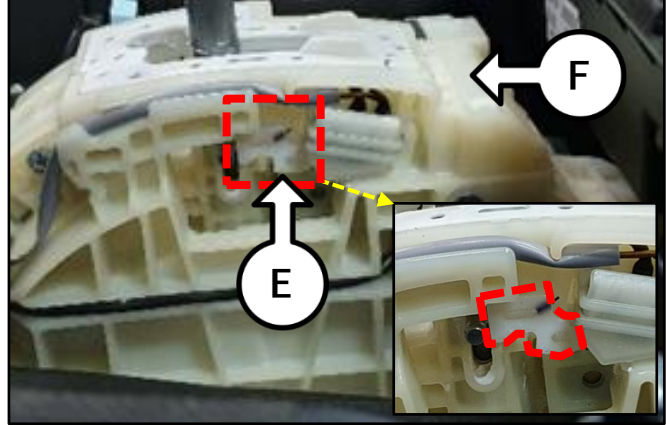
7. Locate the detent damper (E) on the shift lever assembly (F).
