Bulletin No.: PIT5855G Published date: 05/12/2023

Preliminary Information

PIT5855G Heated and Ventilated Seats Inoperative

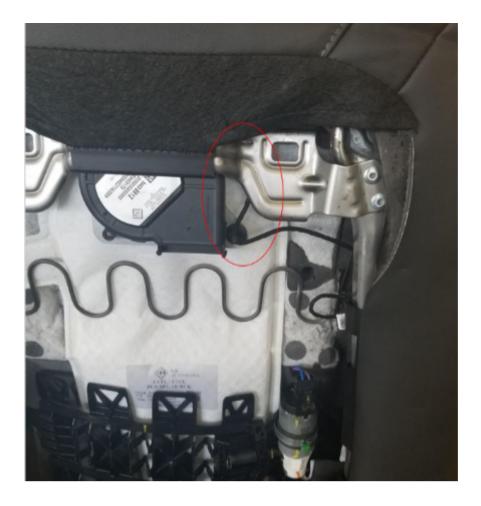
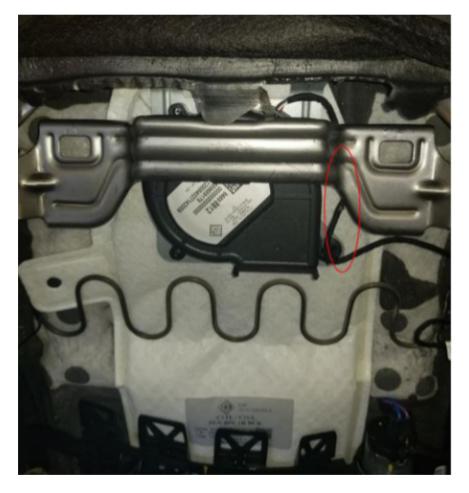
The most likely areas are shown in the photos below, but there could be contact with the harness causing damage anywhere in the seat back.

Repair the damaged circuits following the correct procedure in SI for wire and connector repair.

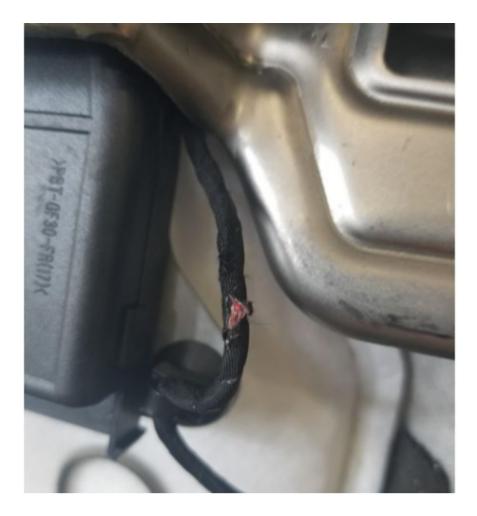
The harness may need to be moved to see the area that is damaged.

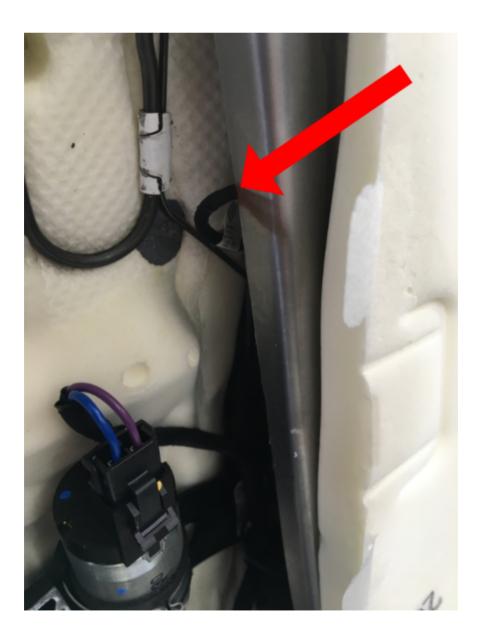
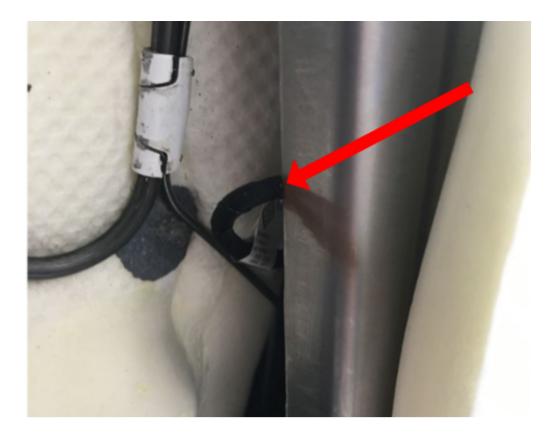
If no damage is found in this area, also inspect the harness along the side of the seat frame as shown in the two photos below.
