Warranty Extension: 2017-22 CR-V A/C Compressor Shaft Seal Leak**Supersedes 23-040, dated May 19, 2023, to revise the information highlighted in yellow.****AFFECTED VEHICLES**

Year	Model	Trim	VIN Range
2017–22	CR-V	1.5T	Check the iN VIN status for eligibility

REVISION SUMMARY**Under REPAIR PROCEDURE, step 16 image was updated and a note added.****BACKGROUND**

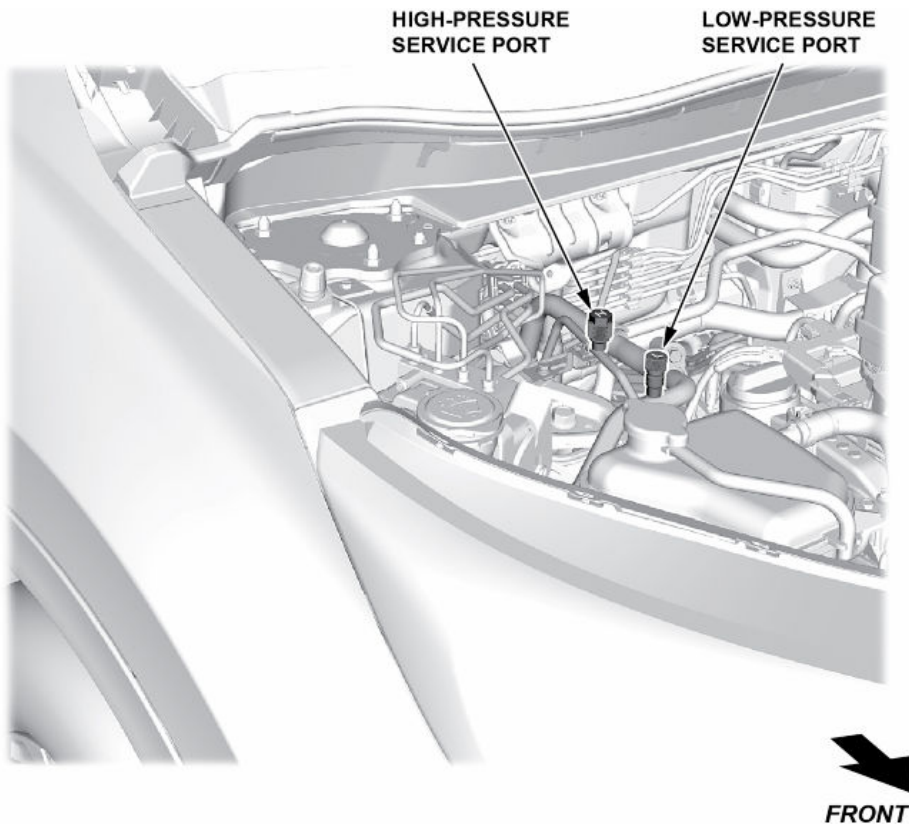
1. Connect an A/C recover/recycle/recharge machine to the high-pressure service port and the low-pressure service port following the equipment manufacturer instructions.

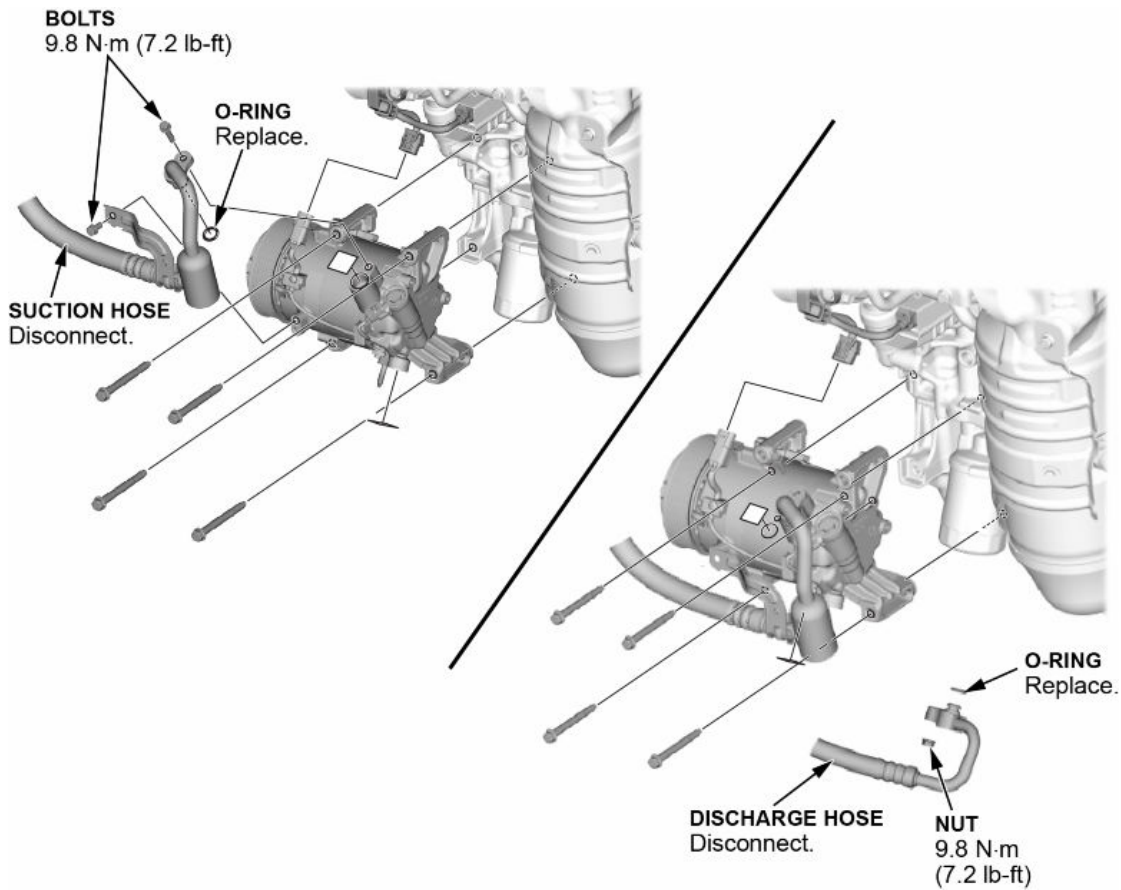
3. Disconnect the discharge and suction hose.

NOTE: Use the port plugs in the seal assembly kit to immediately seal the ports after disconnection. This avoids moisture and dust contamination from entering the air conditioning compressor. Installing an A/C compressor into a contaminated system can result in premature A/C compressor failure.

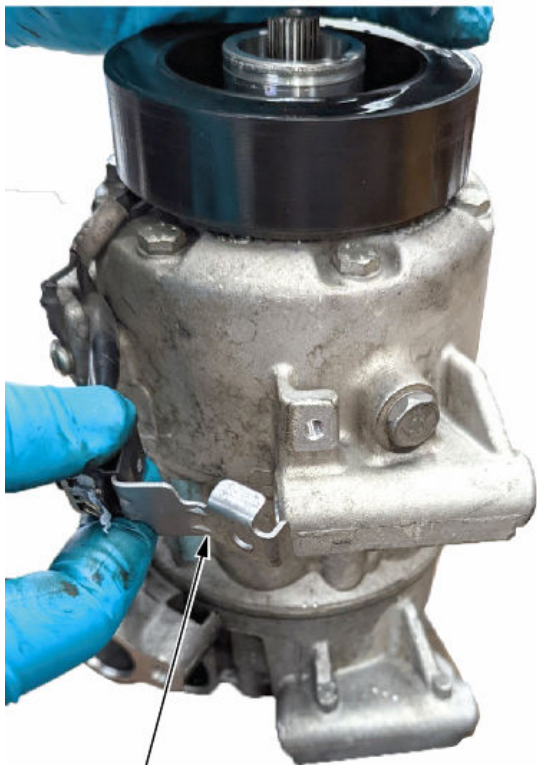
1.5L ONLY

12. Remove the side bracket (1.5L engine only).

SIDE BRACKET
Remove.

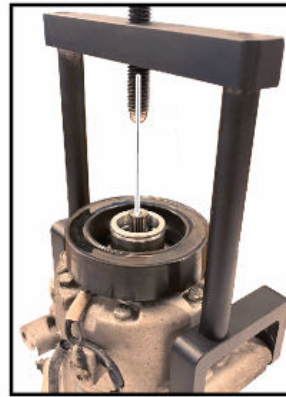
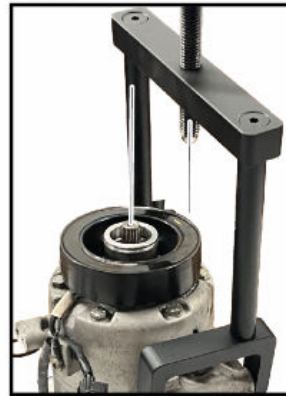
13. Place the press tool onto the A/C compressor and insert the holding pins (2). Make sure the press tool installs where the press shaft should align with compressor shaft. The press tool will only align correctly in one orientation. The pins must go all the way through.

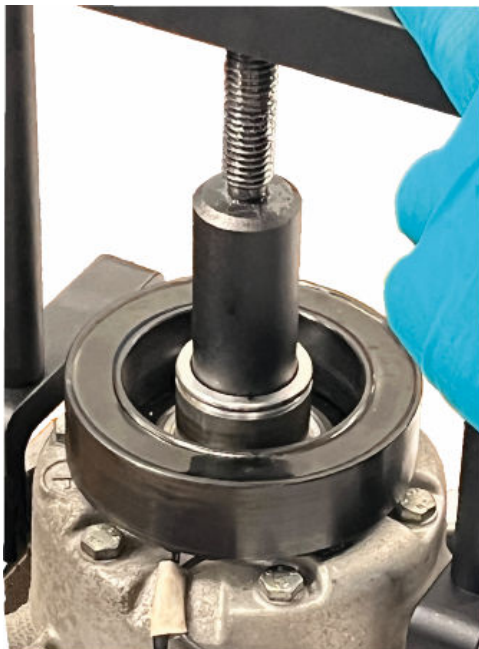
16. Tighten the press until there is no clearance, then **3/4 turn (270°)**.

- The purpose of this step is to break the compressor shaft seal loose.
- Turning the handle more than **3/4 turn (270°)** can damage the tool and seal making it difficult to remove the compressor shaft seal.

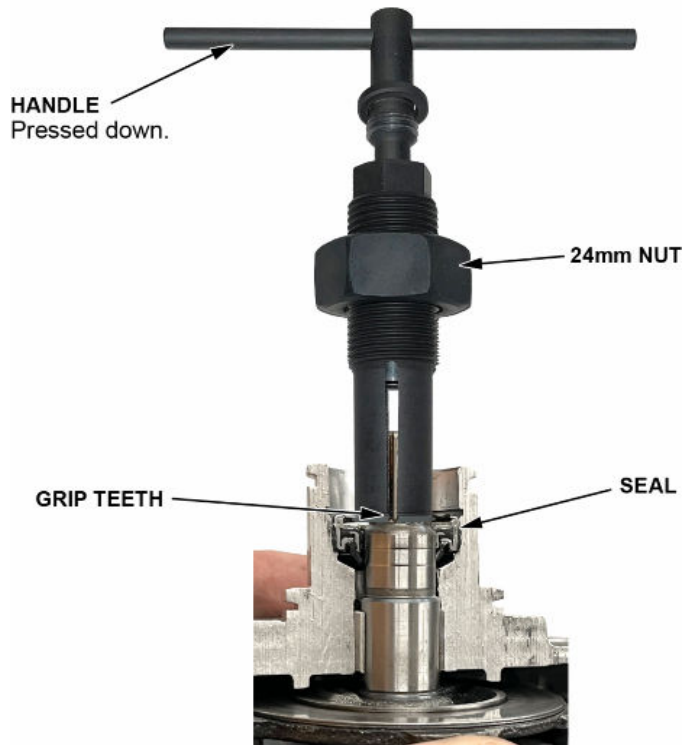
19. Insert the extractor tool, and make sure the **24 mm** nut is positioned towards the top. Look into the cylinder window to align the extractor tool onto the flange and press the handle fully down to grab the seal.

NOTE: The **24 mm** nut will use a **36 mm** wrench.

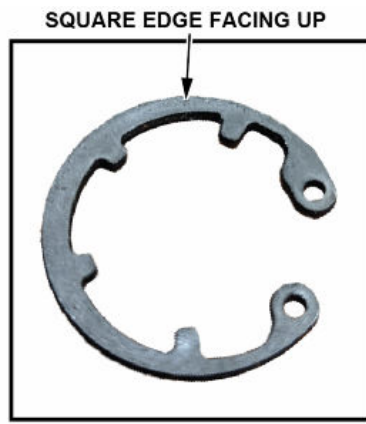
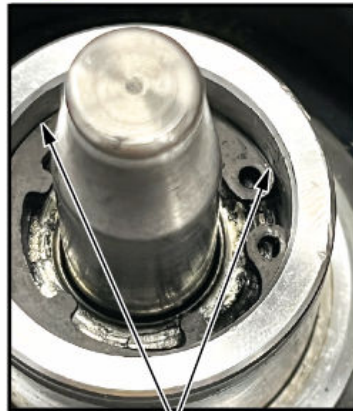
30. Insert the seal C-ring with the teeth's rounded side pointing down into the bore.
