HVAC Drain Hose Disconnected From HVAC Case and/or Oil/Grease Odor From Vents

Service Category Vehicle Interior

Section Heating/Air Conditioning

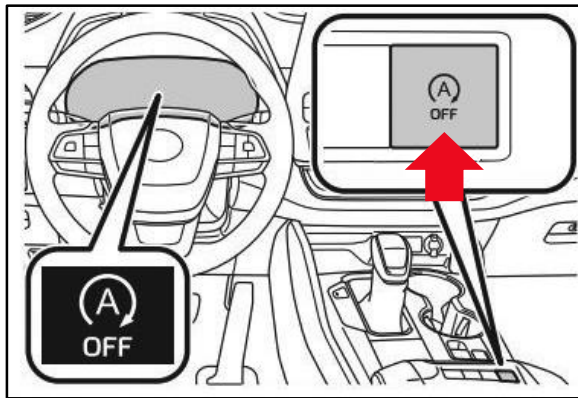
Figure 1. Highlander Start/Stop Switch Location

1. Is the vehicle equipped with a start/stop switch?

- **YES** — Continue to step 2.
- **NO** — This bulletin does NOT apply. Continue diagnosis using the applicable Repair Manual.
