Technical Service Bulletin

69 Airbag warning light on, DTC B1225F1 stored in the airbag control module

69 23 90 2051242/7 June 2, 2023. Supersedes Technical Service Bulletin Group 69 number 22-86 dated May 4, 2022, for reasons listed below.

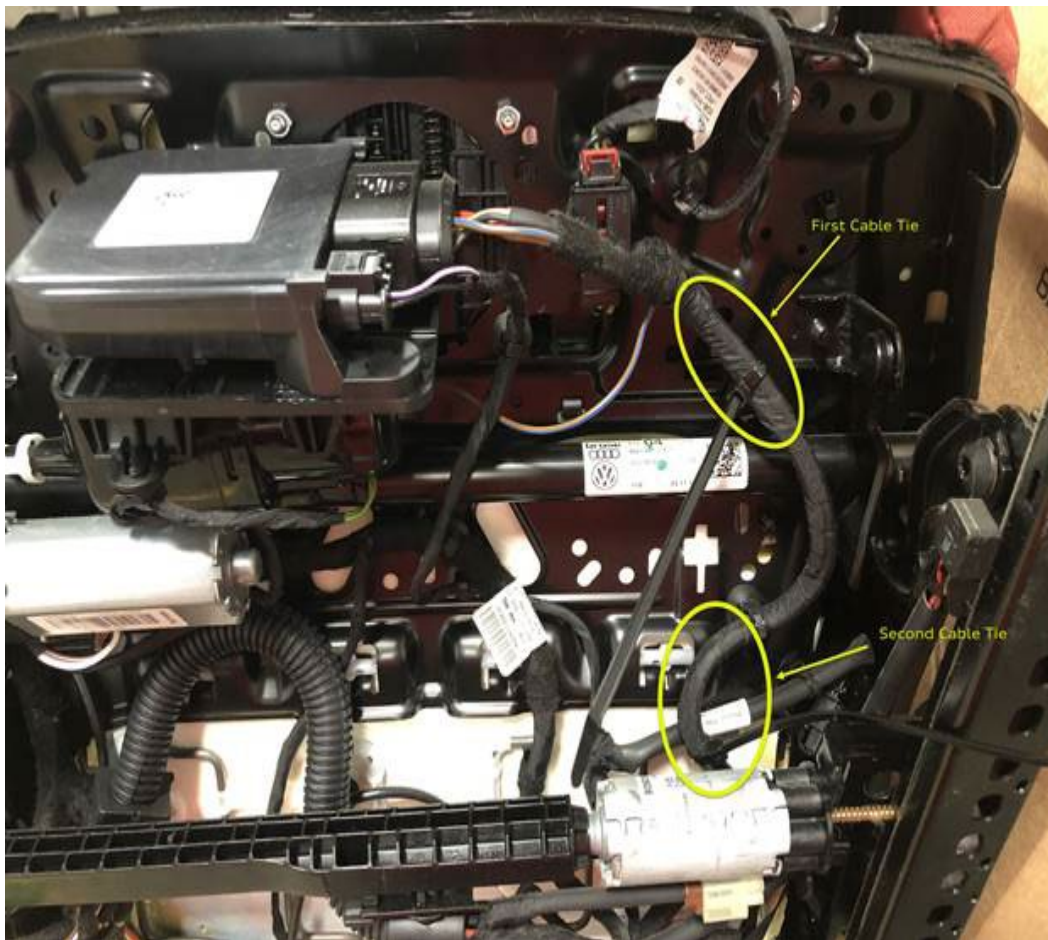
Once the seat is adjusted to the above-mentioned position, you will see the need to attach the cable ties at two points on the harness as shown (Figure 1).

Figure 1. Positions of the cable ties.

1. To apply the cable ties, the seat does not need to be removed. You will need to move the lateral seat adjustment all the way to rearmost adjustment limit and the vertical height adjustment all the way to the upper adjustment limit.

You are not going to secure the harness to any part of the seat with the cable ties, you are only applying the cable ties to the harness to apply clamping force to the harness and shielding. **DO NOT ATTACH THE HARNESS TO THE SEAT FRAME.**

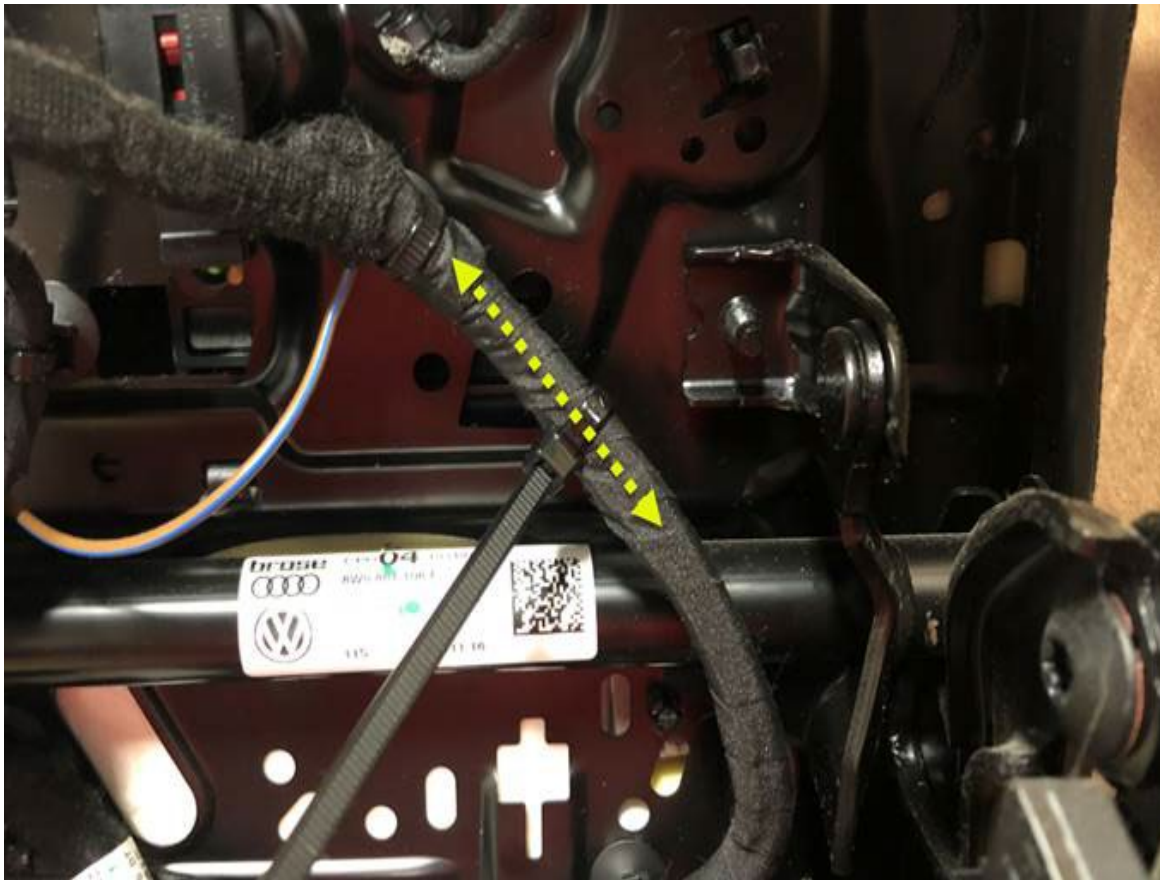
2. You will attach the first cable tie in the yellow marked area on the harness between the cable tie clip and the crossbar tube as shown below (Figure 2).

Figure 2. Attach the first cable tie in the yellow area.

When tightening the cable ties, only tighten them with your hands, do not use any tools to tighten the cable tie as this can damage the harness. Check that the cable ties cannot be rotated on the harness by hand, to ensure that proper tension is achieved. Then cut off the excess length from the tie wrap.

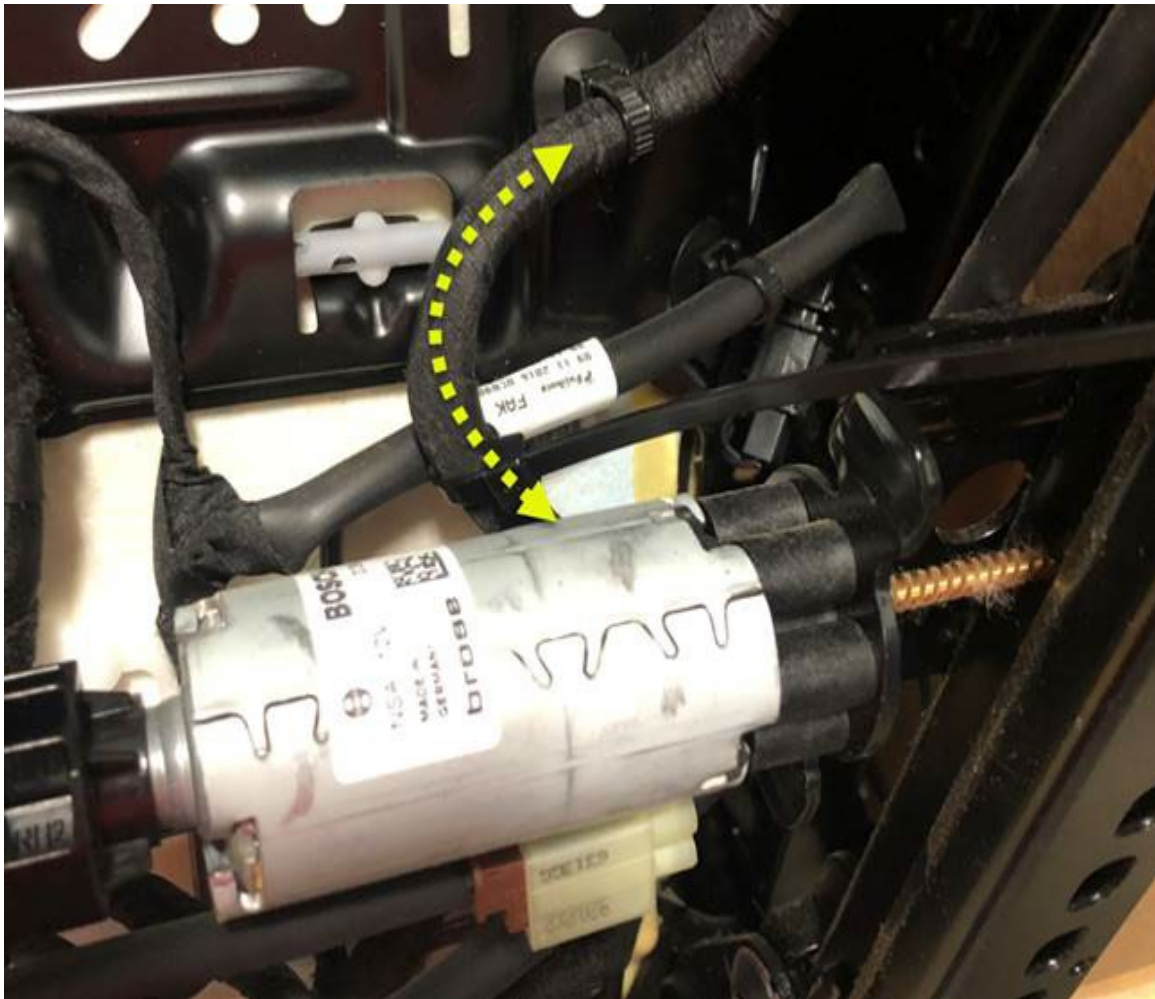
3. The second cable tie position is to the rear of the crossbar tube where the harness drops down from the frame. Place the cable tie in the yellow marked area shown below (Figure 3).

Figure 3. Attach the second cable tie to the yellow marked area.

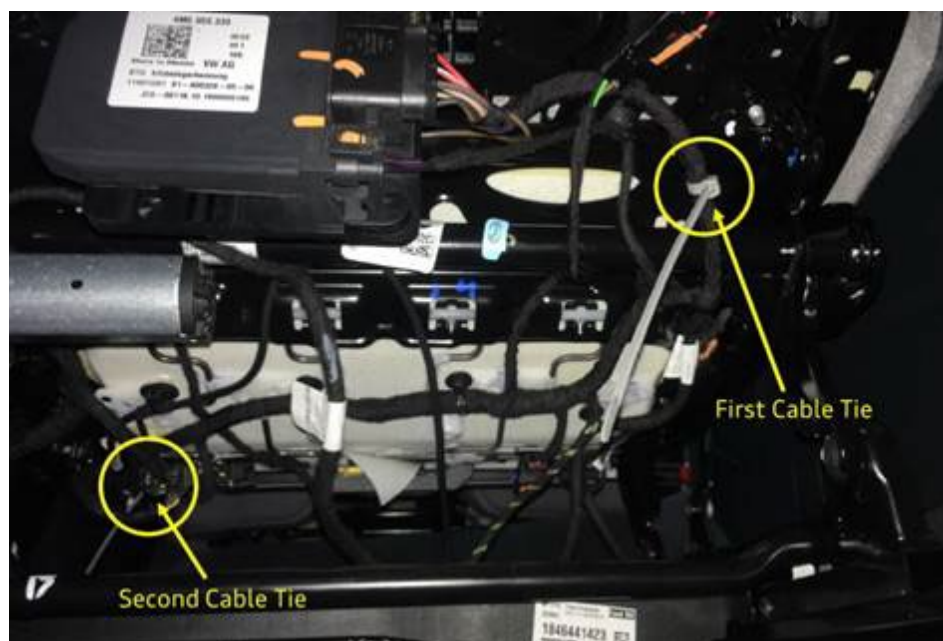
Once the seat is adjusted to the above-mentioned position, you will see the need to attach the cable tie at two points on the harness as shown (Figure 4-6).

Figure 4. Positions of the cable ties (front to back).

1. To apply the cable ties, the seat does not need to be removed. You will need to move the lateral seat adjustment all the way to rearmost adjustment limit and the vertical height adjustment all the way to the upper adjustment limit.

You are not going to secure the harness to any part of the seat with the cable ties, you are only applying the cable ties to the harness to apply clamping force to the harness and shielding. **DO NOT ATTACH THE HARNESS TO THE SEAT FRAME.**

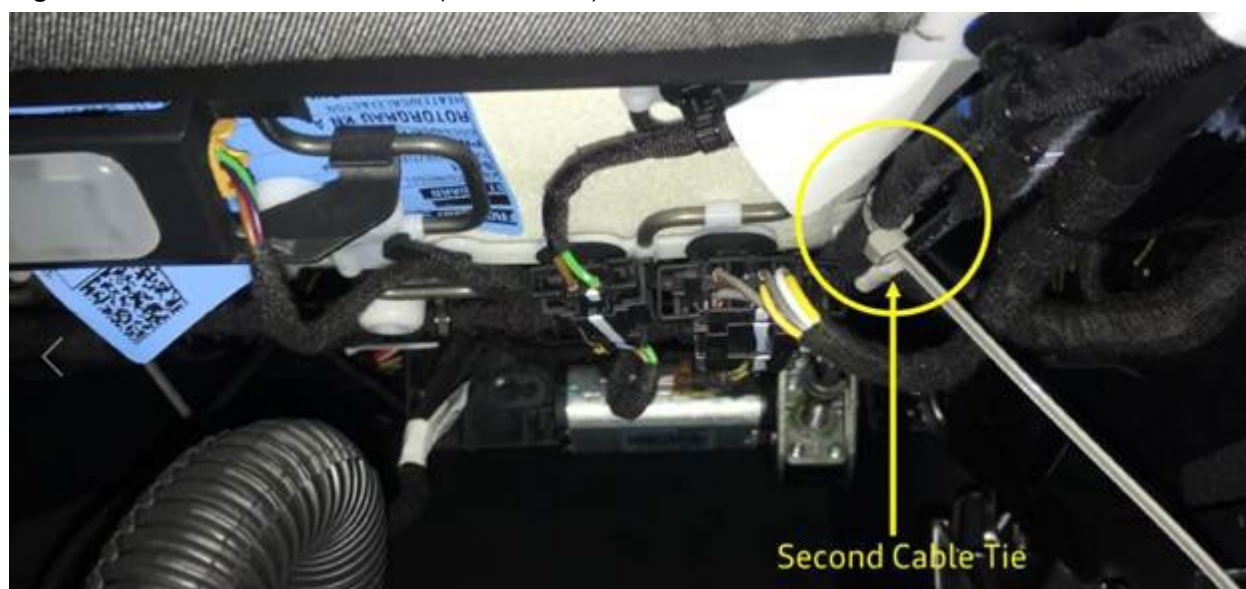
Figure 5. Positions of the cable ties (back to front).

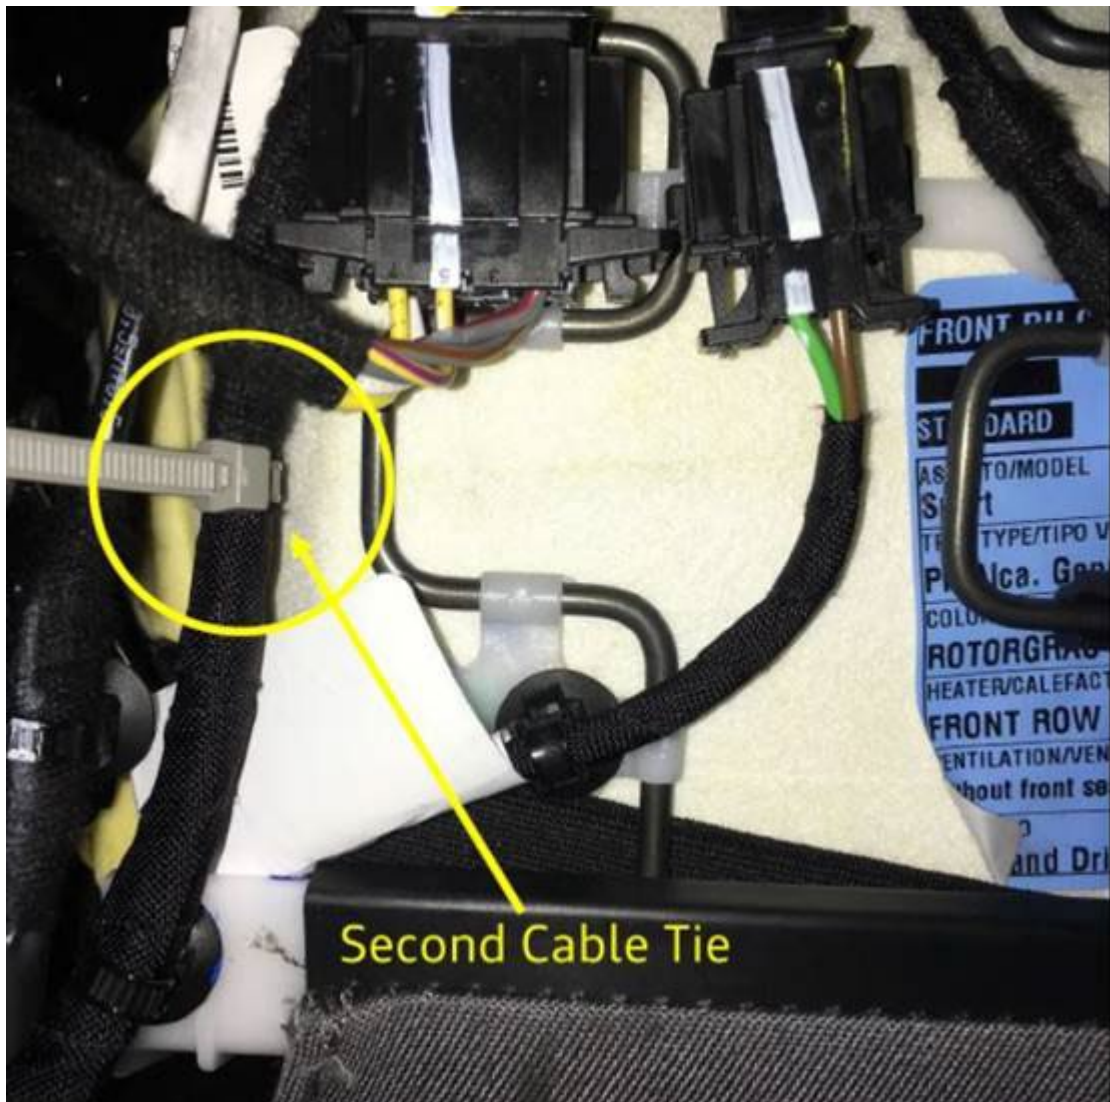
2. You will attach the first cable tie in the yellow marked area on the harness between the cable tie clip and the crossbar tube (Figure 2).
3. The second cable tie position is to the rear of the black 8-pin connector (T8m) for the backrest and lumbar adjustment and in front of the harness push pin (Figure 6).

Figure 6. Position of second cable tie behind the 8-pin connector.

When tightening the cable ties, only tighten them with your hands, do not use any tools to tighten the cable tie as this can damage the harness. Check that the cable ties cannot be rotated on the harness by hand, to ensure that proper tension is achieved. Then cut off the excess length from the tie wrap.
