# Technical Service Bulletin

## 87 Unpleasant odor is coming from the heating and ventilation system

87 23 44 2010146/18 June 14, 2023. Supersedes Technical Service Bulletin Group 87 number 22-25 dated April 16, 2022 for reasons listed below.

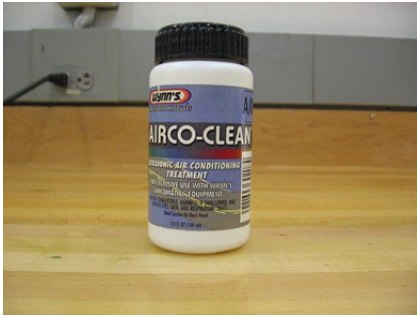
Part Number	Part Description	Quantity
See ETKA	Fasteners, Bolts, Nuts, and Screws as needed per the Repair Manual	See ETKA/ELSA
VAS 6189/1	Airco-Clean® Ultrasonic Air Conditioning Treatment (100ml bottle)

1 bottle

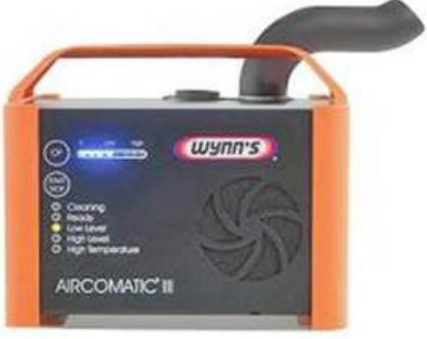
Tool Number	Tool Description
VAS 6189B

Aircomatic® II Ultrasonic Climate System Cleaning unit
