Technical Service Bulletin

**RE: Technical Service Bulletin (TSB)  
2024 Model Z – Trailer Brakes  
Lippert TSB#45B-001-2023**

# HUB AND BRAKE ASSEMBLY REPLACEMENT ON BRINKLEY MODEL Z 5TH WHEELS

TSB Number:	45B-001-2023		
Product:	Hub and Brake Assembly		
Date:	June 23, 2023	Labor Rate:	2.5 hours per axle

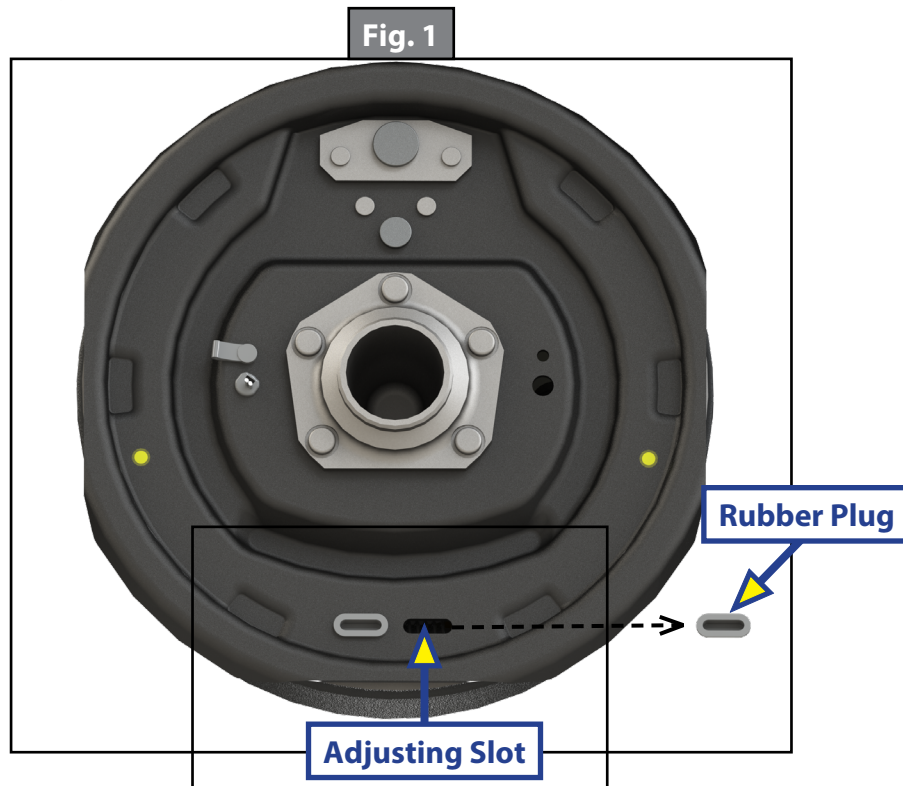
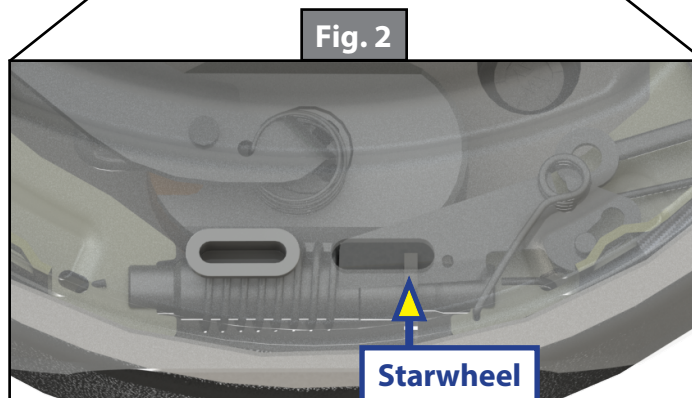
2. Remove the rubber plug from the adjusting slot on the bottom of the brake backing plate (Fig. 1).
3. Insert a screwdriver or standard adjusting tool into the adjusting slot to rotate the starwheel (Fig. 2) of the adjuster assembly to retract the brake shoes.

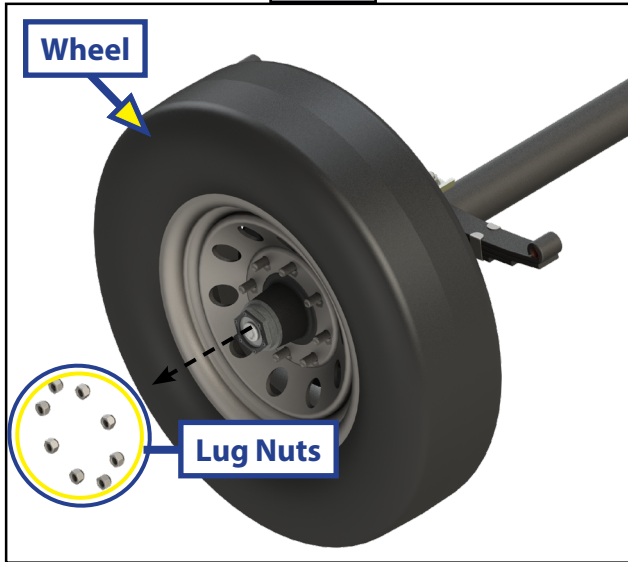
Fig. 3

4. Remove the lug nuts from the wheel and set aside (Fig. 3).
5. Remove the wheel from the axle hub and set aside (Fig. 4).

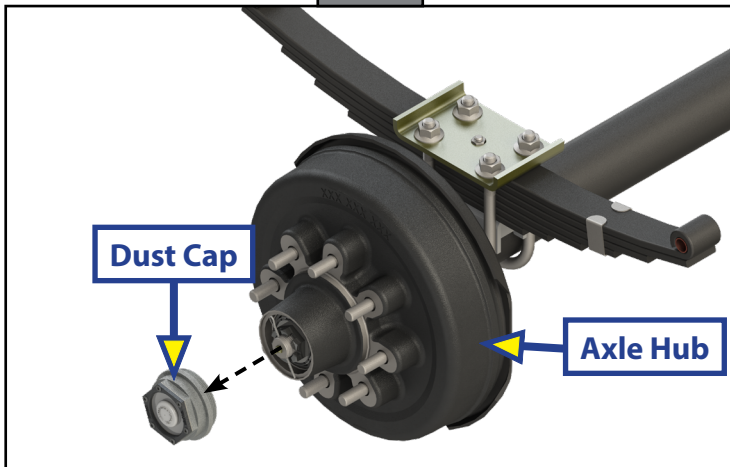
Fig. 5

6. Unscrew the dust cap and remove from hub (Fig. 5).
7. Pull the cotter pin from the castle nut and **DISCARD THE COTTER PIN** (Fig. 6).

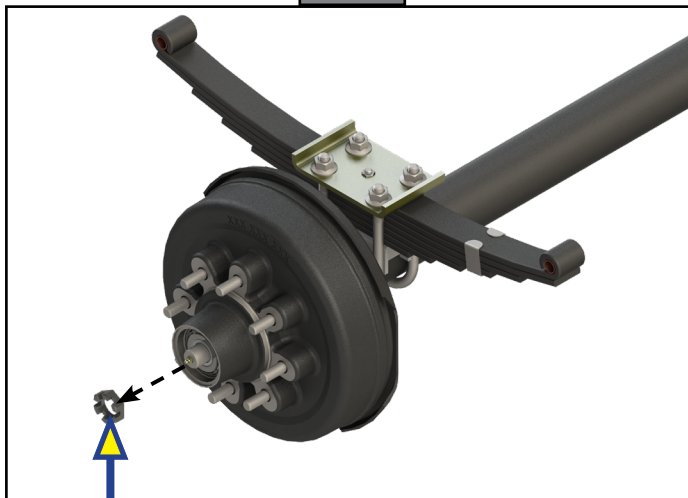
Fig. 7

8. Remove the castle nut from the spindle (Fig. 7).
9. Remove the spindle washer from the spindle (Fig. 8).
10. Place hand over nose of hub during removal to contain outer bearing cone or remove outer bearing cone prior to removal of hub. Remove the hub from the spindle (Fig. 9).

Castle Nut

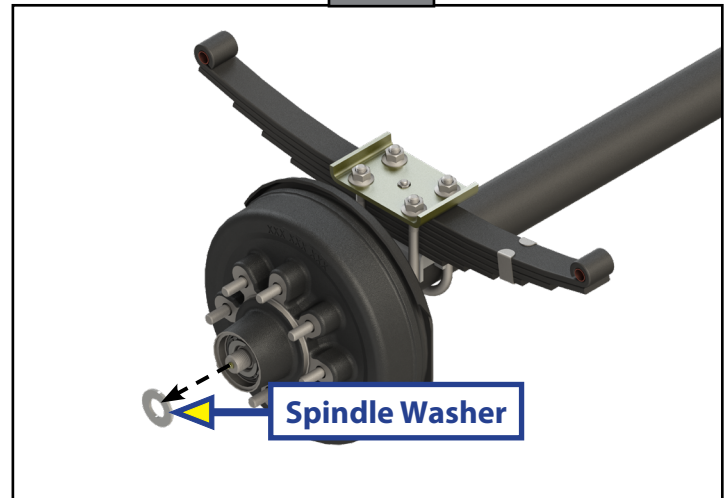
Fig. 8

Spindle Washer

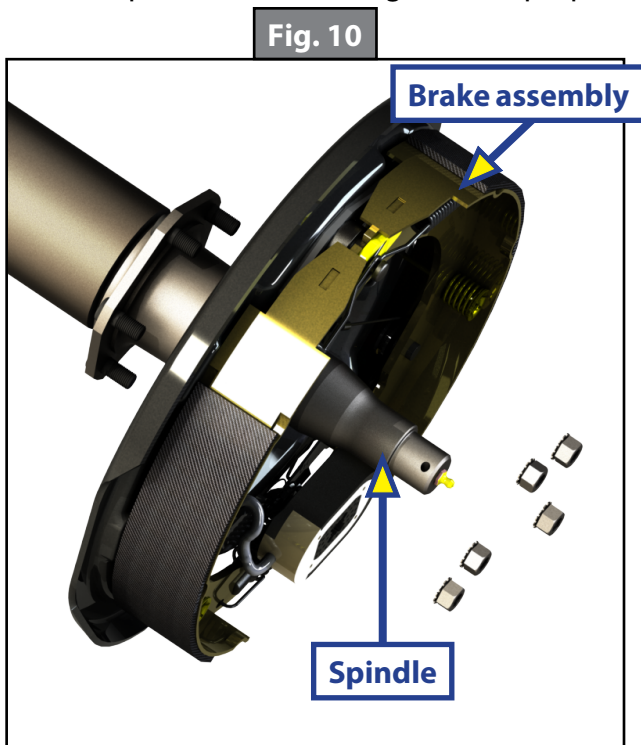
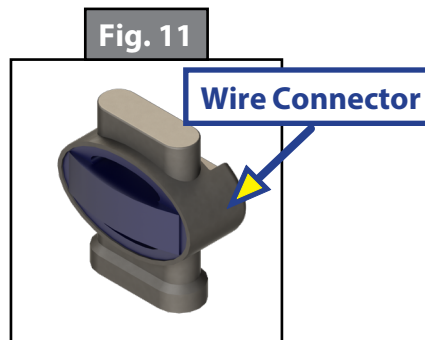
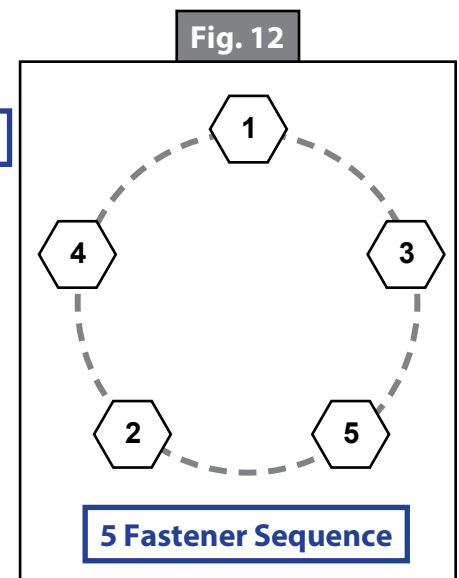
6. Using sealed wire connectors (Fig. 11), reconnect the brake wires.
7. Install by hand the remaining nuts and tighten in a sequential pattern as shown in Fig. 12.
8. After the brake assembly nuts are fully hand tightened, torque the nuts to 25-35 ft-lbs in the sequential pattern shown in Fig. 12 until proper torque is indicated by the torque wrench.

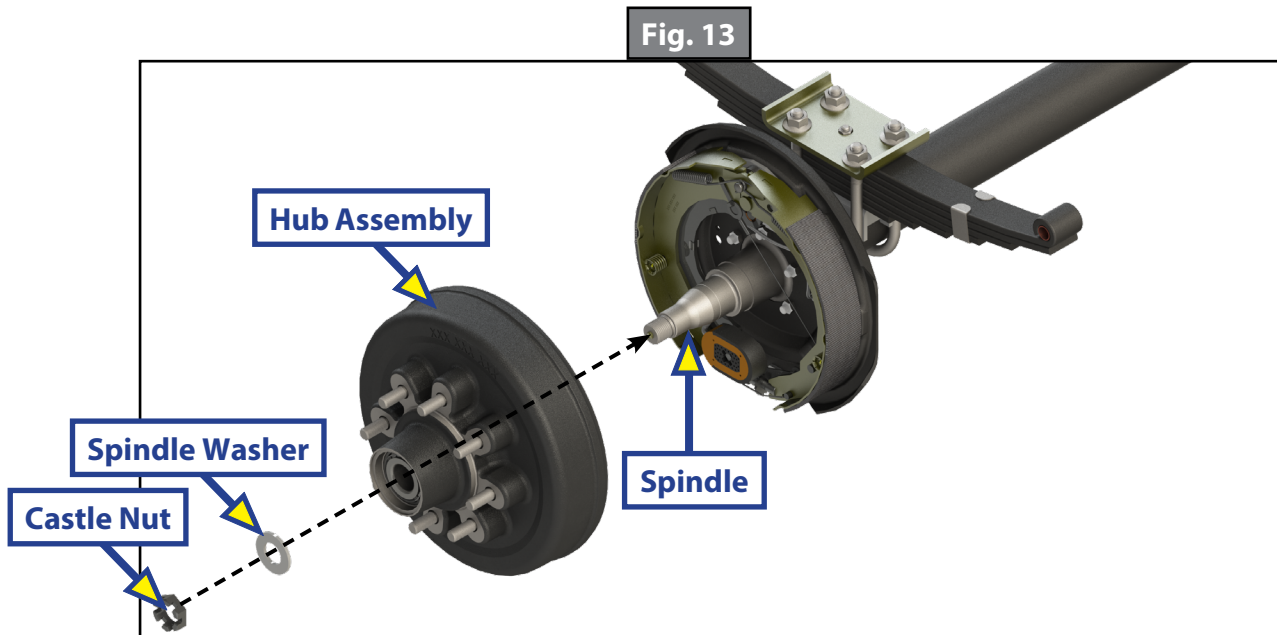
1. Place hub assembly onto the axle spindle followed by the spindle washer and castle nut (Fig. 13). Castle nut should be torqued to 50 ft-lbs. Rotate the hub during the tightening process.

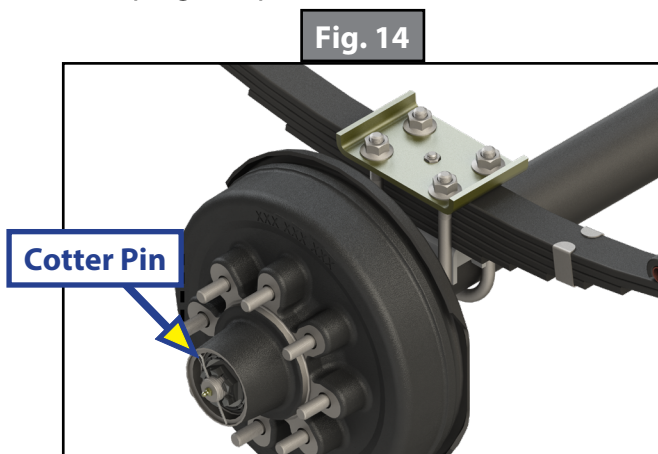
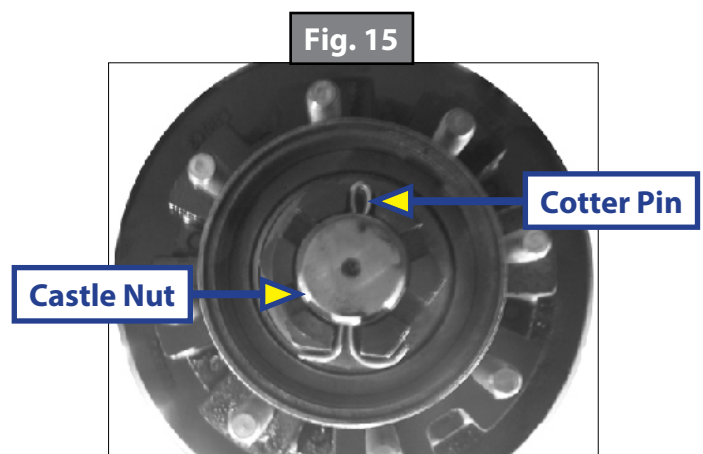
2. Loosen castle nut to back off the torque.
3. Tighten castle nut finger tight until snug.
4. Insert **NEW** cotter pin (Fig. 14). If cotter pin does not line up with hole, back castle nut up slightly until pin can be inserted.
5. Bend cotter pin over to lock nut in place (Fig. 15). Nut should be free to move with only the cotter pin keeping it in place.

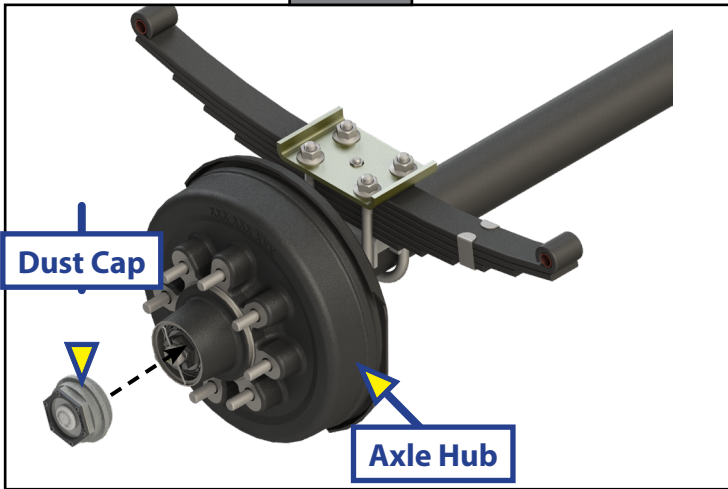
Fig. 16

- Reinstall dust cap onto the hub assembly by screwing it in at 20 ft-lbs (Fig. 16).
- Reinstall the wheel onto the hub assembly (Fig. 17).
- Reinstall the lug nuts onto the hub studs (Fig. 18) using sequential pattern as shown in Torque Requirement Chart (Fig 19).

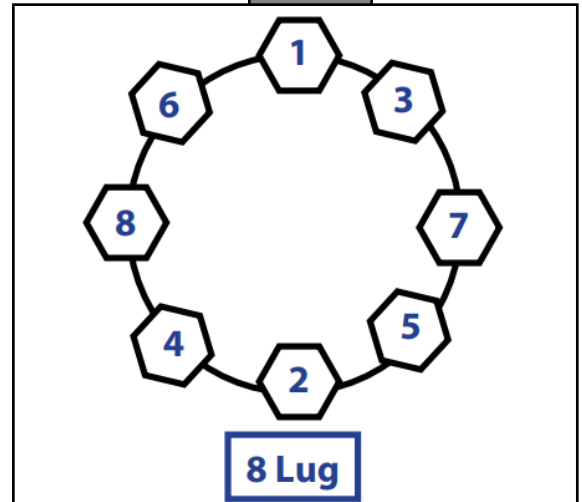
Fig. 19

Torque Requirement Chart

Wheel Size	Stud Size	Torque Sequence		
		1st Stage	2nd Stage	3rd Stage
16"	9/16"	20-25 ft-lbs	60-70 ft-lbs	120-130 ft-lbs
16.5" x 6.75"	9/16"	20-25 ft-lbs	60-70 ft-lbs	120-130 ft-lbs

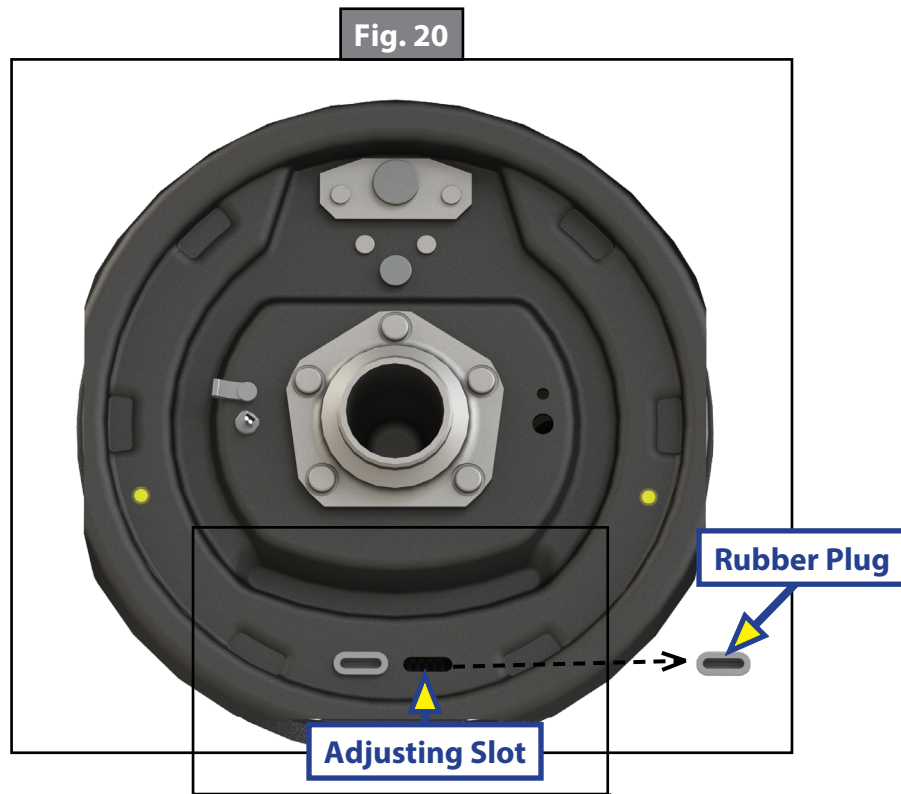
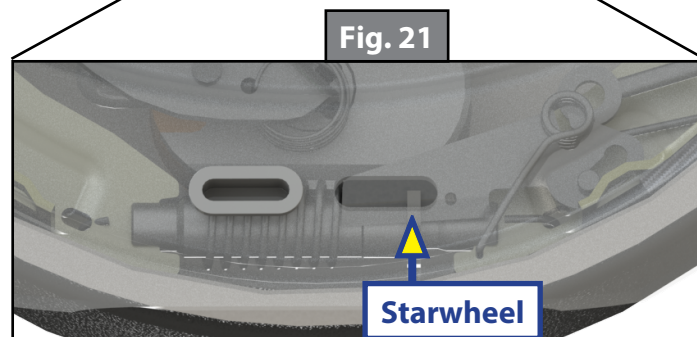
9. Remove the rubber plug from the adjusting slot on the bottom of the brake backing plate (Fig. 20).
10. Insert a screwdriver or standard adjusting tool into the adjusting slot to rotate the starwheel (Fig. 21) of the adjuster assembly to expand the brake shoes. Adjust the brake shoes out until the pressure of the linings against the drum makes the wheel very difficult to turn.
11. Then rotate the starwheel in the opposite direction until the wheel turns freely with a slight lining drag.

**NOTE:** A second screwdriver will be needed to push the auto adjusting lever away from the starwheel so that the starwheel can be rotated backwards.
12. Replace the rubber plug in the adjusting slot and lower the wheel to the ground.
13. Repeat the above procedure on all brakes. For best results, the brakes should all be set at the same clearance.

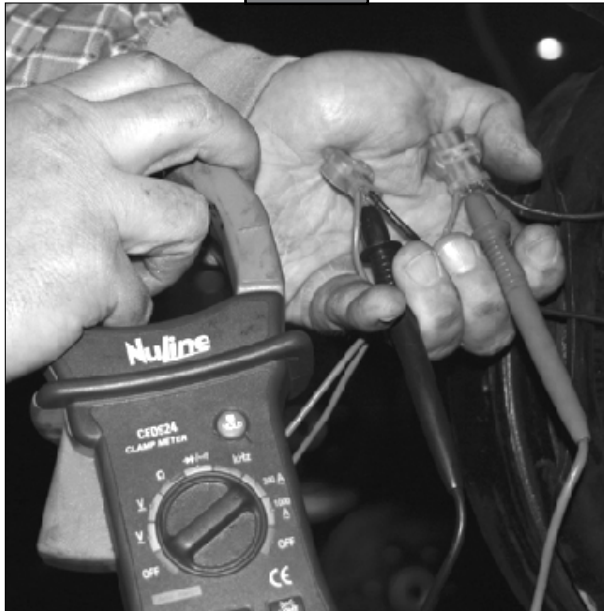
Fig. 22

Make sure that the wires are properly reconnected and sealed after testing is completed. Testing for Amperage can be done with probes (Fig. 22) or alligator clips on the leads or an amp clamp (Fig. 23).
