Technical Service Bulletin

GROUP CAMPAIGN	NUMBER 23-01-037HG
DATE JUNE 2023	MODEL(S) G80 (DH)

SUBJECT: DH AUXILIARY CANISTER INSTALLATION
(SERVICE CAMPAIGN 902G)

Description: Certain 2017-2020MY G80 vehicles may exceed evaporative emissions standards due to Onboard Refueling Vapor Recovery (ORVR) system. To correct this symptom, install an auxiliary canister assembly between the canister and Canister Close Valve (CCV).

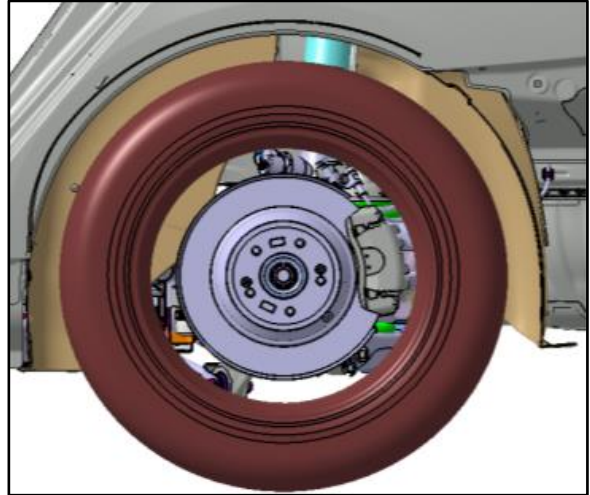
1. Lift the vehicle.

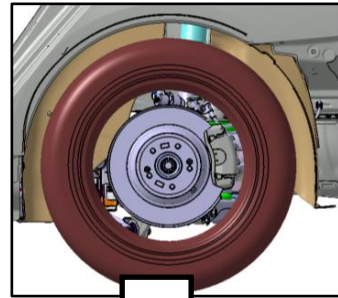
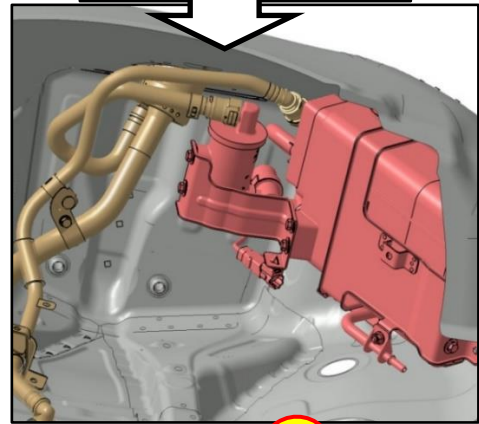
2. Remove the tire and wheel guard to expose the inside LH rear wheel housing.

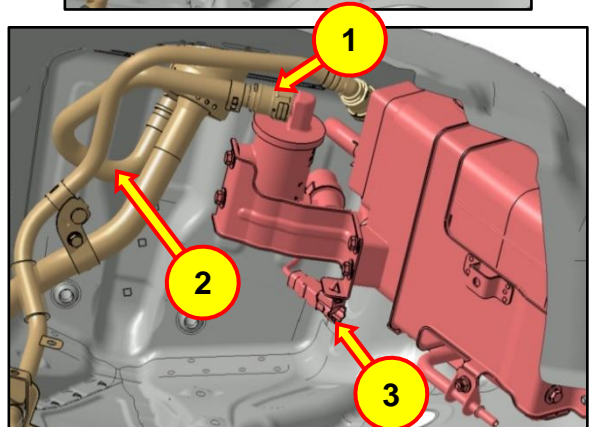
3. Remove the air filter and CCV.

1. Remove the vent hose connected to the air filter.
2. Cut the middle of the vent hose to prevent interference as it is not going to be used and will hang freely.
3. Remove the vehicle side CCV extension wire connector.

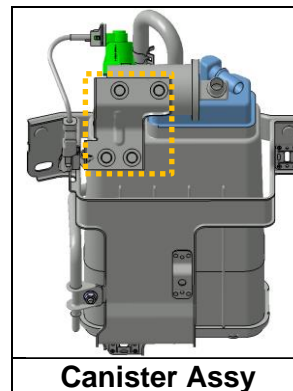
4. Remove the bracket mounting bolts at the Canister Assy and the bolt securing the bracket to the air filter.

Keep bolts for reuse.

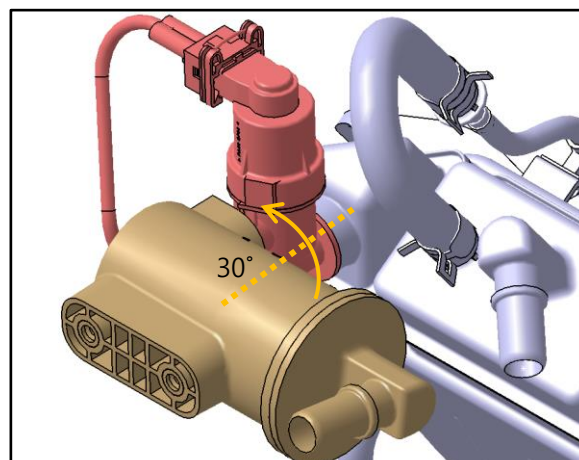
5. Remove the connected air filter, CCV, and air filter bracket assembly by rotating the assembly 30° counterclockwise and detaching it.

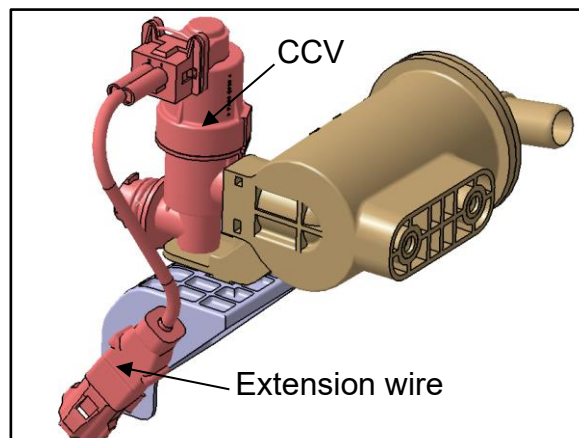
6. Remove the CCV and extension wire from the removed assembly by rotating clockwise.

The CCV and extension wire will be reused.

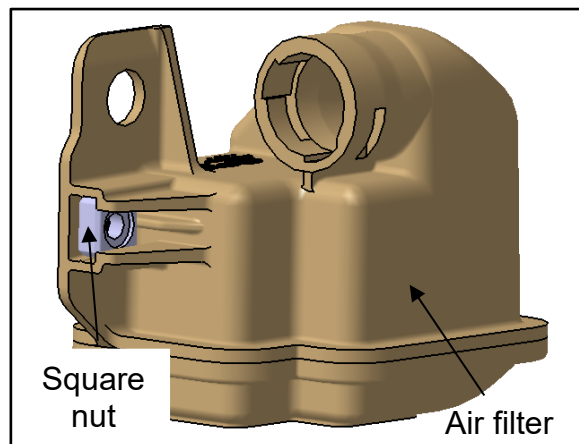
7. Attach the square nut to the new supplied air filter.

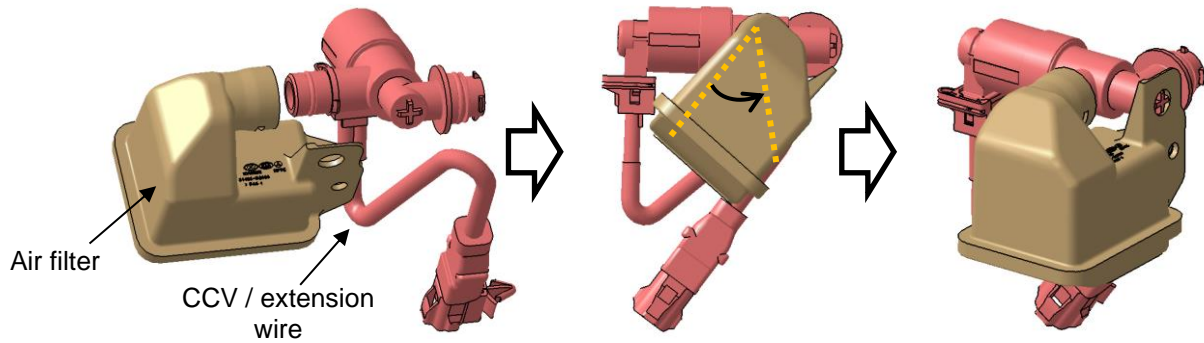
8. Attach the air filter to the CCV and extension wire. 40° rotation

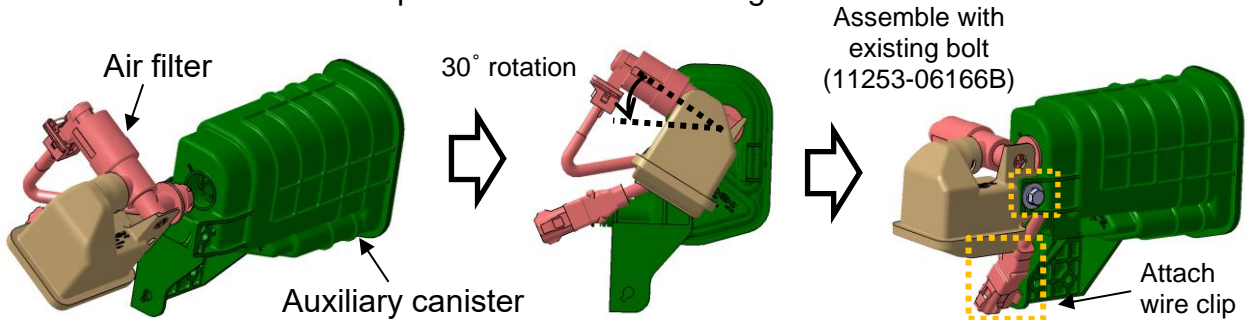
9. Install the assembled air filter to the auxiliary canister.

Attach the wire extension clip to the canister mounting hole.

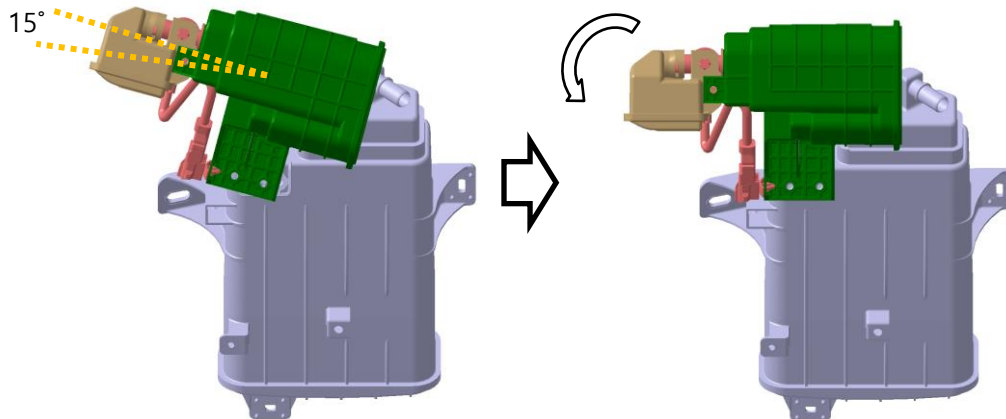
10. Press and rotate the auxiliary canister 15°, then rotate the canister back in the reverse direction.

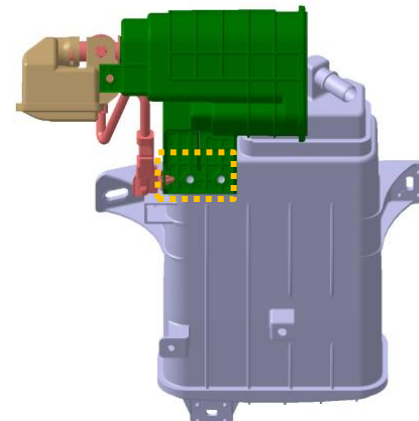
11. Reassemble the removed air filter bracket mounting bolts.

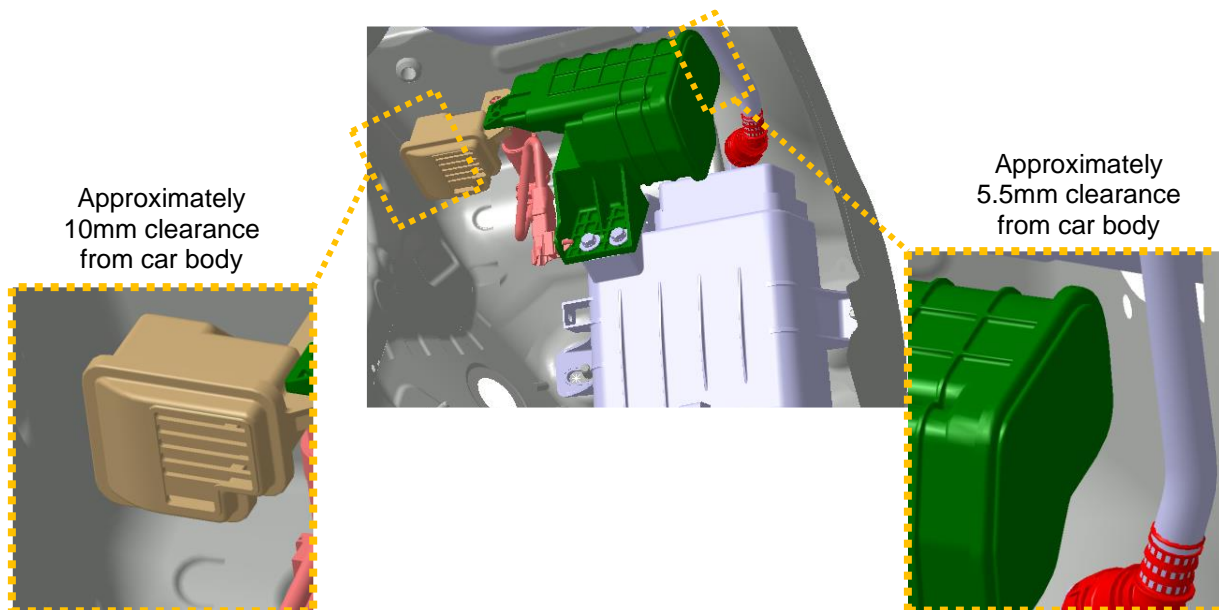
12. Verify the auxiliary canister assembly installation using the reference diagrams below.

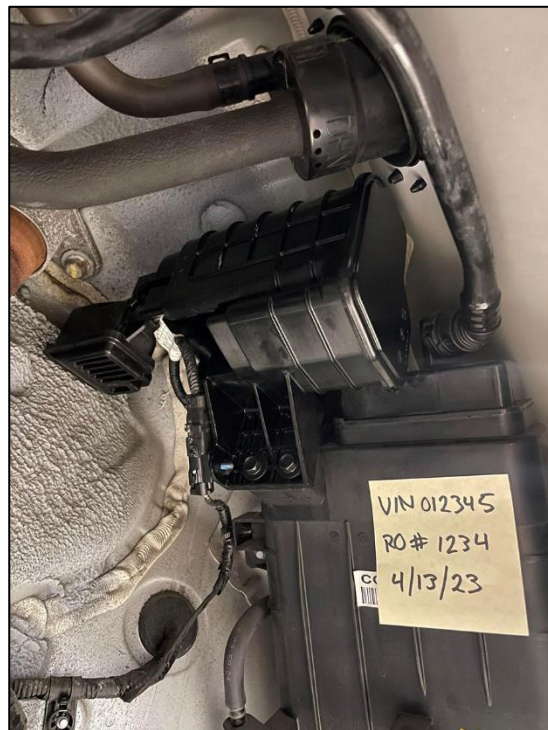
Using STUI, photograph the auxiliary canister along with the last 6 digits of the VIN and the date of the repair on a piece of paper.

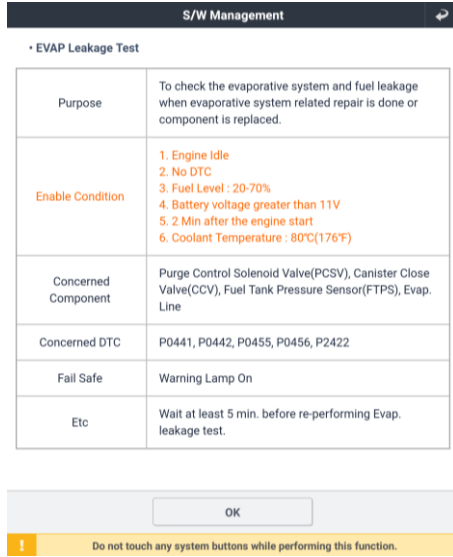
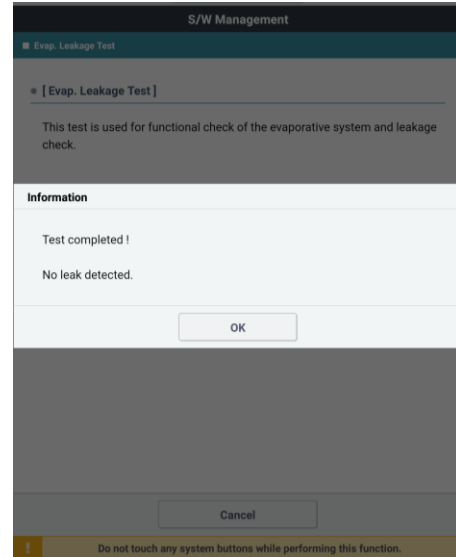
15. Perform GDS Evap Leakage Test according to the GDS instructions.

This confirms installation of parts and hoses are secure without a vacuum leak.

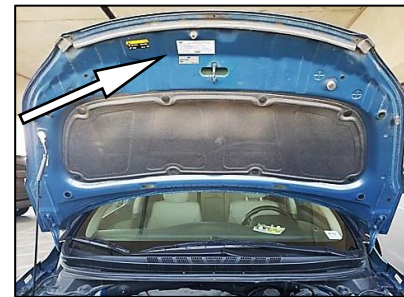
16. Using a permanent marker or pen, fill in the information on the 00305-SC902G Campaign Sticker and apply onto the hood in the area next to the Emission Label as shown.

Be sure to clean the mounting surface to ensure proper label adhesion.

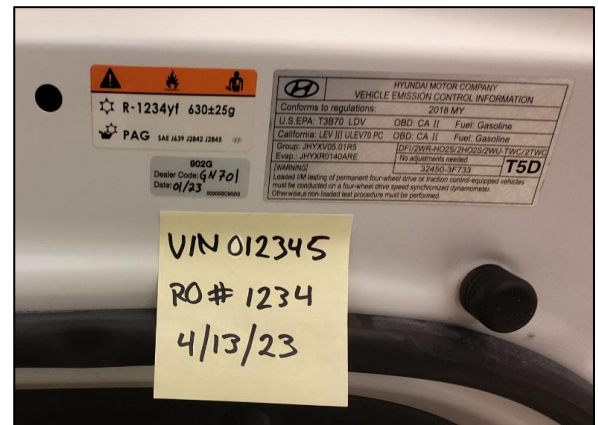
17. Using STUI, photograph the already installed campaign sticker next to the emissions label with the last 6 digits of the VIN and the date of the repair on a piece of paper.
