Technical Service Bulletin

GROUP HYBRID CONTROL	NUMBER 23-HC-001H
DATE JUNE 2023	MODEL(S) SONATA HYBRID (YF HEV)

SUBJECT: HYBRID POWER RELAY DTC P1B25, P1B76, P1B77, P0A0D

Description: On certain Sonata hybrid (YF HEV) vehicles, the HEV safety plug or power relay assembly (PRA) may cause the following symptoms and one or more current related DTCs. Follow the Service Procedure before diagnosing the hybrid battery. Please review the following instructions carefully to determine applicability depending on the model year of your vehicle.

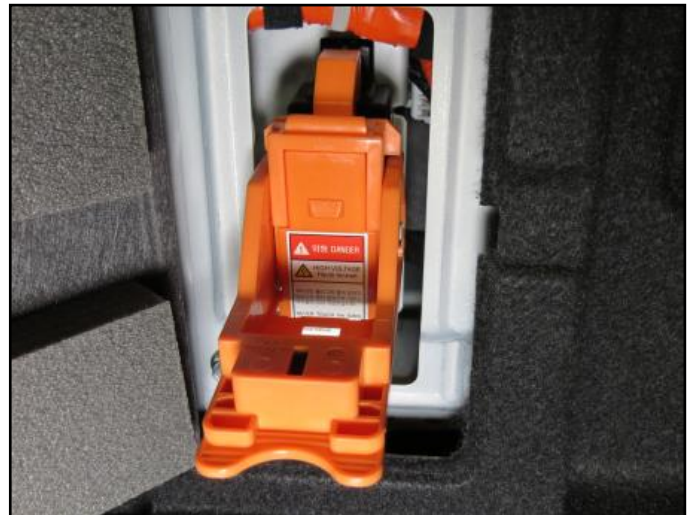
Put on insulating gloves and pull up on the black tab and pull out the safety plug.

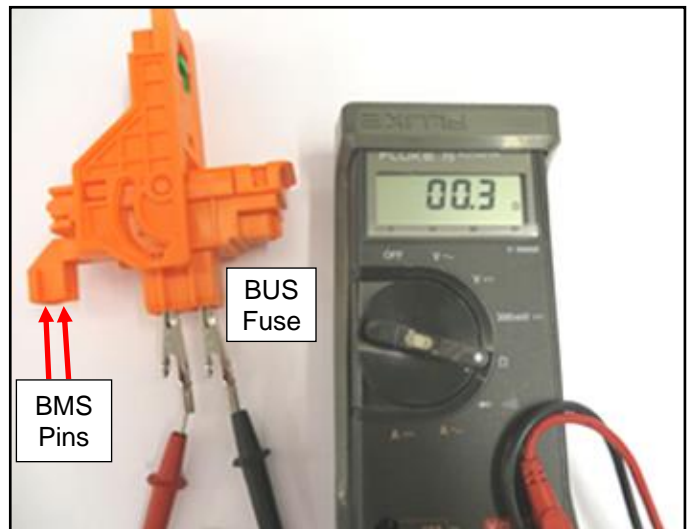
5. Use a DVOM to measure the resistance of the BUS fuse inside the safety switch.

Measure the resistance between the BMS pins.

Specification: 1Ω or less

- Not within specification: Replace the safety plug and proceed to step 7.
- Within specification: Go to step 6.

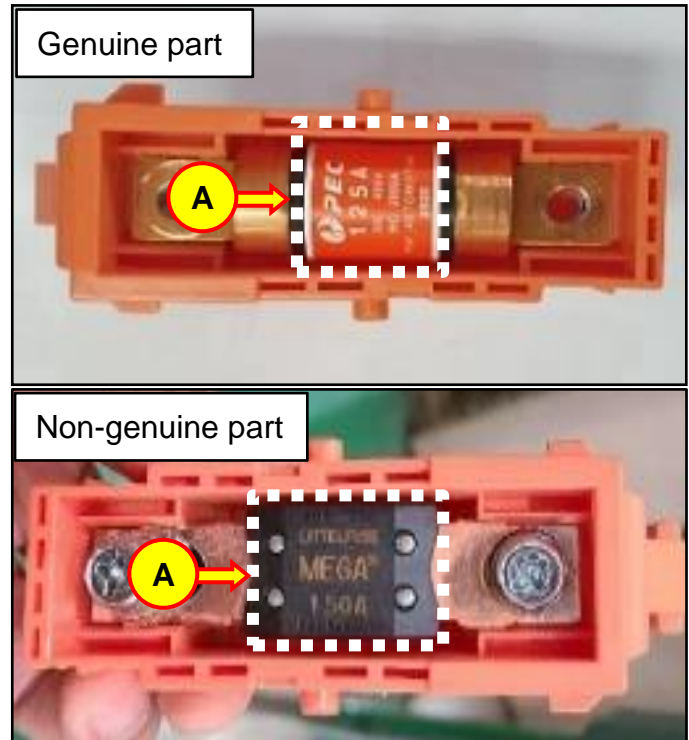
6. Visually inspect the lower part (A) of the safety plug to see if the fuse is genuine or non-genuine as shown at right.

- Genuine part (“PEC” Branded): No need to replace. Reinstall all parts in reverse order of removal and proceed to step 8.
- Non-genuine part: Replace the safety plug, reinstall all parts in reverse order of removal.

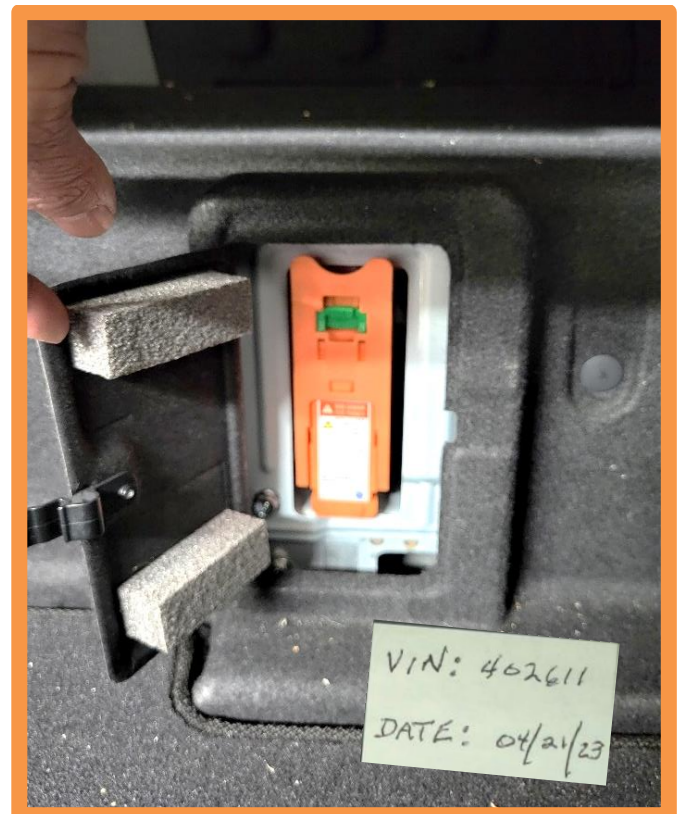
Using STUI, photograph the installed Safety Plug with the last 6 digits of the VIN and the date of the repair on a piece of paper.

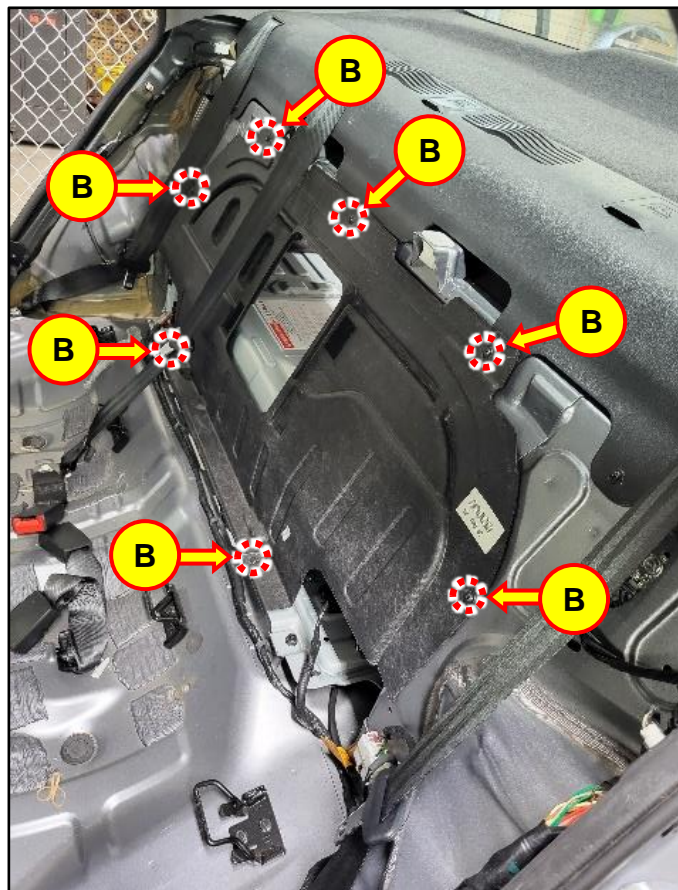
Remove the 7 screws (B) securing the rear seat access cover.

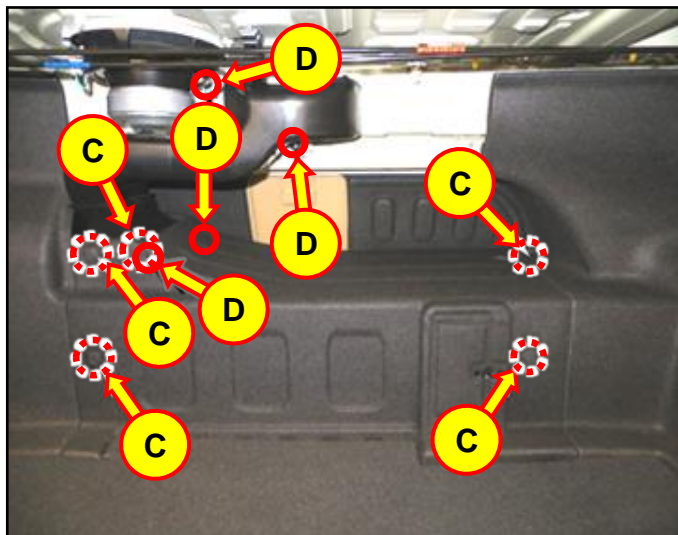
Remove the 5 fasteners (C) and remove the carpet trim.

Remove the 4 nuts (D) securing the air duct and remove the air duct.

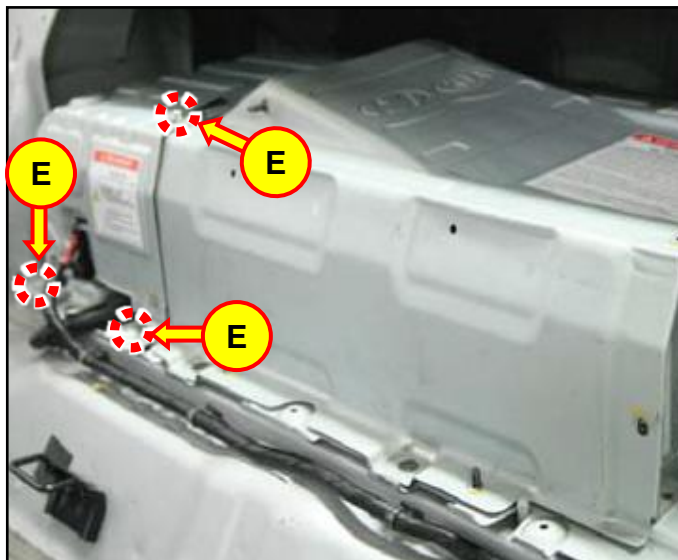
10. Remove the nuts and bolts (E) securing the steel cover and remove the cover for the power relay assembly (PRA).

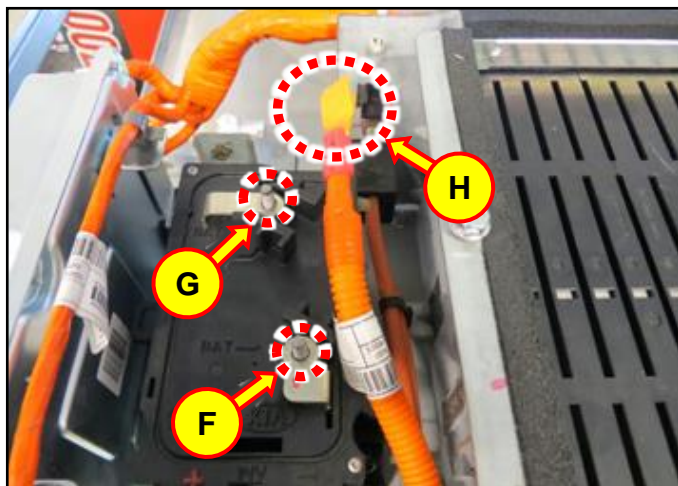
Remove the negative (-) cable (F) first and wrap the cable end with insulating tape.

Next remove the positive (+) cable (G) and wrap the end with insulating tape (H).

lb-ft	7.3
lb-in	87
N.m	9.4

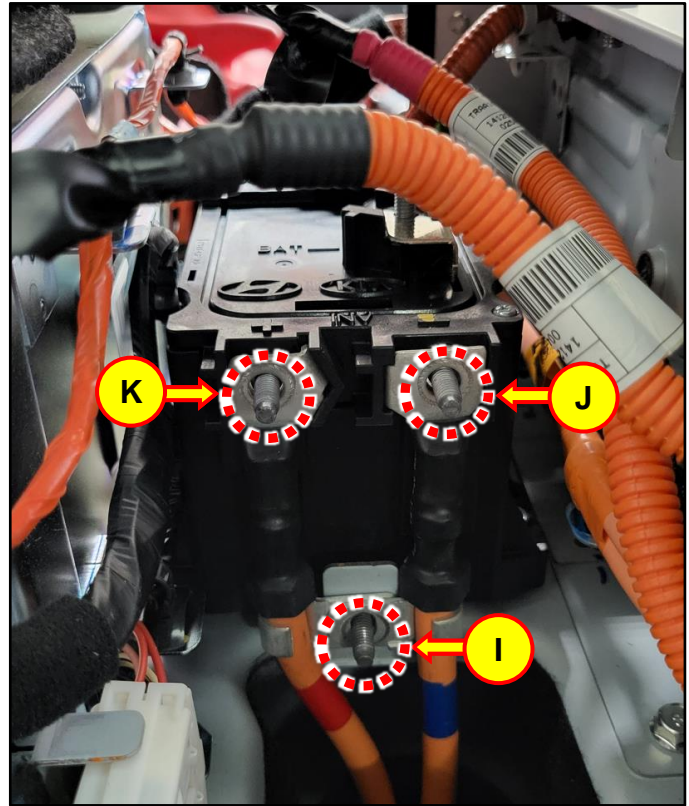
Remove the 10mm nut securing the inverter cables to the power relay assembly (PRA) (I).

Remove the negative (-) inverter cable (J) first, then the positive (+) cable (K).

lb-ft	7.3
lb-in	87
N.m	9.4

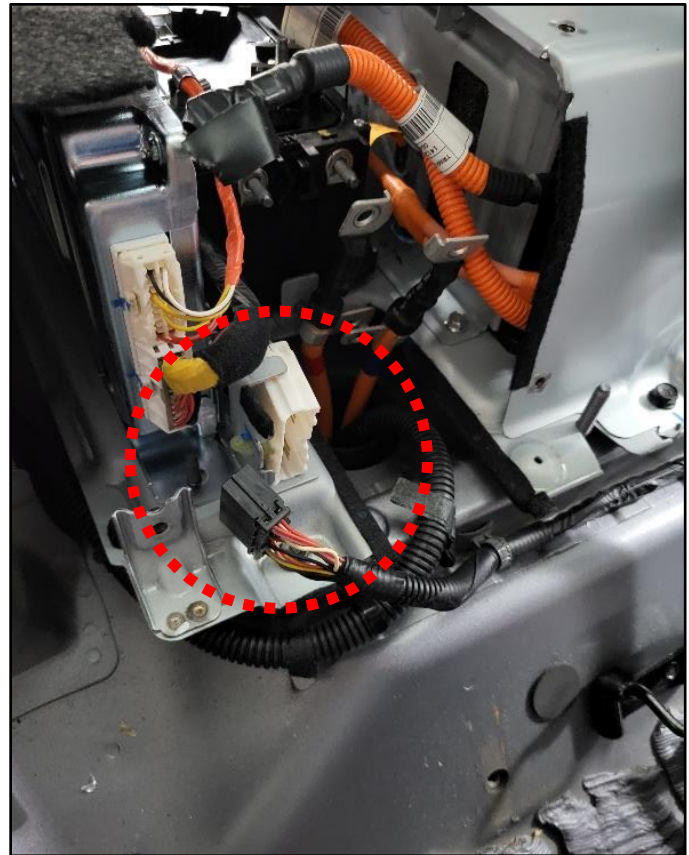
13. Remove the black connector here as well as the mating connector anchored to the steel tab to gain access to the nut securing the BMS ECU.

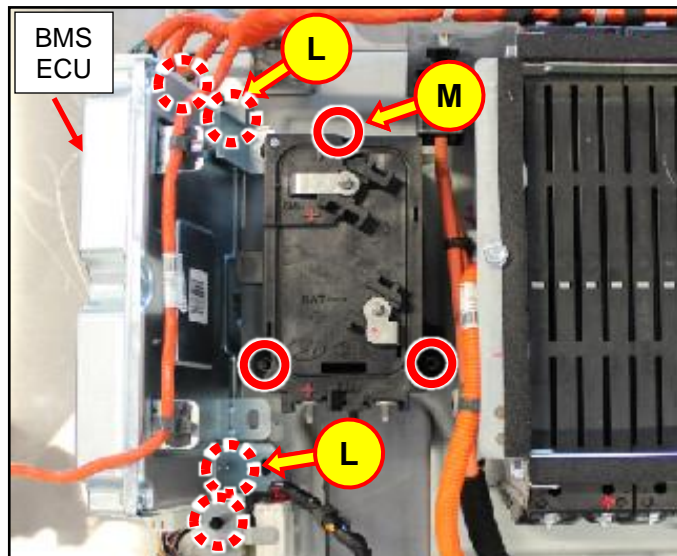
- Loosen the four nuts (L) and tilt the BMS ECU to the left to provide clearance between it and the power relay assembly (PRA).

Remove the three mounting nuts (M) and remove the power relay assembly (PRA). Install a new PRA following the reverse order of removal.

lb-ft	7.3
lb-in	87
N.m	9.4

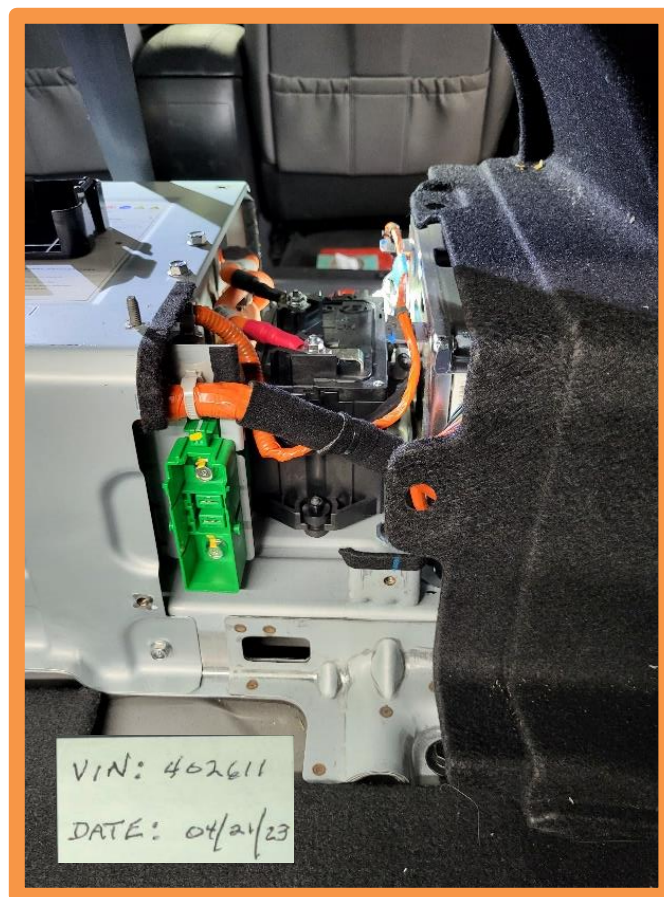
Using STUI, photograph the installed PRA with the last 6 digits of the VIN and the date of the repair on a piece of paper.
