Technical Service Bulletin

| GROUP CAMPAIGN | NUMBER 23-01-051H-1 |
| DATE JUNE, 2023 | MODEL(S) TUCSON PLUG-IN (NX4 PHEV) & SANTA FE PLUG-IN (TM PHEV) |

SUBJECT: COOLING SYSTEM CIRCUIT DEBRIS DISCHARGE AND COOLANT CHANGE (SERVICE CAMPAIGN T9F)

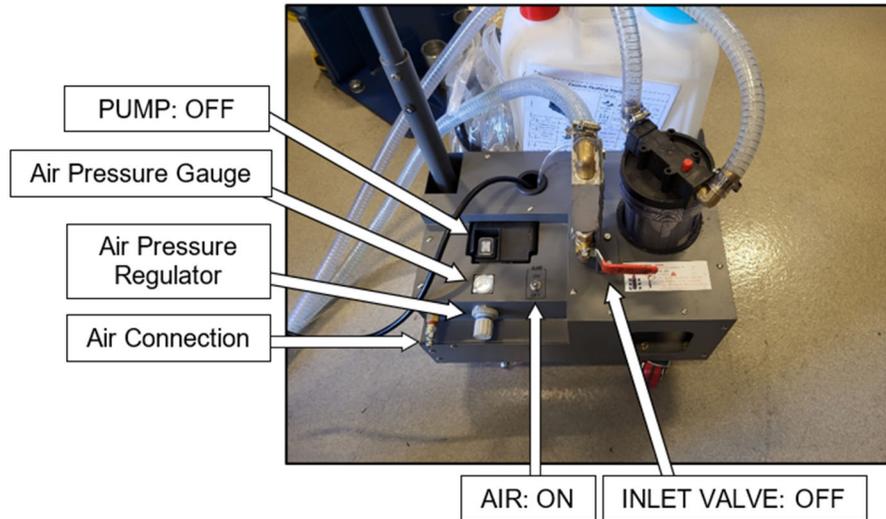
1. Air Draining (Coolant discharge)

- a. When discharging the remaining coolant using air, turn off the coolant pump and close the inlet valve. (If the inlet valve is opened, the air may flow back and the remaining coolant may not be recovered.)
- b. Equipment setting condition:
 - i. **Air 'ON', Pump 'OFF', Inlet valve 'OFF'**

- c. The air pressure can be adjusted up to 3 bar to achieve desired draining performance.

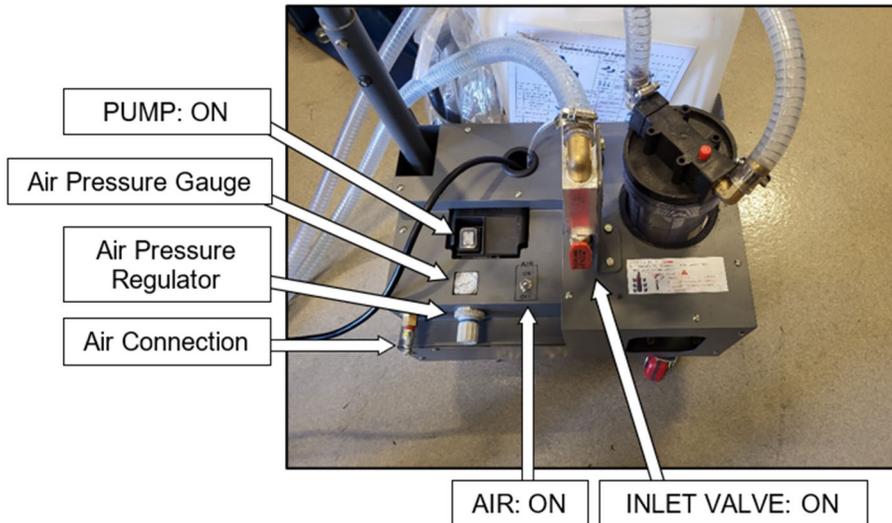
2. Coolant Cleaning (Flushing and filtering of the vehicle's coolant circuit)

- a. Equipment setting condition:
 - i. **Pressure 2 bar, Air 'ON', Pump 'ON', Inlet valve 'ON'**

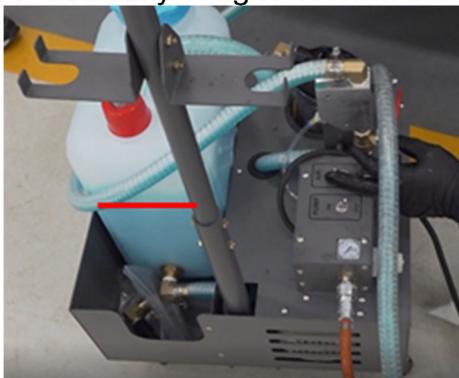
The coolant circulation container must always have 8L (about half of the reservoir bottle) of either tap water, distilled water or coolant (blue BSC-2) that was discharged from the previous vehicle. Never use salty or light water in the coolant circulation container.

- For cleaning equipment, make sure to turn on the water pump first and then turn on the air. After turning on the air, visually check whether the air comes out from the end of the inlet of the equipment. When air does not come out, operate the air pressure valve to increase the pressure a little to check that air comes out and set it to 2 bar.

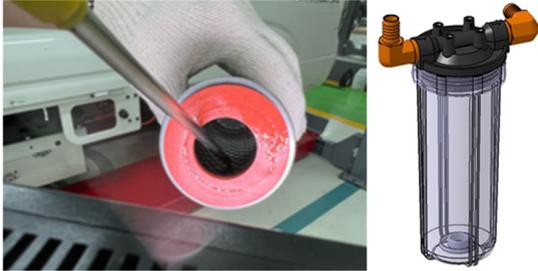
After one cleaning operation is completed, clean the filter & filter case of the equipment with an air gun to remove foreign substances.

- Ensure to remove as much of the foreign substances as possible.
- A poorly cleaned filter can result in decreased flow rate and degrade the cleaning effect of the cleaning machine.

- Sludge can get stuck to the inner wall of the filter gaps, be sure to clean the filter evenly.

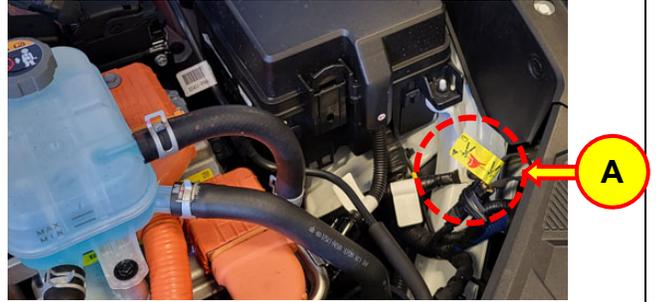
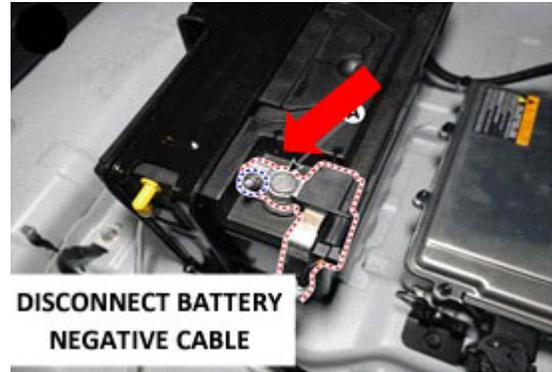
1. Check for blue coolant inside the inverter reservoir tank.
2. Using the GDS under “Data Analysis”, monitor the initial RPM of the EWP when starting vehicle to confirm Refill Inverter Coolant warning.
 - Spec is 2,000 – 2,800 RPM
 - “Refill Inverter Coolant” displayed above 2,800 RPM.
3. Turn off the vehicle and remove the service interlock connector (A). Disconnect the negative battery cable under the rear deck in the hatch area.

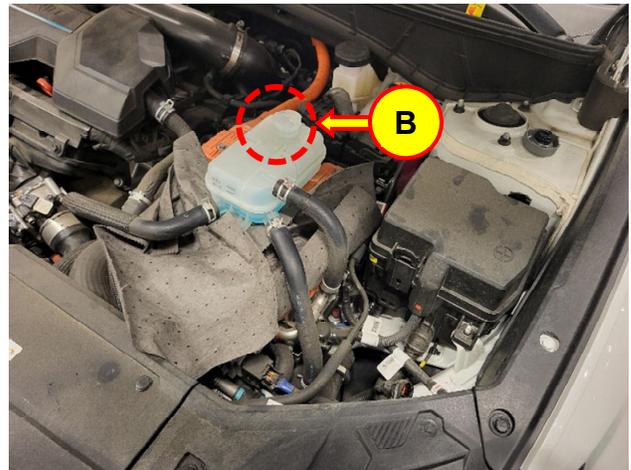
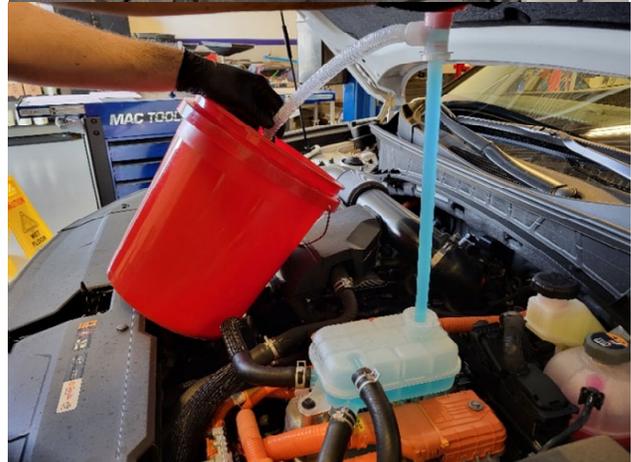
**Siphon Pump Hose**

4. Remove the reservoir tank cap (B) then remove the coolant from inside the tank using the Siphon Pump Hose.
 - Use a bucket to catch the coolant that comes out from the discharge side of the Siphon Pump Hose as seen in the photo.

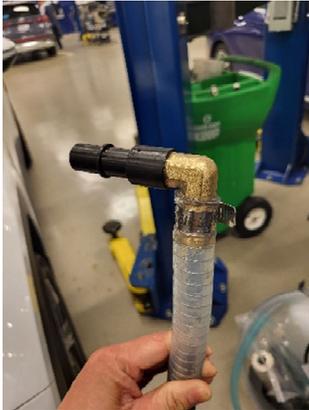
5. Ensure that the supplied 90Deg angled hose fittings are installed on the hose ends.

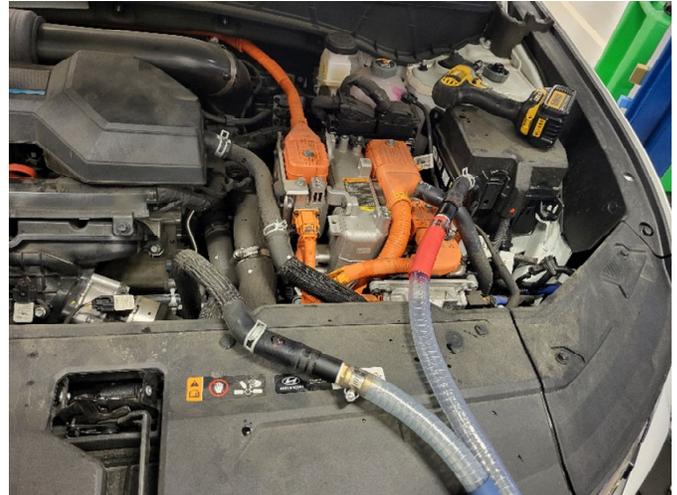
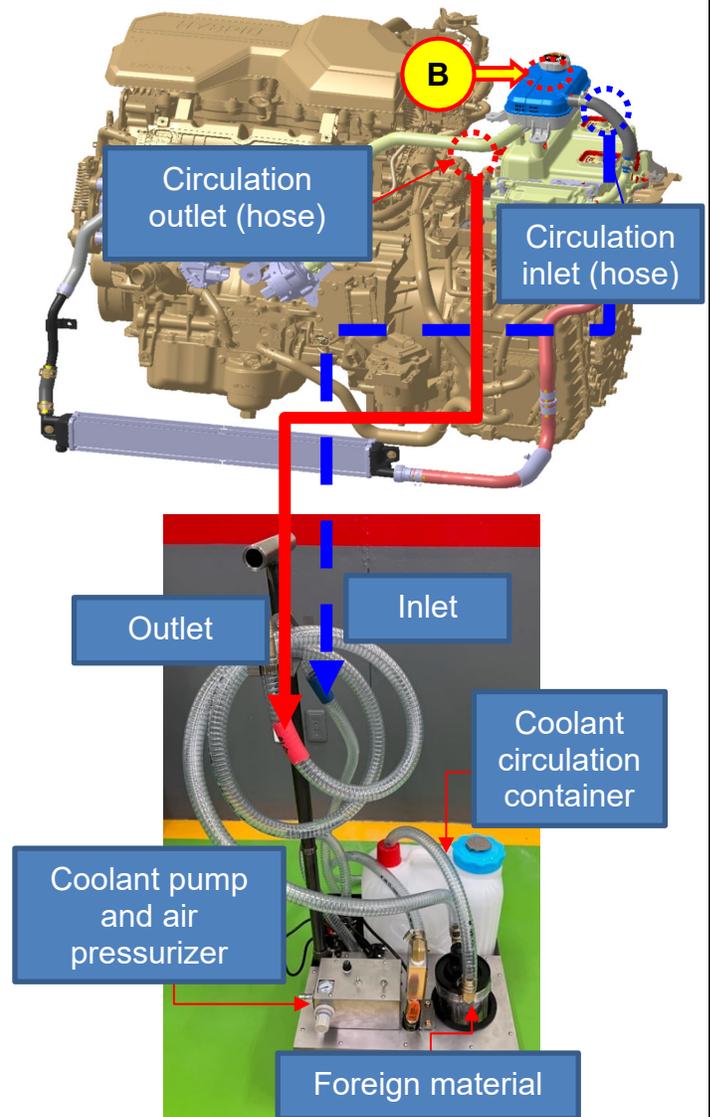
6. Disconnect the two hoses from **the reservoir tank** and connect them to the cleaning equipment as follows:

- Circulation inlet hose **Blue** to the hose located **on the left side of the reservoir tank.**
- Circulation outlet hose **Red** to the hose located **on the upper right side of the reservoir tank.**
- Circulate coolant and air to perform a 3-minute cleaning.

7. While the cleaning equipment is in operation, remove the reservoir tank to clean the residual coolant and debris inside.

- Use tap or distilled water to flush out thoroughly ensuring there is no blue coolant residual visible.
- Once thoroughly flushed out, use an air tool to dry out the reservoir.

8. After 3 minutes, turn off the coolant pump in the cleaning equipment and allow air to blow through the system for 30 seconds. Turn off the air to the cleaning equipment.

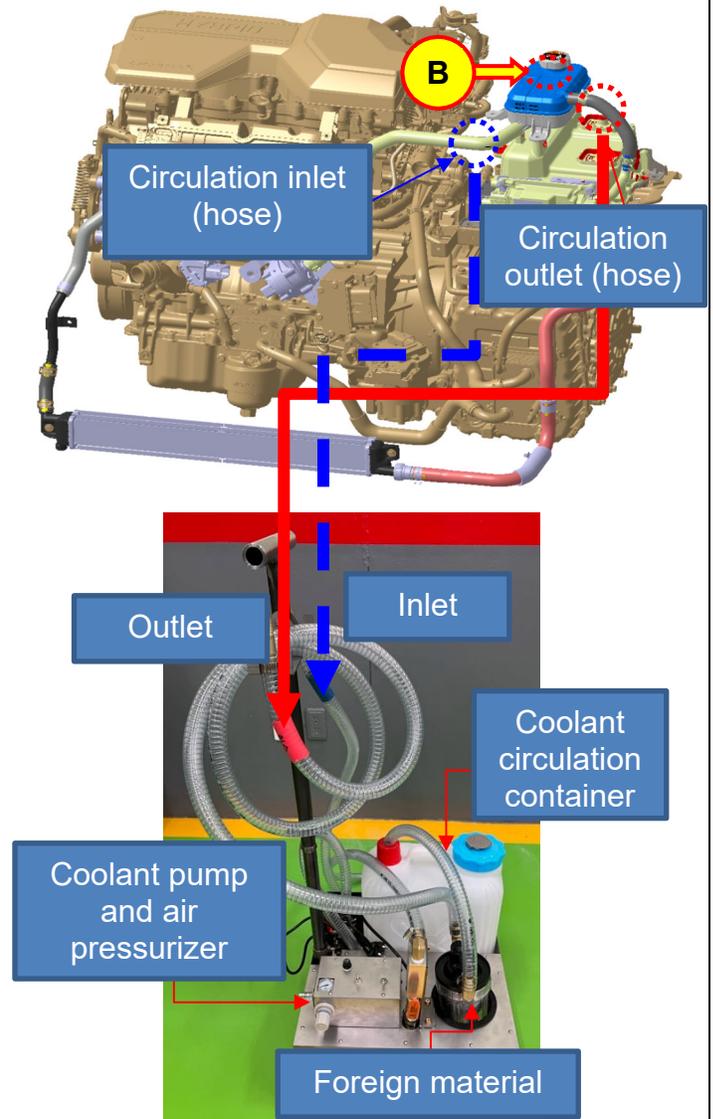
9. Reverse the hose connections from step 6.
 - Circulation inlet hose **Blue** to the hose located **on the upper right side of the reservoir tank.**
 - Circulation outlet hose **Red** to the hose located **on the left side of the reservoir tank.**

- Circulate coolant and air to perform a 3-minute cleaning.
10. Repeat operation 7.
 - After 3 minutes, turn off the coolant pump in the cleaning equipment and allow air to blow through the system for 30 seconds. Turn off the air to the cleaning equipment.

11. Repeat operation 6.
 - Circulation inlet hose **Blue** to the hose located **on the left side of the reservoir tank.**
 - Circulation outlet hose **Red** to the hose located **on the upper right side of the reservoir tank.**

- Circulate coolant and air to perform a 3-minute cleaning.
12. After 3 minutes, turn off the coolant pump in the cleaning equipment and allow air to blow through the system for 1 minute. Turn off the air to the cleaning equipment.

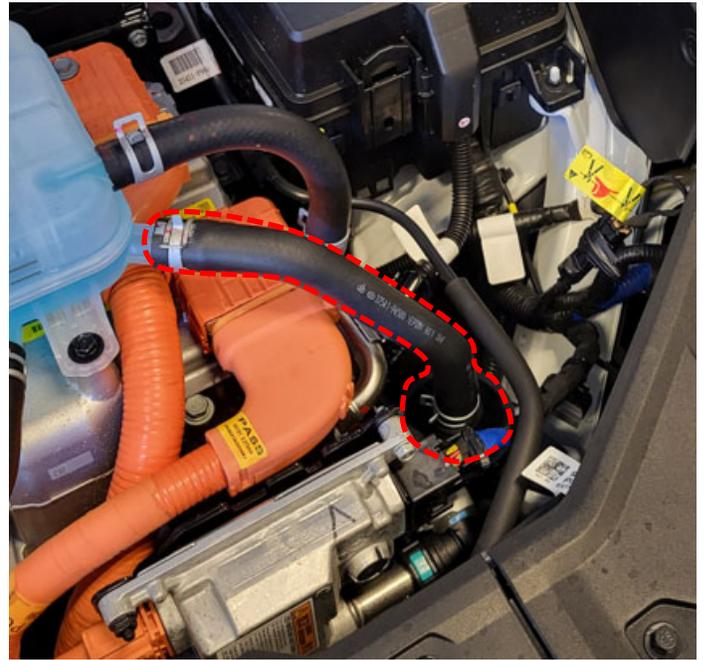
13. Remove the air separator.

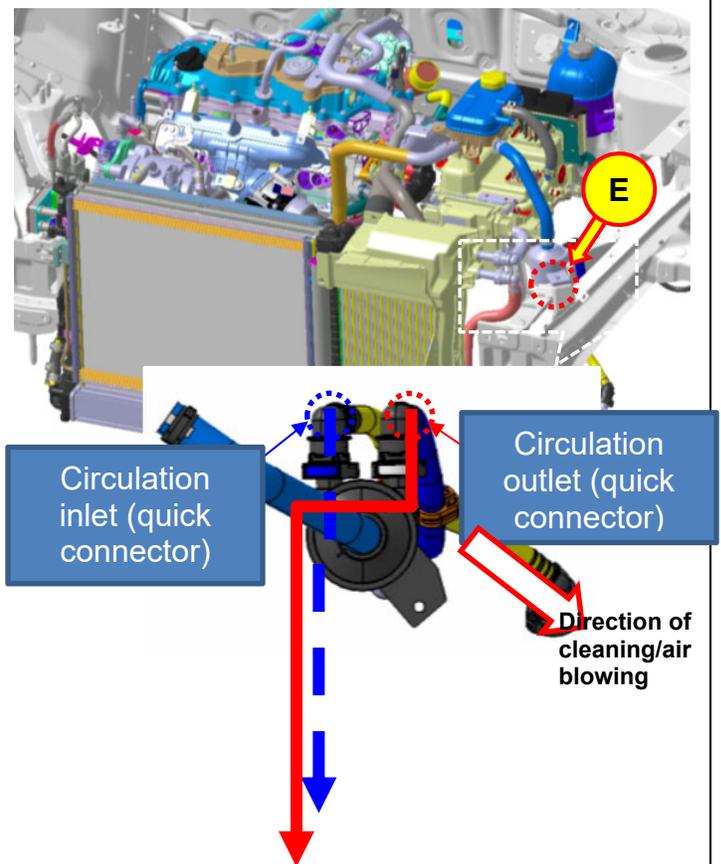
14. Disconnect the two circulation hoses from the reservoir tank hoses and connect them to the air separator hoses as follows:

- Circulation inlet hose **Blue** to the air separator inlet hose (left when looking from the top)
- Circulation outlet hose **Red** to the air separator outlet hose (right when looking from the top).
- Circulate coolant and air to perform a 5-minute cleaning.

15. After 5 minutes, turn off the coolant pump in the cleaning equipment and allow air to blow through the system for 1 minute. Turn off the air to the cleaning equipment.

16. Remove the circulation equipment and reinstall the air separator, inverter reservoir tank and all hose connections.

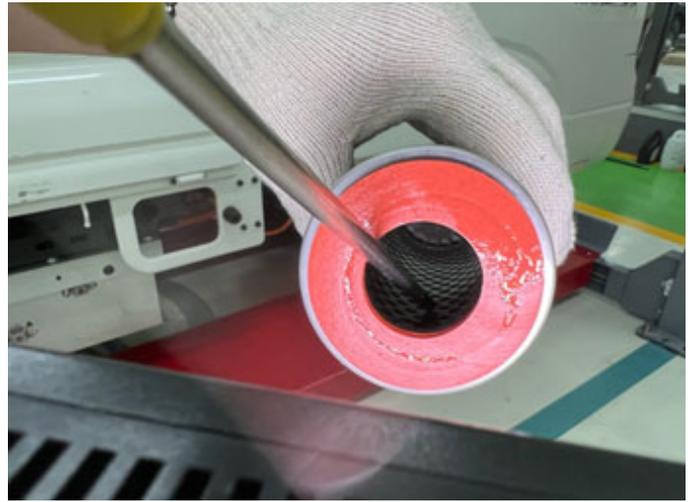
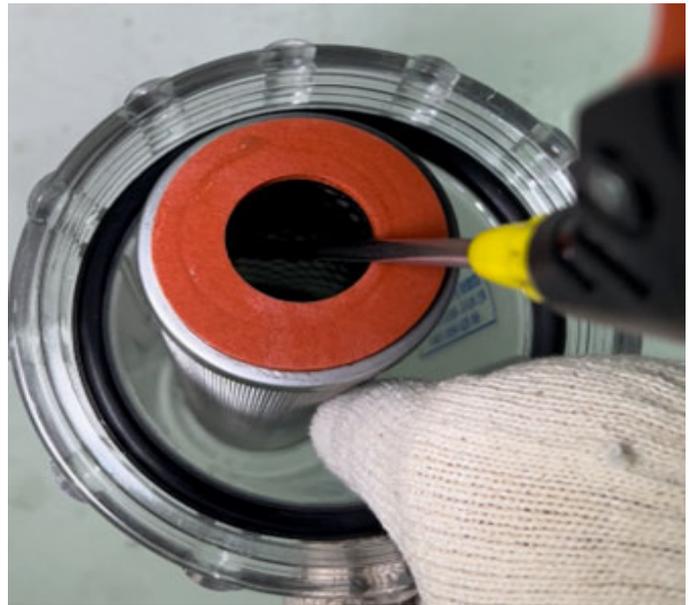
19. Clean the filter & filter case of the equipment with the air gun to remove foreign substances.

- Ensure to remove as much of the foreign substances as possible.
- A poorly cleaned filter can result in decreased flow rate and degrade the cleaning effect of the cleaning machine.
- Sludge can get stuck to the inner wall of the filter gaps, be sure to clean the filter evenly.

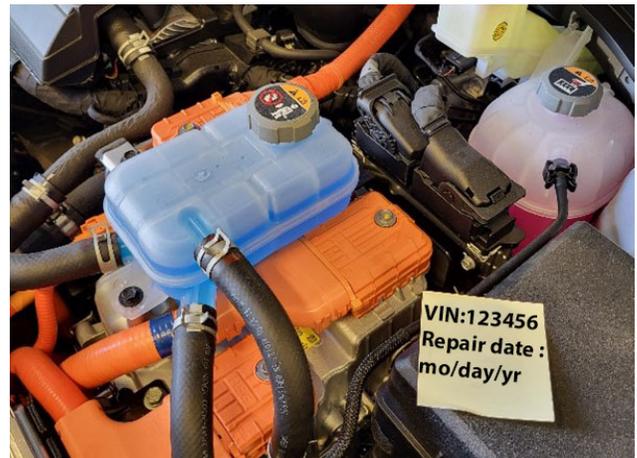
Using STUI, photograph the reservoir showing Blue BSC-2 coolant along with the last 6 digits of the VIN and the date of the repair on a piece of paper.

Upload the photo to STUI.
